Members of the American Galvanizers Association (AGA) in the Pacific Northwest region are currently experiencing a surface condition identified as laps in the steel surface (**Figure 1**) which present themselves as sharp, raised spikes after hot-dip galvanizing (**Figure 2 - Right**). These laps tend to be present on hot-formed semi-finished products, including flat bar, round/square stock, angle and channel.

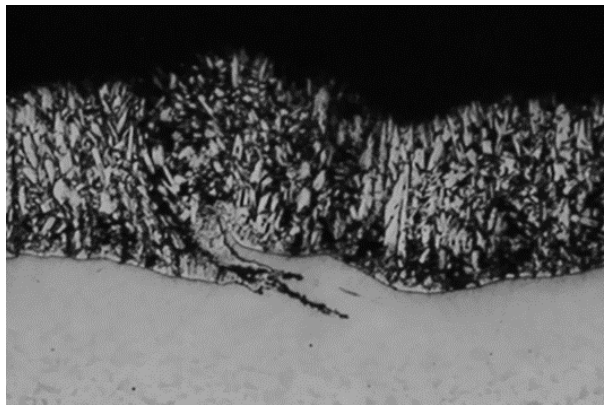
Figure 1: magnified image of lap as seen after hot-dip galvanizing

Because the raised spikes contain steel within, attempts to remedy the spiked appearance after galvanizing are often not feasible without exposure of bare metal. The bare areas experienced after smoothing can be repaired where practical using a galvanizing repair compound, or due to the small surface areas involved the surrounding zinc can provide cathodic protection to these areas with only a minor impact on overall corrosion protection.

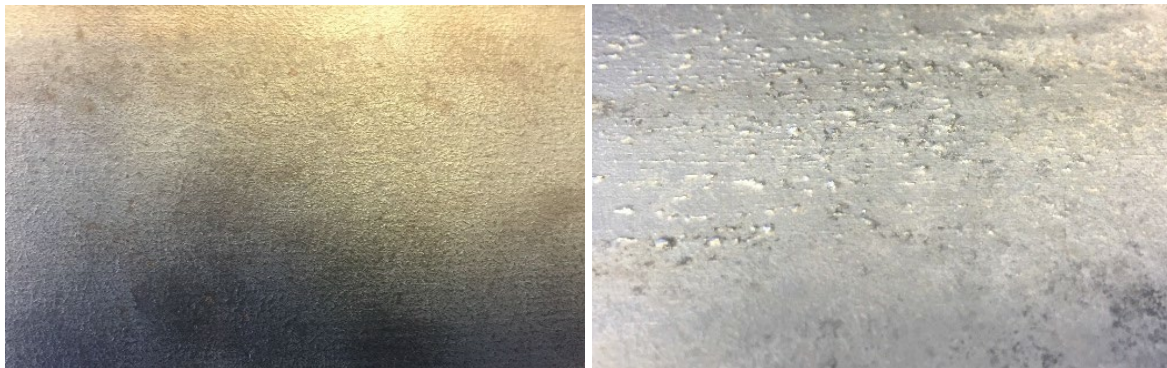
Figure 2: relatively smooth steel surface containing laps before galvanizing (left) and resulting coating formed after galvanizing (right)

This surface condition is very difficult to identify prior to galvanizing (**Figure 2 - Left**). Even if laps are detected, alternative pre-treatments such as extended pickling times and mechanical cleaning (abrasive blasting, wheel abrading) before galvanizing have not proven a successful solution for remedying the steel surface.
