Galvanizing Kettle Lessons Learned

Presentation overview

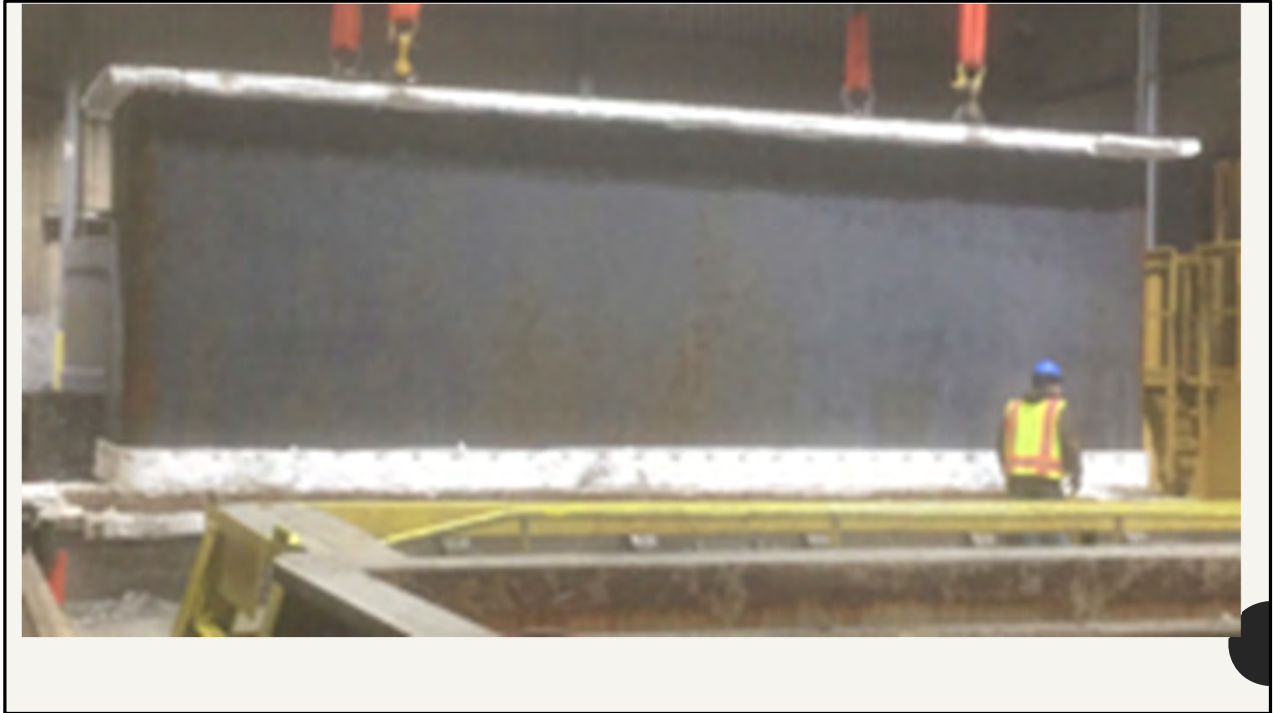
**Picture shows insulated areas of kettle in the fire chamber.
Two layers of 2" wool under lip in the ash build up area and one 2" thick layer 12" wide around the bottom of the kettle in dross area.
2" bottom plate allows for 10" of dross before you get above insulation creating a dangerous condition of overheating walls.**

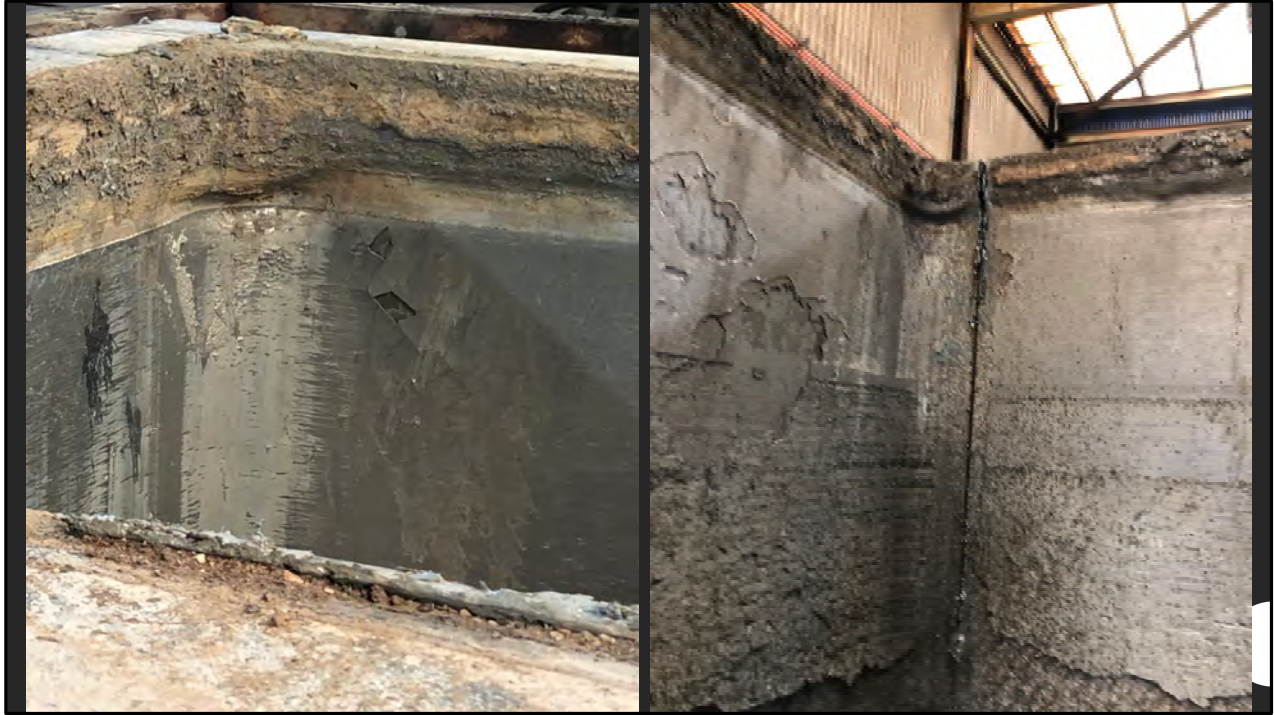
Terrible bath level control and ash buildup cleaning practices.
These pictures were at kettle change and picture on the right was when we
were cutting up after some corner buildup was removed.
(point out) Chipping that was done to cut kettle up.
Ash is an insulator, Air is an insulator, Dross is an insulator and Zinc is a
conductor.

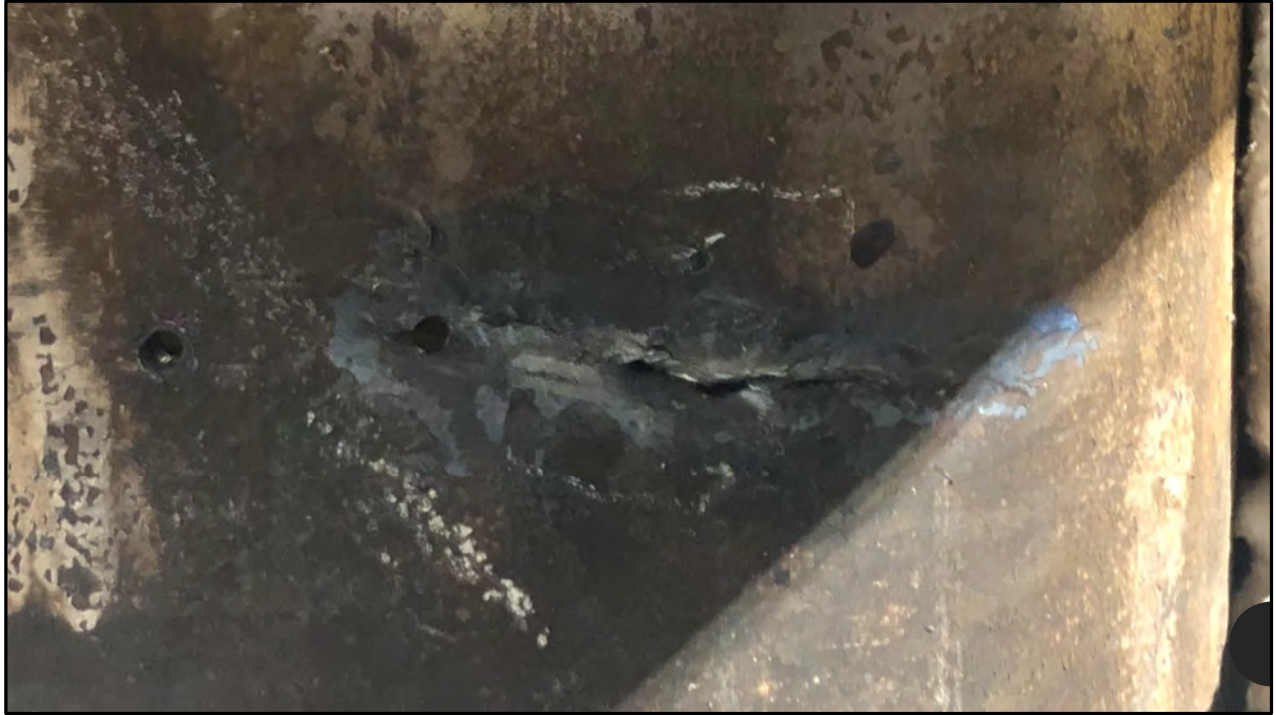
Outside view of leak

Tear in the corner of kettle from a piece of steel getting galvanized caused the leak

Drilled some holes to determine steel thickness for welding

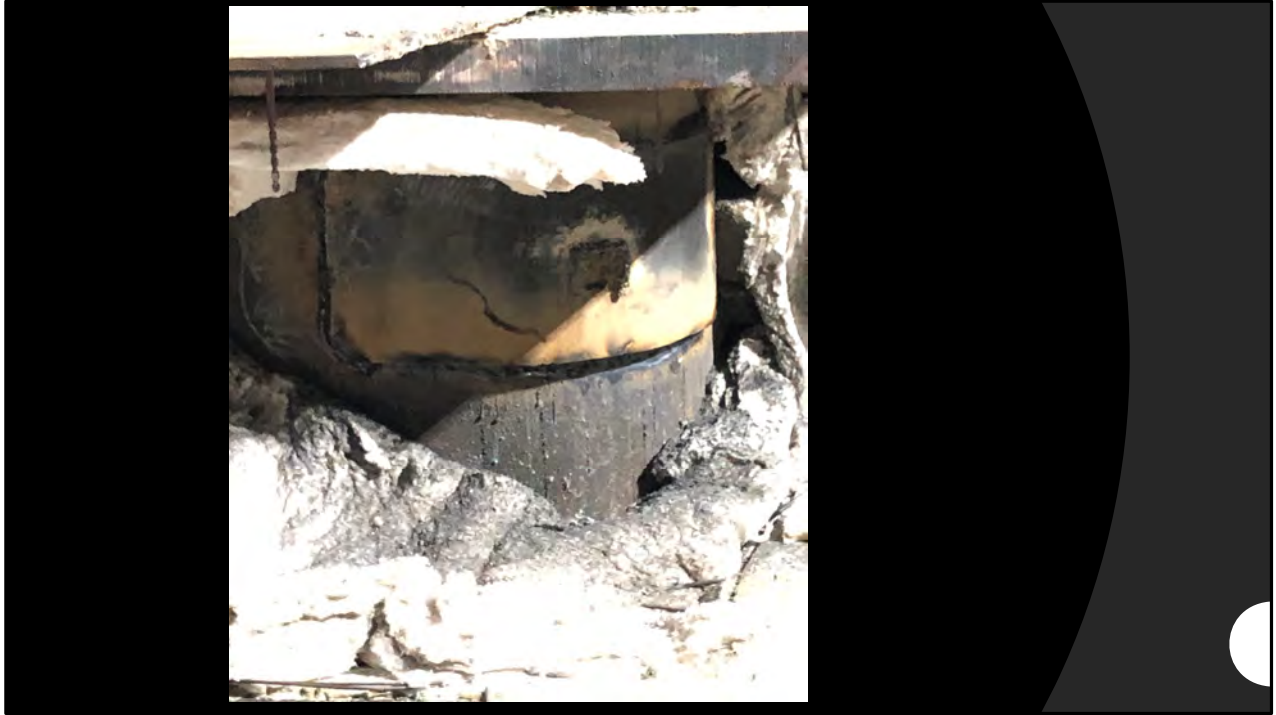
Very minimal production loss. Scooped a few pans out while identifying where leak area was.

Kettle was 7 plus years, so we scheduled for kettle change later that year.

Repair used was a radius corner patch we had on hand in our emergency leak container.

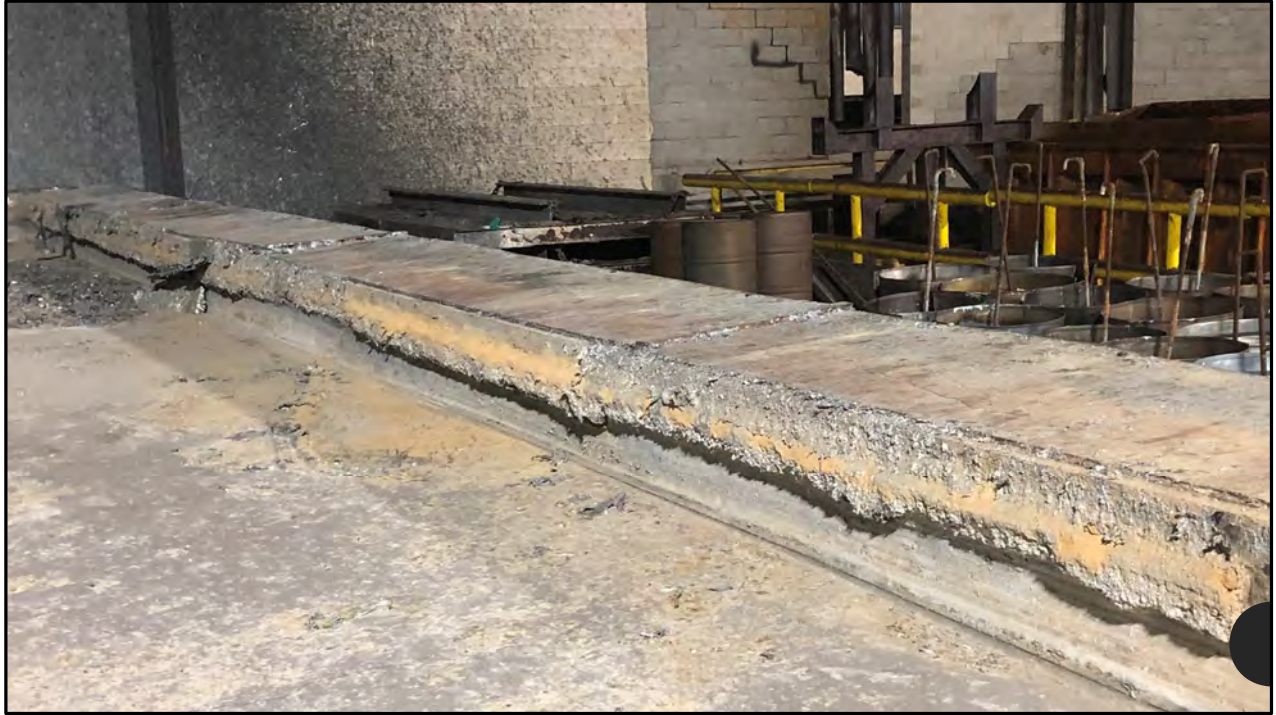
Long Wall ash build up after leak.

Corrosion rate of the steel that is being heated to over 1000 deg F can be up to 1000 times faster.

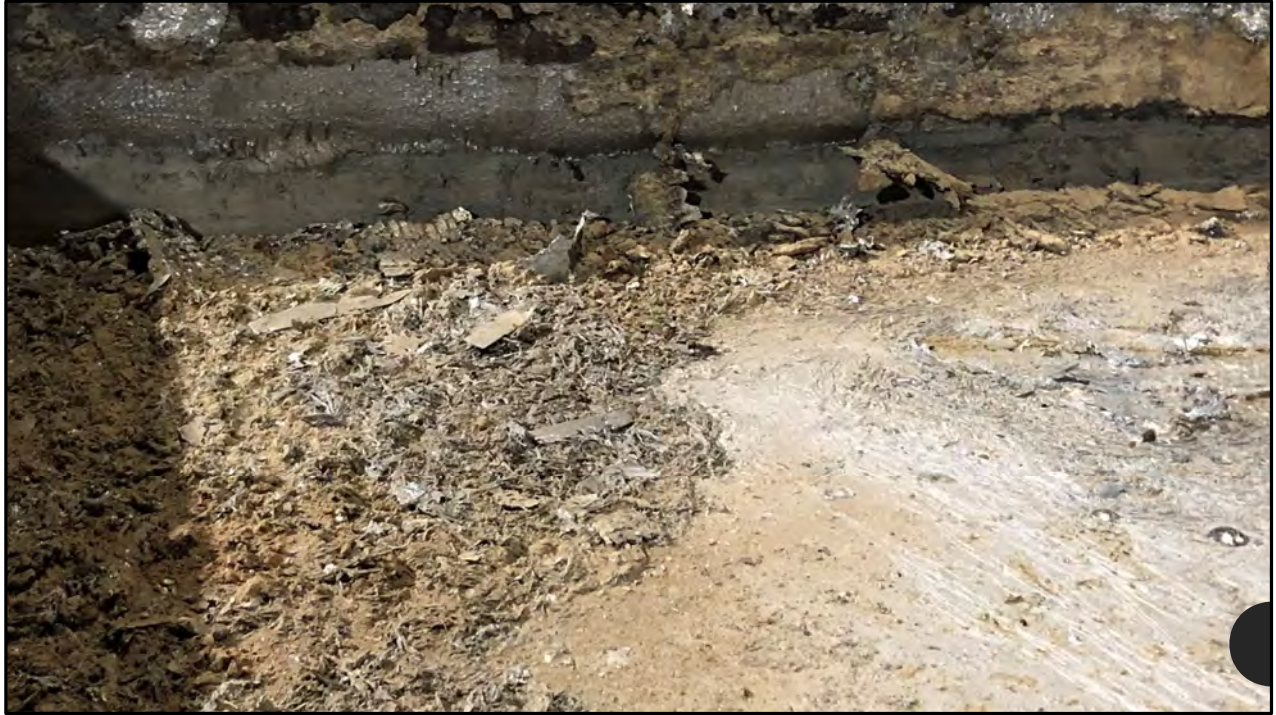
This is what you will have happen if these poor practices continue.

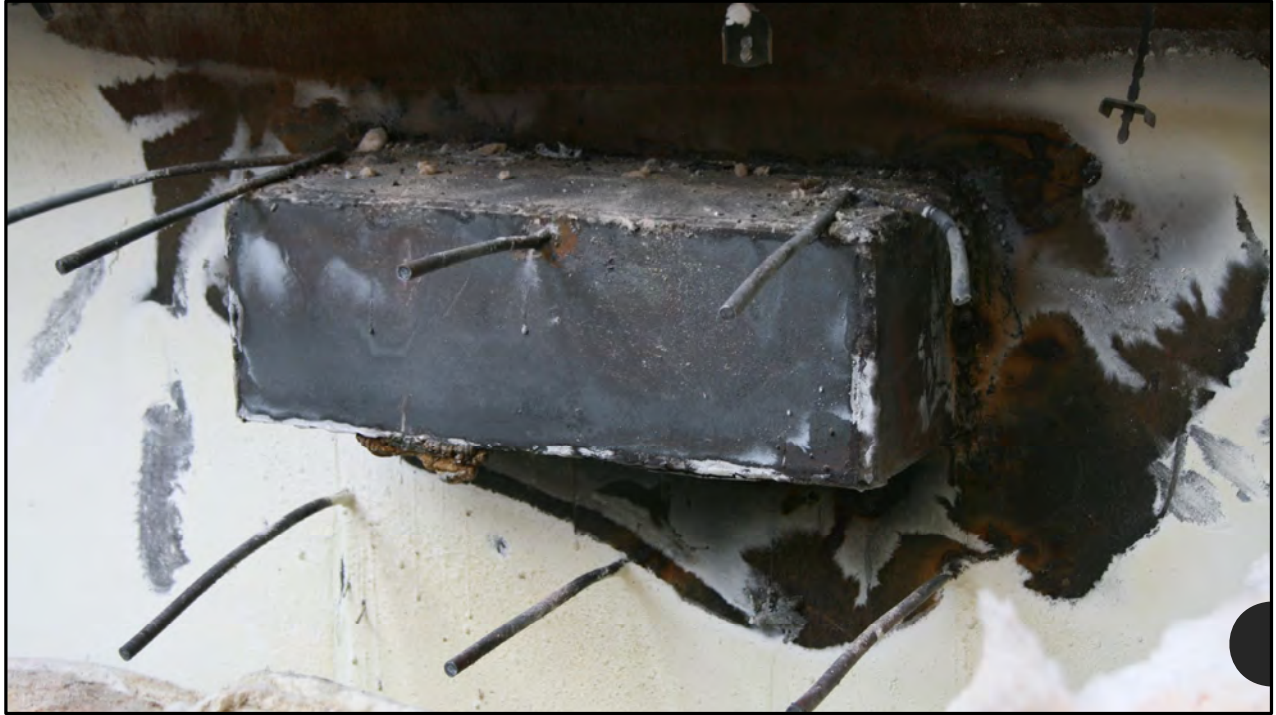
**Sidewall washout leak. Repaired with sand box insulated and this is two years later when kettle is being changed.
After being there for two years and no weld repair when we cut box off there was a nickel sized piece of zinc between sand and the hole**

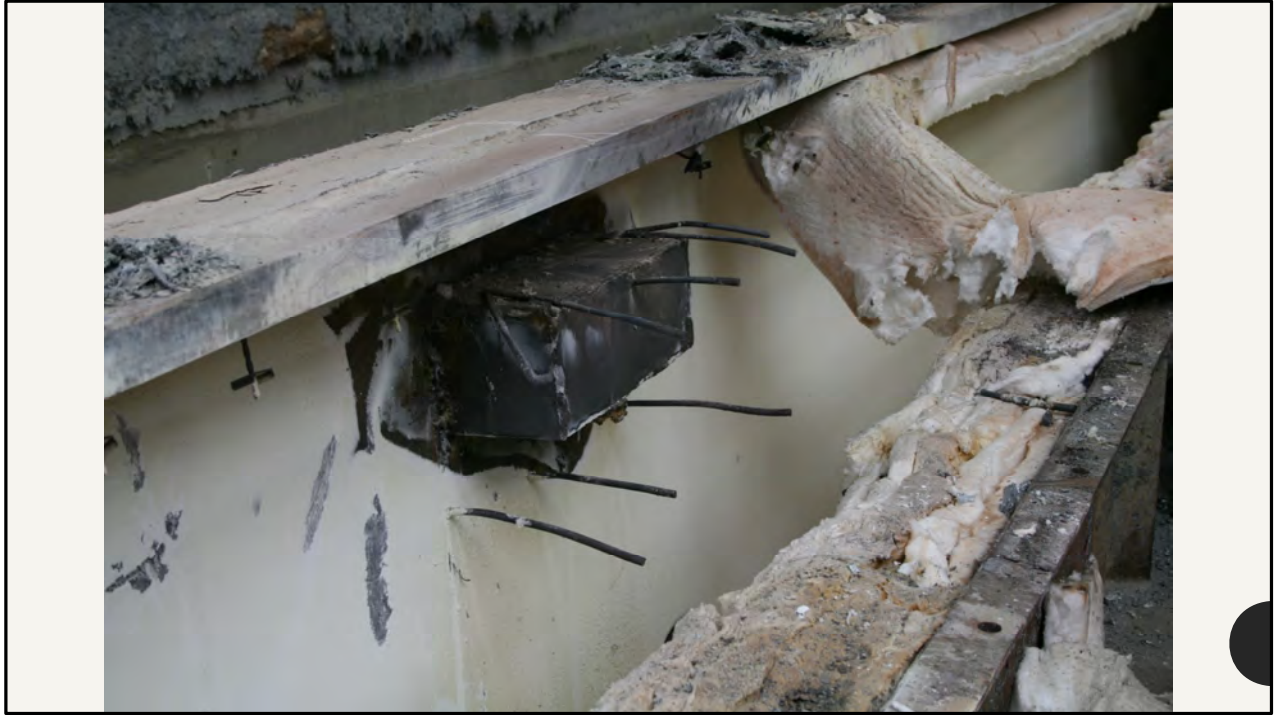
Second picture of sidewall sandbox.

Leak was right at a burner so there was white smoke from the leaking zinc spraying on the burner.

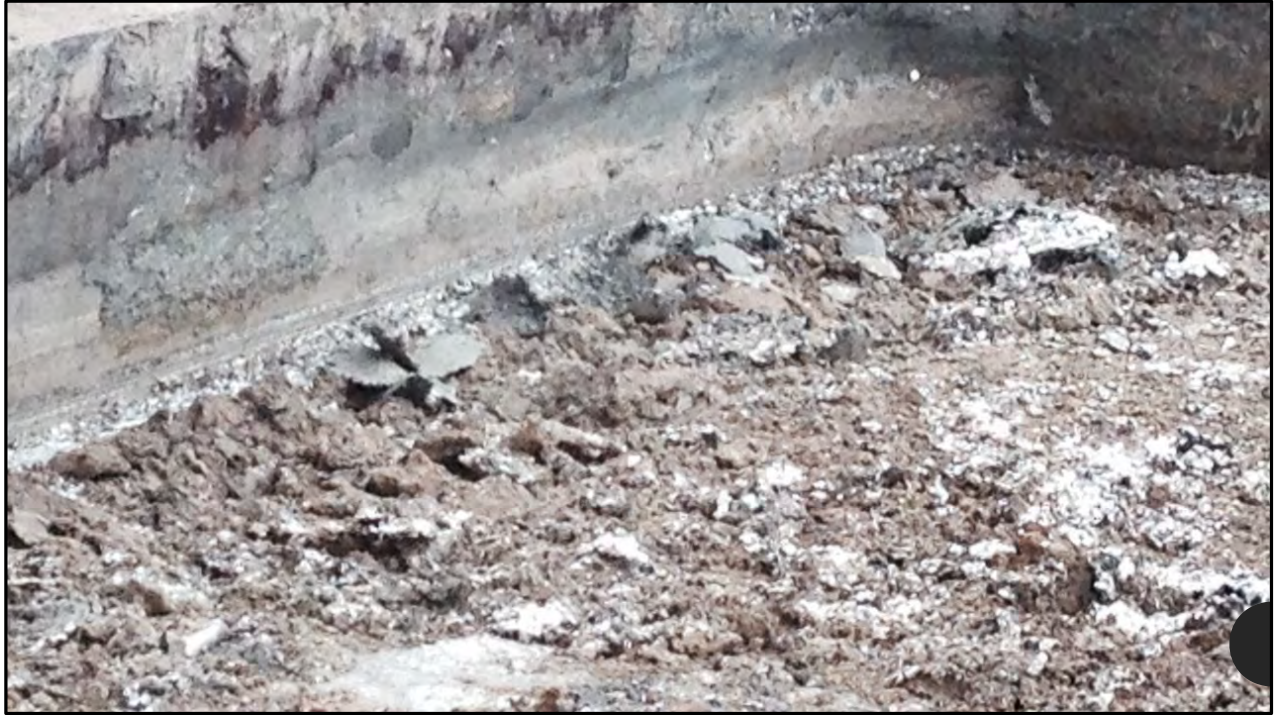
Washout 8" from top of 6 year old kettle.
If you can see erosion started just below the 6 inch point.

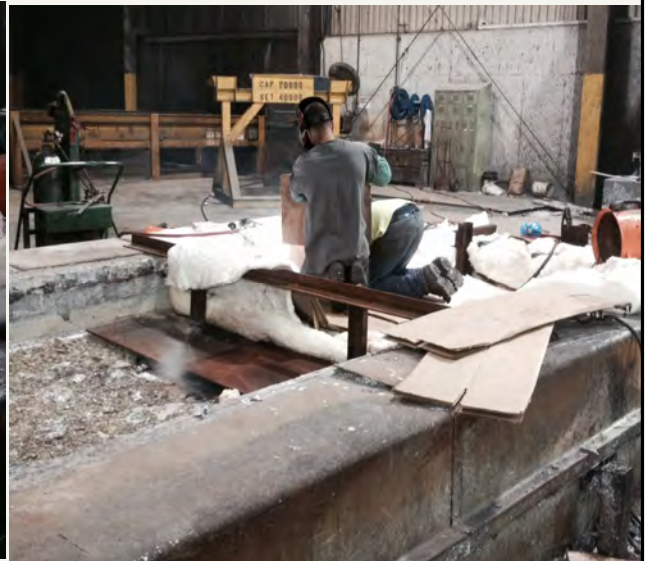
Very long process to repair.

Hours Of Weld Repair

Grind and cook out all zinc to clean steel entire repair area.

Weld back up pass after pass.

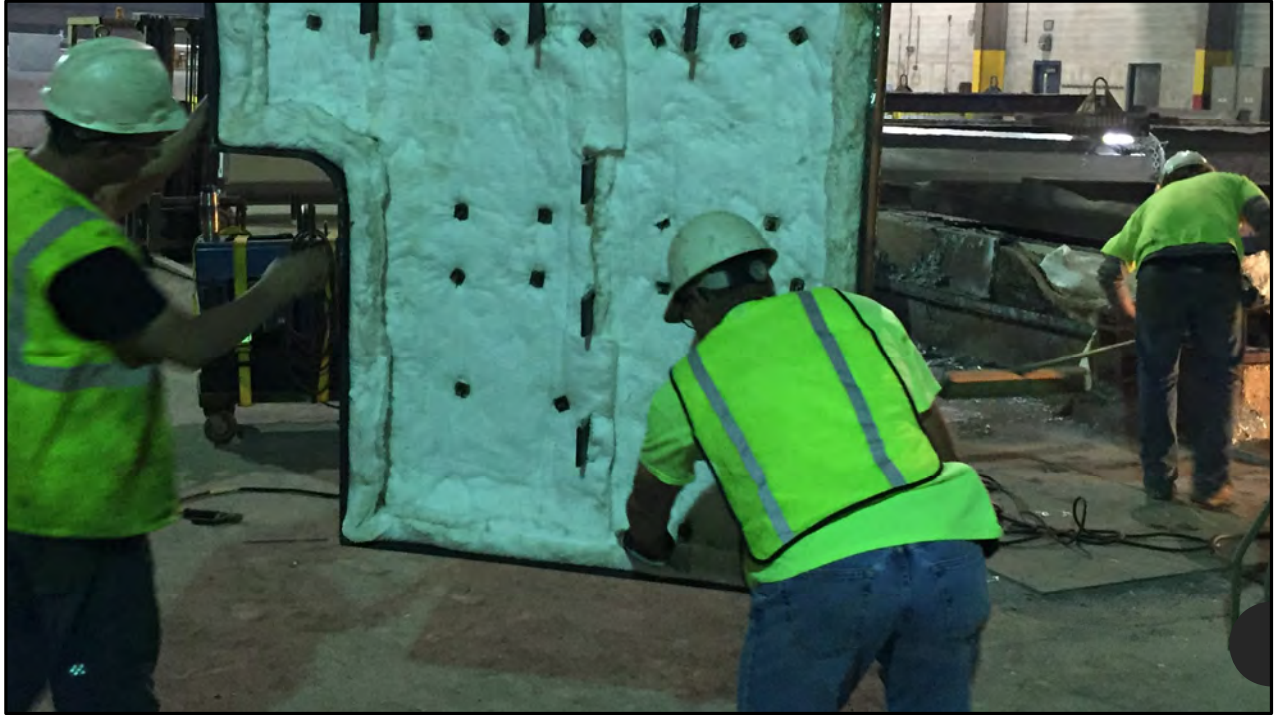
Same kettle after ultrasound identified very thin wall in the same area of the kettle. Burner turned until new kettle installed
Testing showed large area several feet down all $\frac{1}{2}$ inch thick.
Identified as cracked burner block creating overheating in this area.
Worried about catastrophic failure so we fabricated this sandbox to help if a leak and keep this area cool.

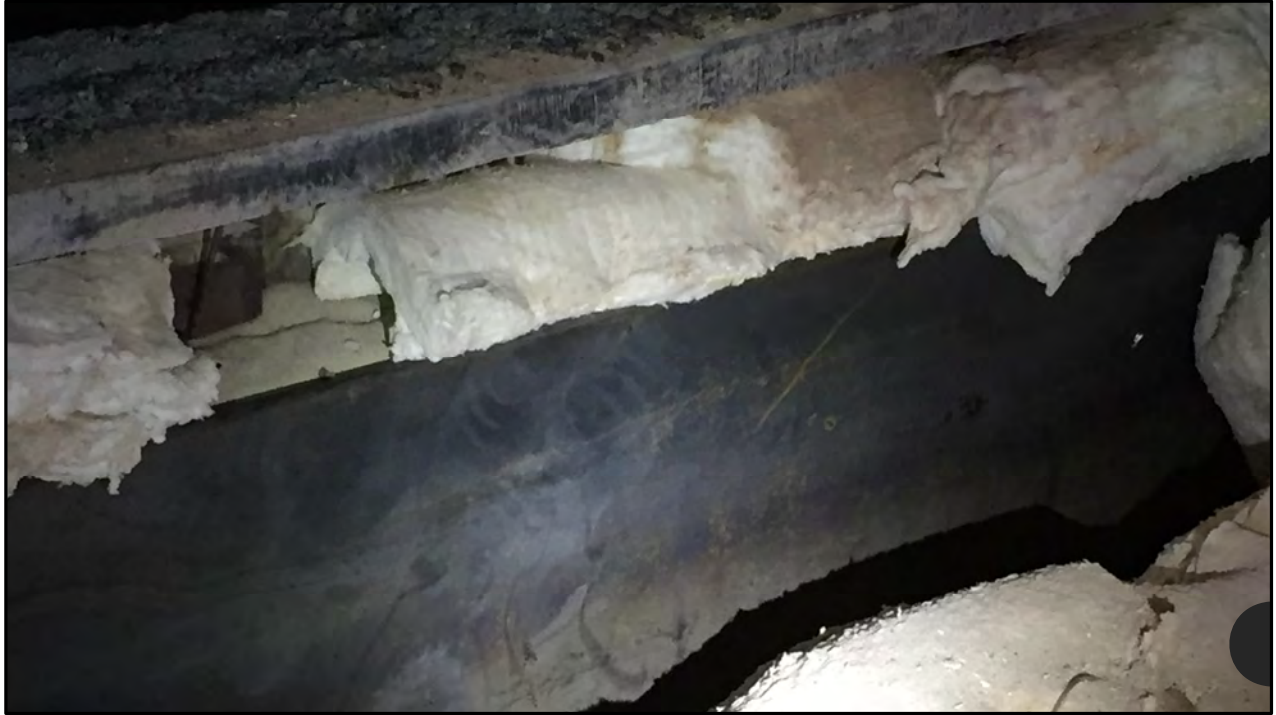
Only problem with repair after weekends with two days shutdown some frozen zinc occurred on wall in this area.

Once production started and we went to high fire and zinc started really moving some chunks of zinc floated for the first few racks as they melted off wall

We then filled with sand.

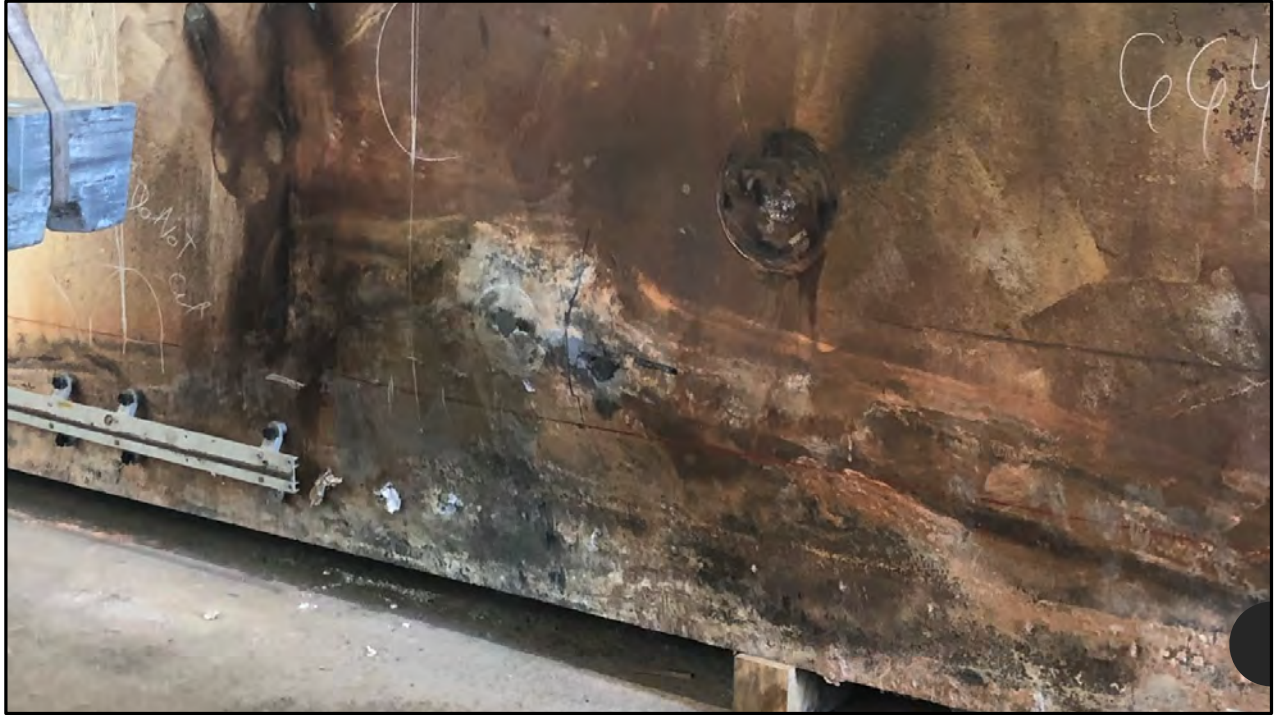
Kettle damage and leak determined to be a combination of excess dross and burner issue.

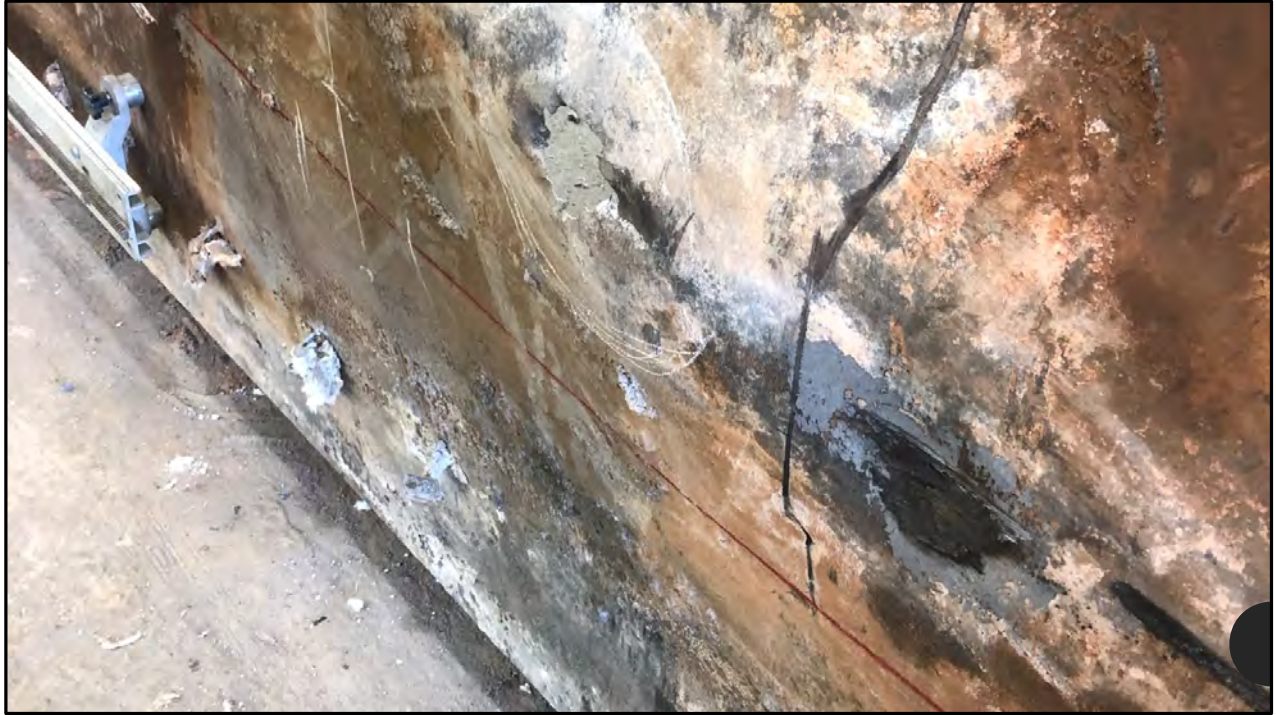
Dross build up over long periods of time and not cleaning where wall meets the floor good.

Use depth indicator when checking for dross so you know where the bottom is. You can also have this marked somehow on dross shovel to tell you are on the bottom of your kettle.

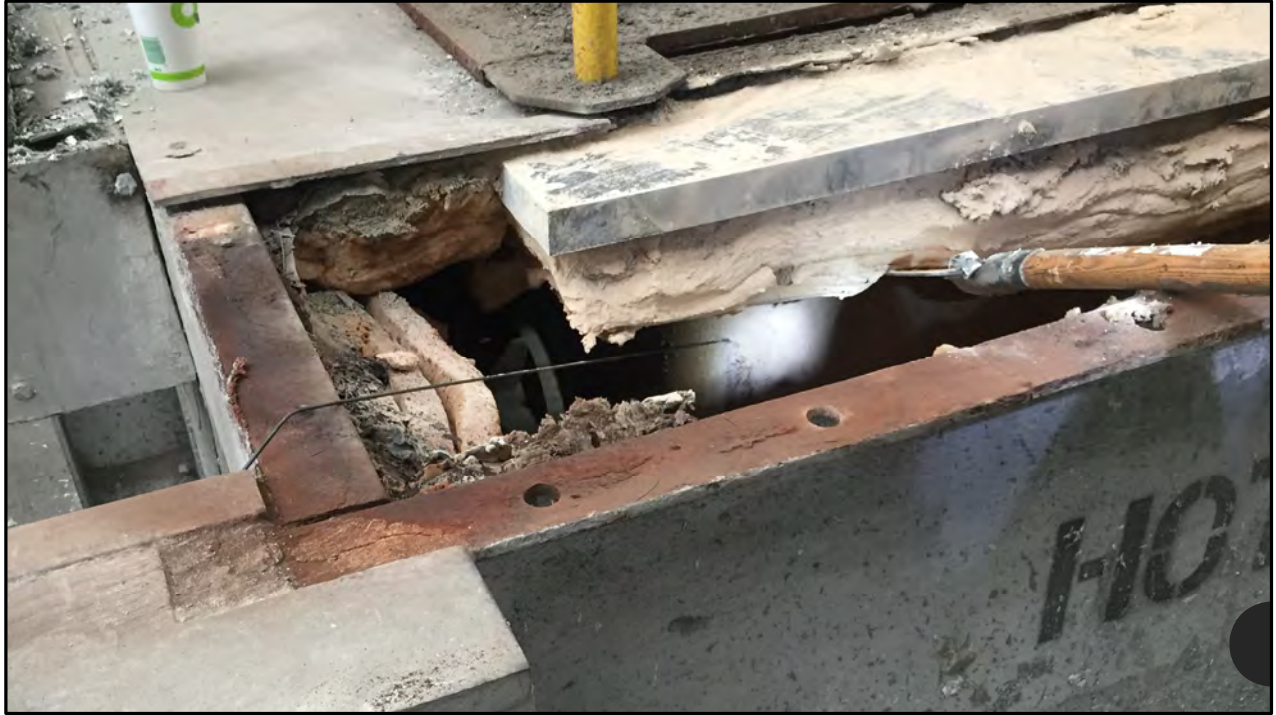
Another corner leak from not keeping walls clean.

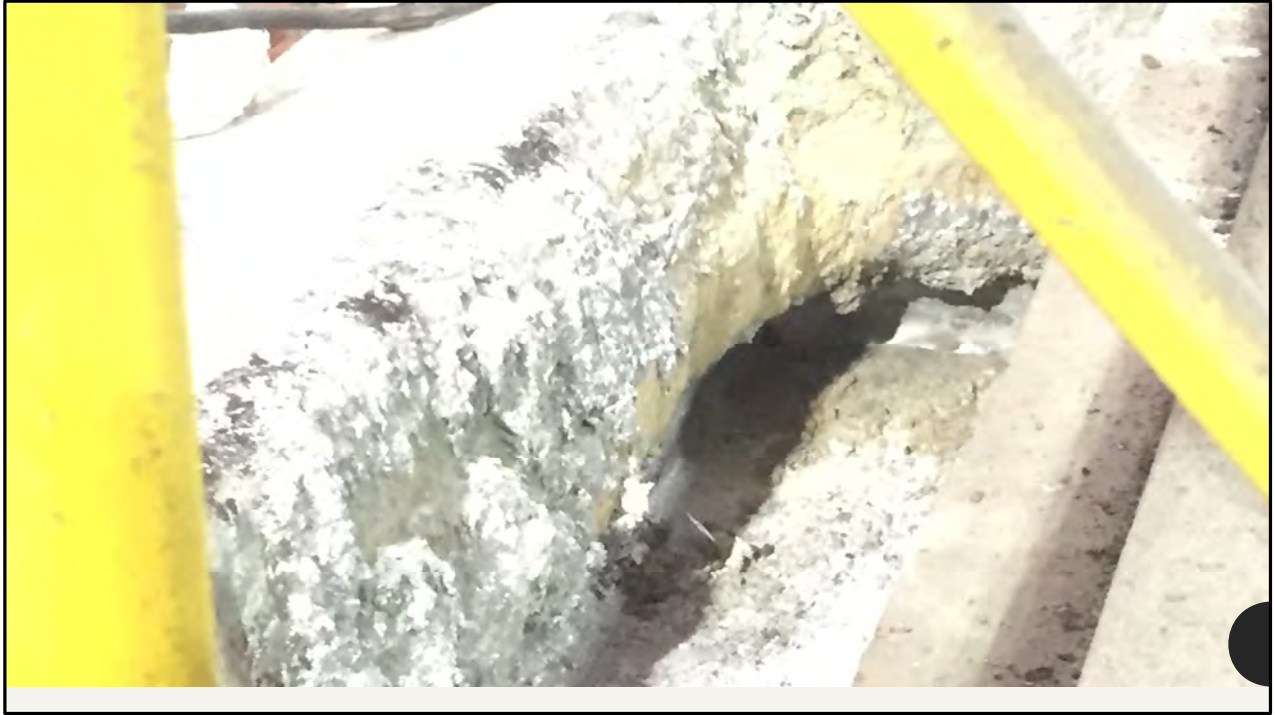
Inside view after leak.

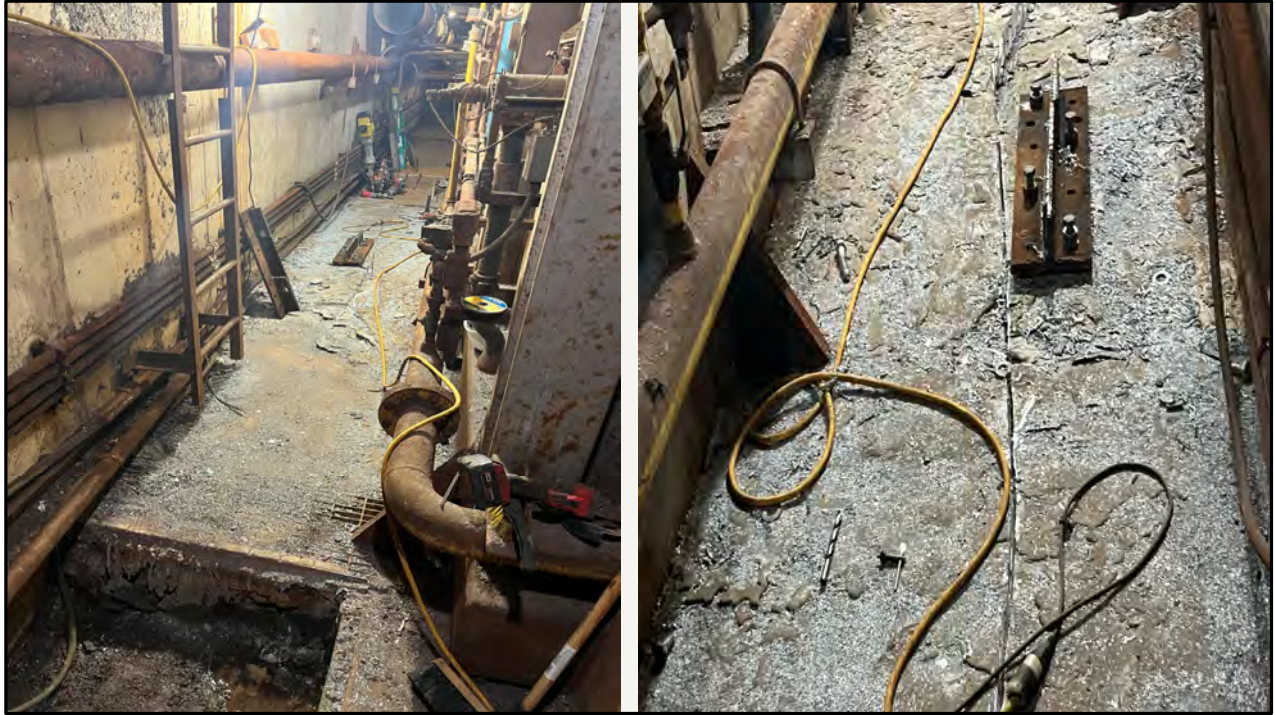
Don't be this guy having to figure out how to clean your kettle pit up.

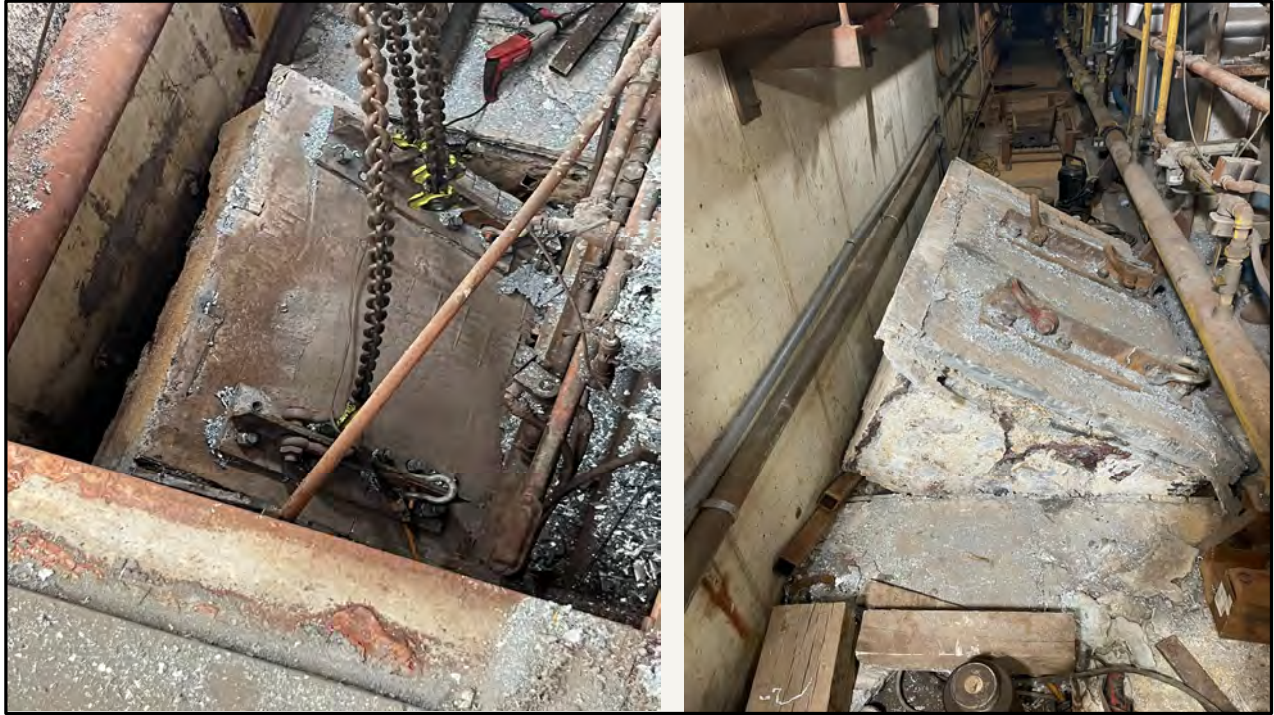
Hours of work cutting and jacking to remove this zinc

Easiest way we found to lift zinc is drill holes and use long lag bolts $\frac{3}{4}$ " to 1" to anchor lifting points.

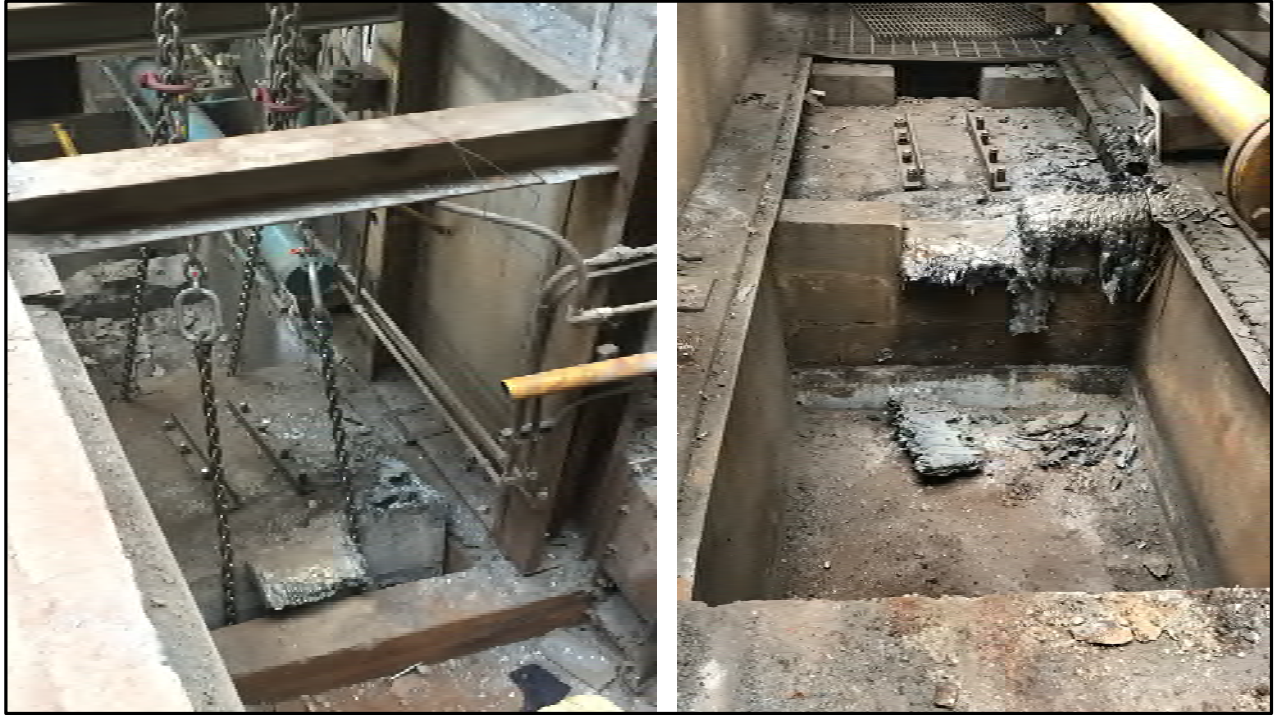
**Removing zinc from another kettle pit from a leak.
Point out and talk about leak port.**

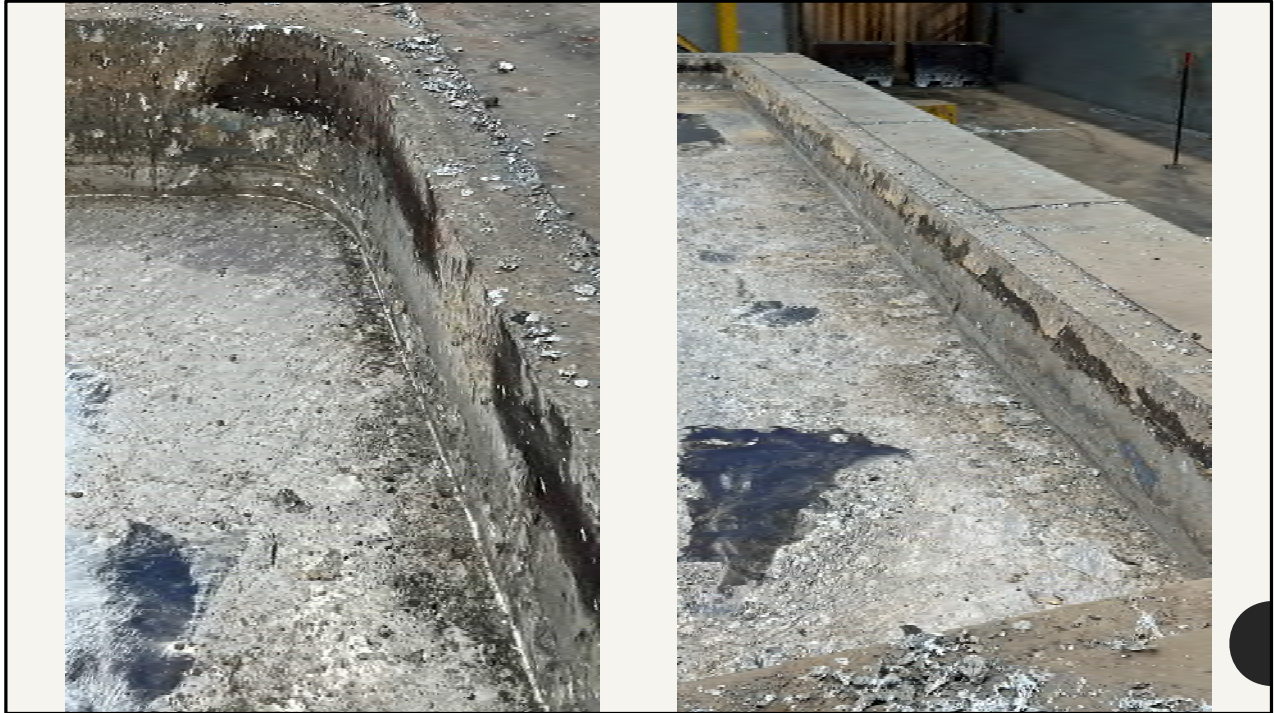
After lowering zinc 10-12" take some pictures and inspect walls for wash areas.
