Baseball Man

Gulfport, Mississippi

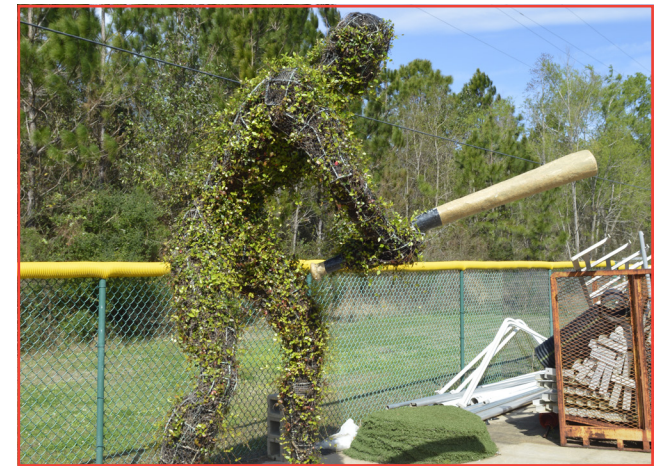
The test revealed an average coating thickness of 7.8 mils on the frame and 6.8 on his rebar shaping. The coating was intact with normal brown staining from the patina growth. The base frame had a few areas of rust which were easily repaired.

Sample Area	Reading (mils)					Average
Channel Frame Legs	9.60	9.10	8.60	9.50	8.90	9.10
Mid-Frame Channel	8.80	9.30	9.10	8.90	9.00	9.00
Rebar Shaping	6.20	5.90	6.30	6.20	5.80	6.80
Base	6.20	5.90	6.30	6.20	5.80	6.80

Restoration began at once with local contributions, including the original galvanizer. The topiary was replanted and seeded for growth. There were a few setbacks with heavy rain during the growing season, but Baseball Man is returning to his normal self. He has regained his place as the proud symbol of baseball at the Gulf Port Sports Complex. Thanks to the tenacious hot-dip galvanized frame, Baseball Man is BACK! ■
