Marketplace Center

Boston, Massachusetts

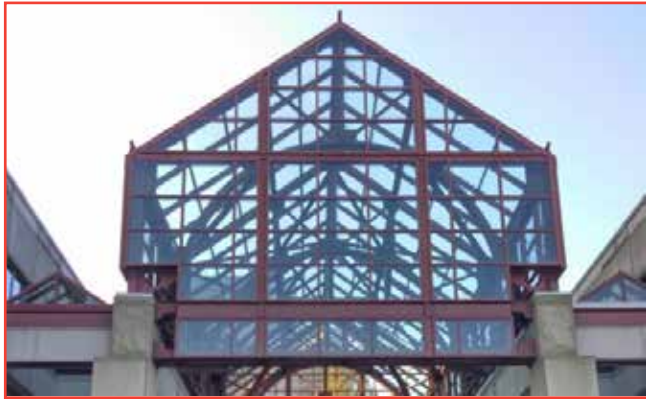
One of the main features of Marketplace Center is the open "Walkway to the Sea." This is a steel framed, glass canopied structure designed to allow pedestrians to walk from Faneuil Hall directly to the waterfront. Since it is an architectural element and highly visible open structure constantly exposed to the moist sea air, the architect wanted a coating system that would not only protect the steel from corrosion, but would also provide the aesthetics required of the structure. Based on these criteria, a duplex system of hot-dip galvanizing and paint was specified.

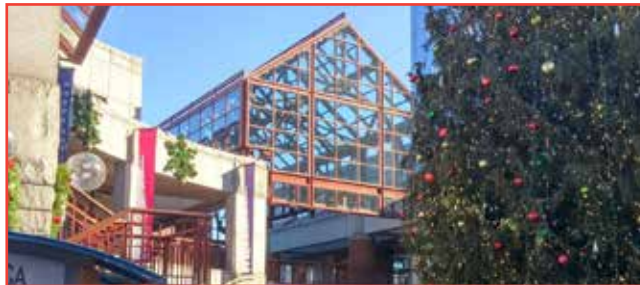
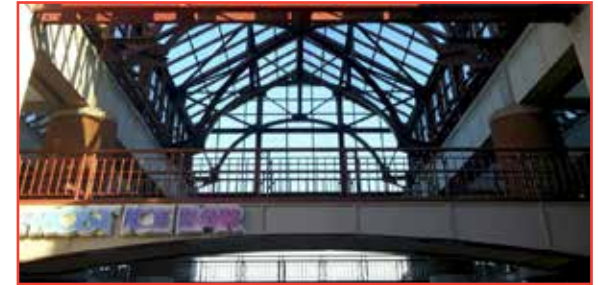
An inspection conducted in 2014 shows the duplex coating system of the Marketplace Center is still in great condition. There were no signs of visible rust, and the coating thickness readings show a significant amount of zinc and paint are still present. The synergistic effect of the paint and galvanizing working in tandem have protected this tourist attraction for 30 years, and based on the current readings, will be able to keep the Marketplace Center rust-free for at least 30 more. ■

Sample Area	Reading (mils)					Average
Second Level Railings	11.0	8.5	7.5	9.0	10.5	9.3
Canopy Support Steel	8.5	9.5	9.0	8.5	8.0	8.7
Stair Stringers and Risers	10.0	9.5	9.5	8.5	8.5	9.2
