Val-des-Bois Bridge

Bowman, Quebec

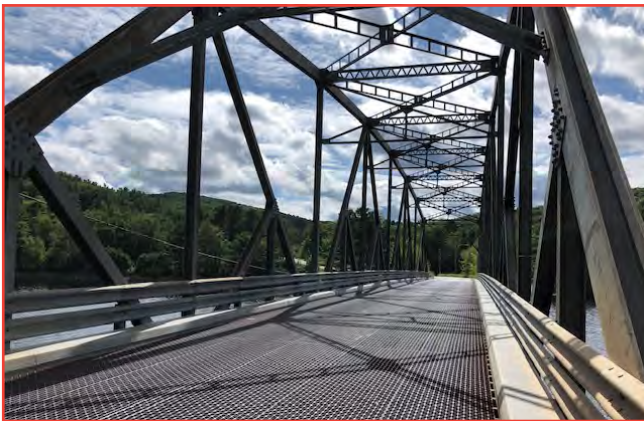
The entire structure was hot-dip galvanized; H-beams and plates for the main structure, cold form plate for the curbs-sidewalk, riveted style steel deck grating and two-layers of guardrail to form railings. Eastern Canada winters are extremely challenging to infrastructure and this area sees at least six months a year of winter conditions with regular application of de-icing salts and abrasives. The severe cold cycles of winter and hot humid summer weather create metal contractions and expansions that quickly degrade paint systems, cracking them and allowing the corrosive salt-laced moisture to begin its dirty work.

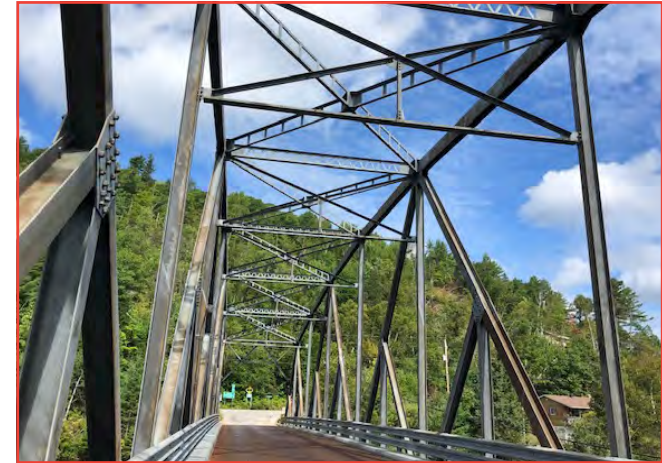
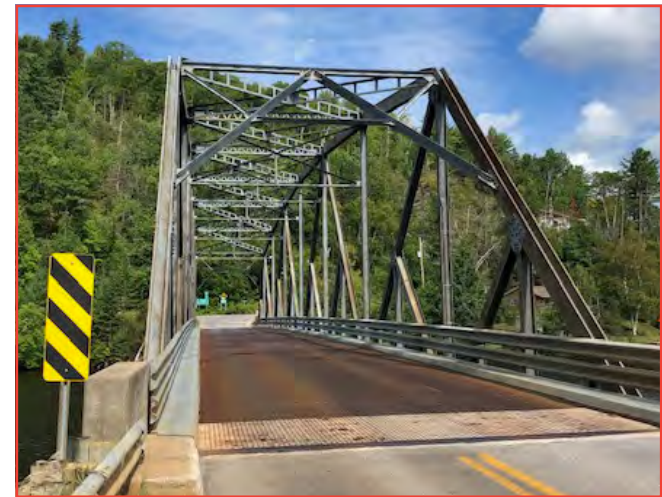
According to Sylvain Cordeau, the engineer responsible for the Ministry of Transport, the Val-des-Bois Bridge has exceeded all expectations of the Ministry. A thorough 2018 inspection found no steel corrosion on the truss structure; amazingly they still show anywhere from 100% to over 300% of minimum zinc thickness for new construction! Even the deck grating is only beginning to see base metal corrosion, mostly related to over half a century of snowplows and studded snow tires gradually grinding away the steel grating itself.

The only corrosion issue that has required maintenance was the deck grating support beams. A poor design of laying the grating directly on the top flange of these supports trapped corrosive liquid and moisture retaining salt and sand. But even these components are still in service 56 years later. ■
