Can't eat the Core

Tests show decks with hot-dip galvanized centers are standing up to corrosion

Phil Rahrig
Contributing Author

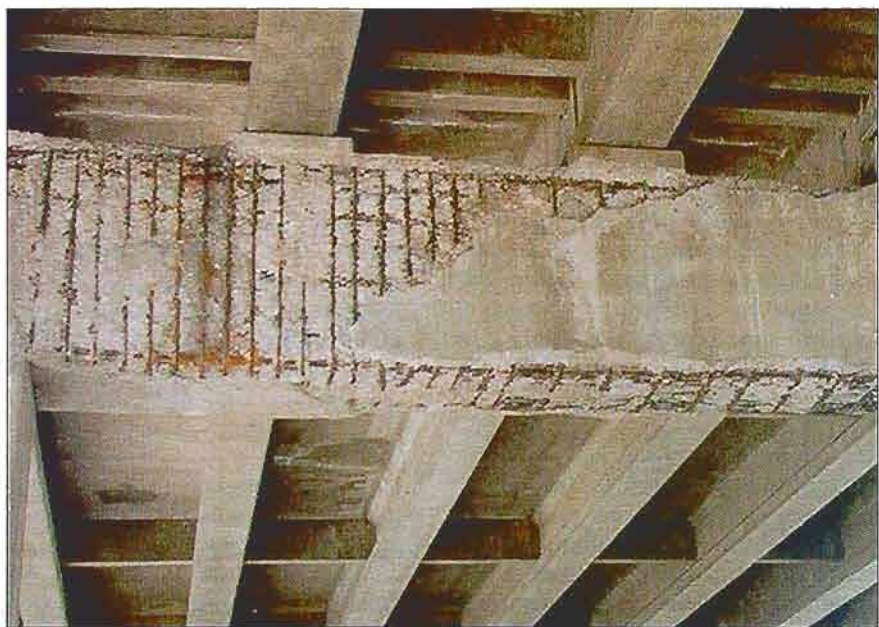
The development of dense corrosion products on the surface of black (uncoated) rebar builds up pressure against the surrounding concrete. When these expansive forces elevate to a level that exceeds the strength of the concrete, cracking and spalling occur, ultimately resulting in failure.

Concrete is a permeable material and in certain corrosive environments (coastal climates and climates that require deicing salts in the winter), the entrance of moisture, salts and oxygen can initiate corrosion of reinforcing steel. The development of dense corrosion products on the surface of black (uncoated) rebar builds up pressure against the surrounding concrete. When these expansive forces elevate to a level that exceeds the strength of the concrete, cracking and spalling occur, ultimately resulting in failure.
