# Hot-Dip Galvanized Rebar vs. Epoxy-Coated Rebar

## Hot-Dip Galvanized Rebar: A Concrete Investment

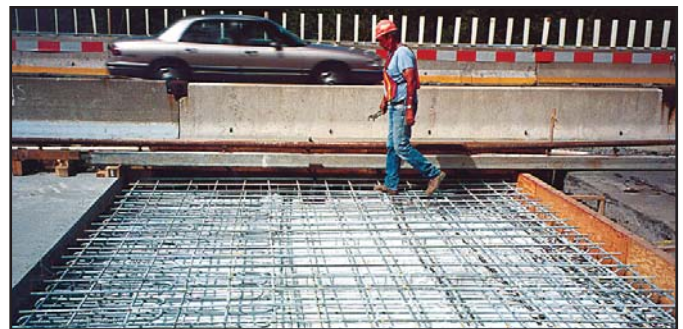
## Service Life Model of Uncoated vs. Galvanized Rebar

This model illustrates how the service life of concrete is affected by chloride concentration and corrosion of the embedded rebar. Corrosion of rebar can be described in three stages: initiation, protection, propagation.

Initiation is the time it takes for chlorides to permeate the concrete and accumulate at the rebar surface to a concentration that will cause corrosion. A certain critical chloride threshold exists for different rebar materials to begin active corrosion. The galvanized rebar threshold is 2 to 4 times higher than black steel<sup>2</sup>.

Once the chloride threshold has been reached, black rebar enters into the stage of active corrosion, or in the case of galvanized rebar, the zinc coating begins to provide protection for the underlying steel.

Pressure builds up in the concrete as steel corrosion products develop on black rebar. Once this pressure exceeds the tensile strength of the concrete, the concrete will crack and allow additional corrosive chlorides to penetrate the concrete. The corrosion products of galvanized steel cause harmless pressure that migrates from the surface of the bar into the concrete, filling any voids, cracks, or crevices that may already preexist. The less dense zinc corrosion products allow the galvanized coating to provide corrosion protection while extending the integrity of the concrete itself.

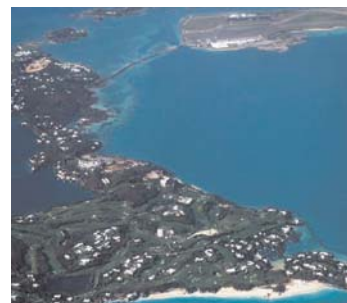
Hot-dip galvanized rebar has been used extensively since the early 1950s. One of the first known installations is the Longbird Bridge in Bermuda by the US Navy in 1953. Galvanized rebar was used to reinforce the bridge deck in the construction of a single approach span concrete bridge. The Bermuda marine environment is highly corrosive as exhibited by inspections of the Longbird Bridge in 1978, and again in 1995. Chloride levels in excess of 7.3 lb/yd<sup>3</sup> (4.3 kg/m<sup>3</sup>) were found in concrete samples taken from areas surrounding the galvanized rebar. Despite these high levels of chlorides (about six times the amount necessary to initiate corrosion of black steel) the thickness of the galvanized coating was sufficient enough to qualify as newly galvanized rebar, 42 years after placement.

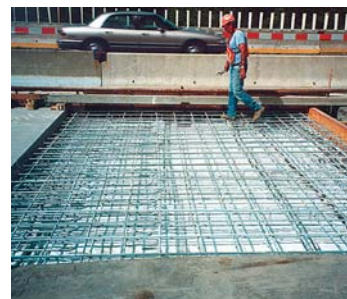
Based on a Federal Highway Association (FHWA) endorsement and research conducted by numerous states, the New York State Thruway Authority (NYSTA) had seemingly solved its corrosion problem by implementing the use of epoxy-coated rebar in bridge decks during the early 1980s. In as little as 10 years, doubts surfaced regarding the protection provided by these epoxy-coated systems. Within another four years, cracks began to appear in these bridge decks, at which time the NYSTA decided to utilize hot-dip galvanized rebar as its corrosion protection method of choice. Other concerns noted in a NYSTA report indicate inferior epoxy-concrete bond, as well as damage to the epoxy coating prior to placement from rough field handling, which compromised the corrosion protection prior to bar placement.
