Hot-Dip Galvanized Reinforcing Steel

A SPECIFIER'S GUIDE

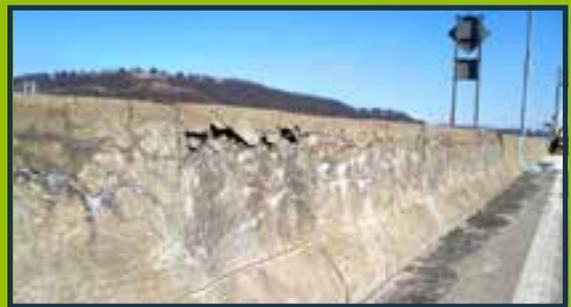
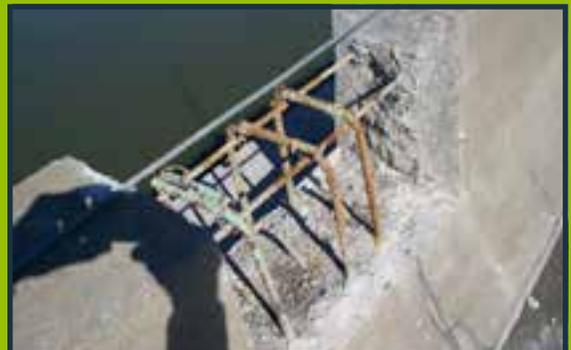
Veterans Memorial Bridge

The Veterans Memorial Bridge, which spans the Ohio River connecting Weirton, West Virginia and Steubenville, Ohio, opened on May 1, 1990. The bridge is an example of what can happen when reinforcing steel fails to withstand the environment in which it is placed. The photos below were taken in February 2009, and after less than 20 years in service, the rebar has corroded, leading to cracking and spalling of the concrete. Utilizing rebar able to withstand the moist river environment and damaging winter road salts would have kept the concrete intact, greatly reducing the economic and time concerning burden required to repair and replace the spalling concrete.

Corroded rebar causing concrete spalling

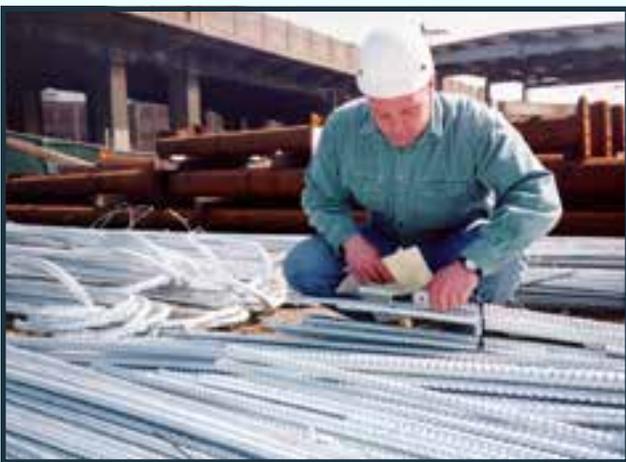
Inspection of galvanized rebar

After reinforcing steel has been galvanized, it should be inspected at the galvanizer's facility to ensure compliance with specifications. The standard specification for hot-dip galvanized rebar is ASTM A 767. However, when bars are fabricated into assemblies prior to galvanizing, the standard specification for hot-dip galvanized assemblies, ASTM A 123, *Standard Specification for Zinc (Hot-Dip Galvanized) Coatings on Iron and Steel Products*, applies.

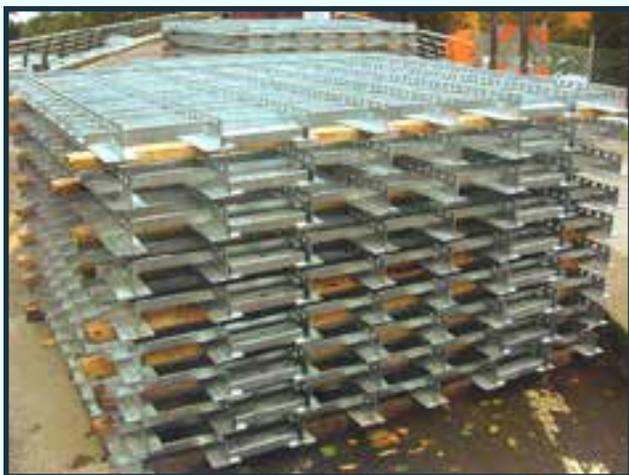
The intermetallic layers of the galvanized coating are harder than the base steel, so galvanized rebar and other embeds are extremely resistant to damage from abrasion.

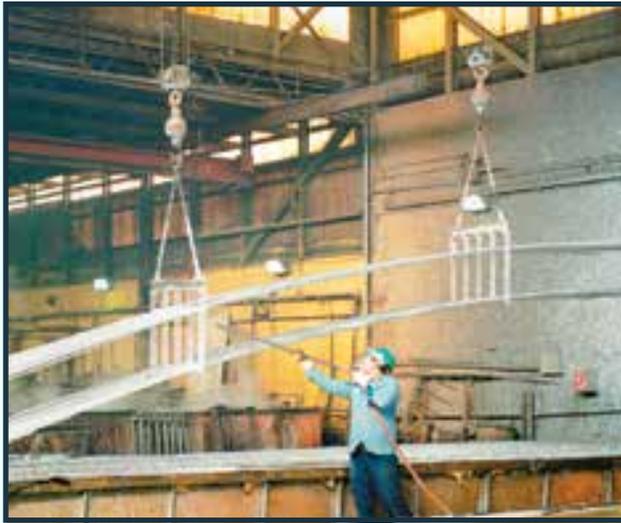
Removal of galvanized rebar from the zinc bath

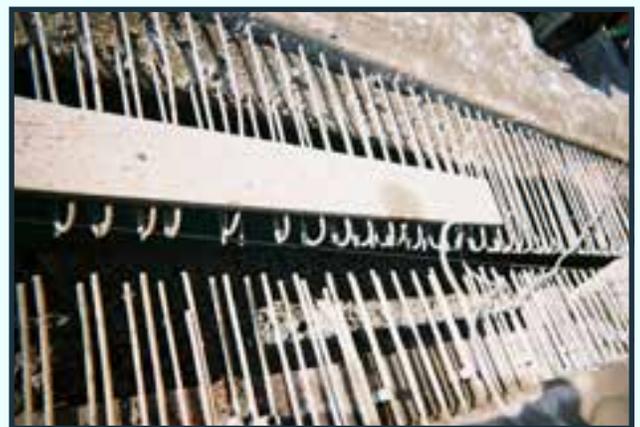
The galvanized rebar from the Route 66 Bridge Deck in Kittanning, Pennsylvania, after more than 30 years of service.

The Route 66 bridge deck refurbishment, south of Kittanning, Pennsylvania, provided a unique opportunity to assess the performance of galvanized rebar after more than 30 years of service. The bridge, built in 1973,

utilized galvanized rebar in the deck. Though the bridge deck was in excellent condition, Penn DOT wanted to replace the post and beam medial barrier with a more secure concrete Jersey barrier. They removed the entire middle section of the deck and exposed the galvanized rebar for inspection. Tests found the chloride content in the concrete surrounding the rebar to be 5 lbs/yd³, far exceeding the chloride threshold for corrosion of black rebar.

Inspection of the rebar showed the coating was in excellent condition with thicknesses still exceeding ASTM A 767 specification for new galvanized rebar. Also noted during concrete removal was the tenacious bond of the galvanized rebar to the surrounding concrete, confirming the superior bond strength obtained from galvanized coatings. No refurbishment of the concrete deck was required and the original rebar remained in place when the Jersey barrier was poured.

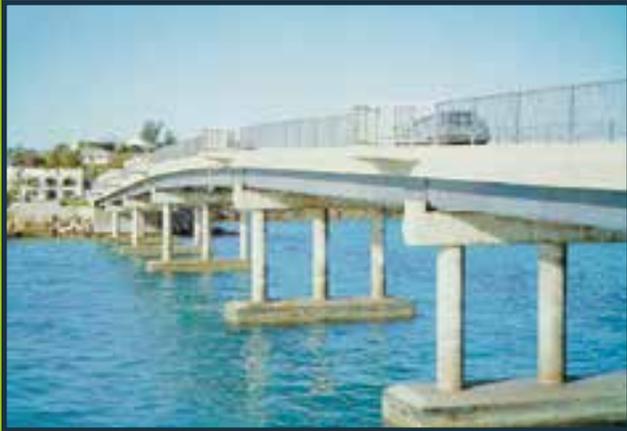
Longbird Bridge

The Bermuda marine environment is highly corrosive, as exhibited in a 1978 inspection of bridges and quays conducted by Construction Technology Labs. This inspection included the Longbird Bridge and showed chloride levels in the concrete up to 4.3 kg/m^3 (7.3 lb/yd^3). During this inspection, a low chloride ion gradient across the concrete cores indicated significant chlorides were already in the concrete at the time of placing (most likely from salt water used to mix the concrete). The internal chloride concentration, combined with salt spray from the nearby ocean, produce an extremely corrosive environment. According to this inspection, the galvanized coating had only been slightly affected by corrosion, as 98% of the initial galvanized coating remained intact.

A later inspection of the galvanized reinforcement in the Longbird Bridge was conducted in response to the Bermuda Ministry of Works and Engineering's unilateral specification of hot-dip galvanized reinforcement. In this report, evidence of zinc coating integrity was found on exposed sections of rebar during repairs made in 1984, after 30 years of exposure to extremely high

chloride levels. A third inspection was conducted in 1995 and core samples revealed after 42 years, the galvanized rebar still had a zinc coating thickness well in excess of specification for a new hot-dip galvanized coating.

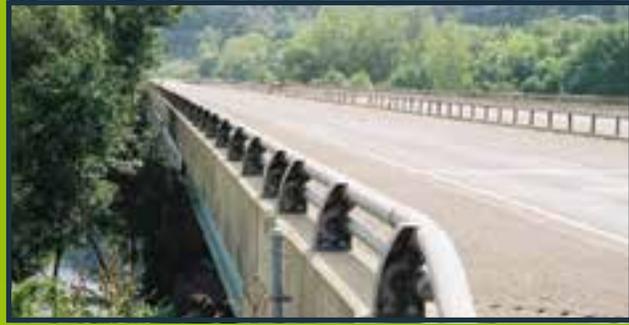
Athens Bridge in Pennsylvania

The Athens Bridge was later inspected in 1991 and 2001, and the analysis generated similar results. No sign of active corrosion on the galvanized reinforcement was found and coating thickness measurements reported were in excess of 10 mils. These current coating thicknesses indicate an estimated 40-plus years of additional maintenance-free corrosion protection.

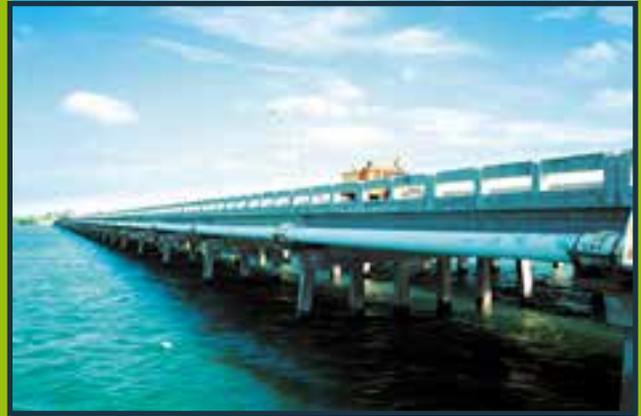
Boca Chica Bridge in Florida

Location	Installed	Inspection Date	Chlorides	Zinc Coating Thickness	
			(lb/yd ³)	mils	µm
Boca Chica Bridge, FL*	1972	1975	1.95	5.1	130
		1991	2.02	4.0	102
		1999	3.21	6.7	170
Tioga Bridge, PA*	1974	1984	0.58	5.9	150
		1991	1.06	8.8	224
		2001	2.23	7.8	198
Curtis Road Bridge, MI	1976	2002	6.88	6.1	155
Spring Street Bridge, VT	1971	2002	4.17	7.5	191
Evanston Interchange, WY	1975	2002	2.55	9.3	236
