Baseball Man

Gulfport, Mississippi

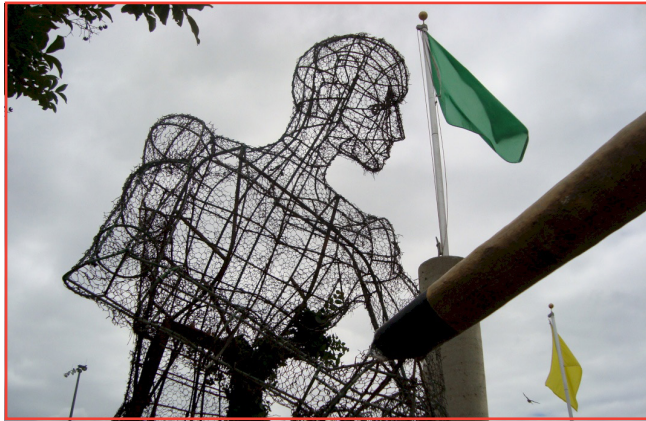
The test revealed an average coating thickness of 7.8 mils on the frame and 6.8 on his rebar shaping. The coating was intact with normal brown staining from the patina growth. The base frame had a few areas of rust which were easily repaired.
