Galvanizing Kettle Lessons Learned

Presentation overview

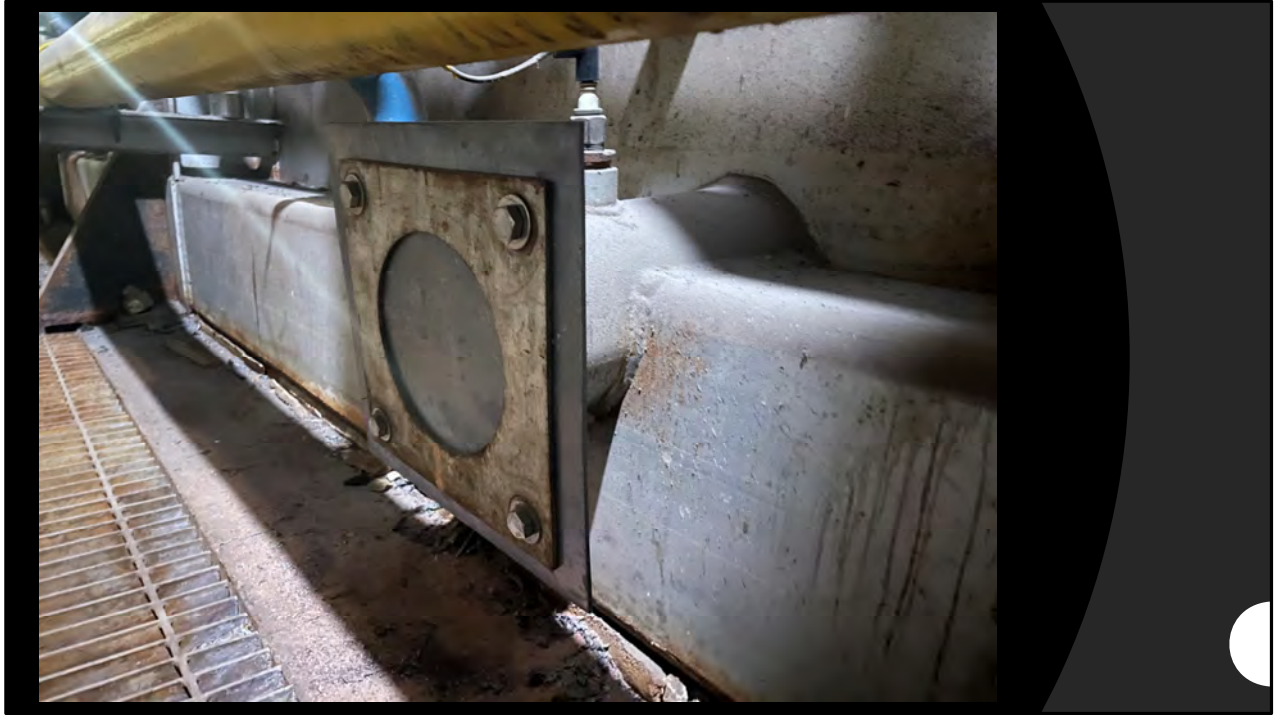
Clean leak port with new lead shield and new flame rod used to complete circuit to detect leak.

Shield holds molten zinc back touching the flame rod setting alarm off.

Shield will then burn through allowing zinc to drain into revisors around the kettle.

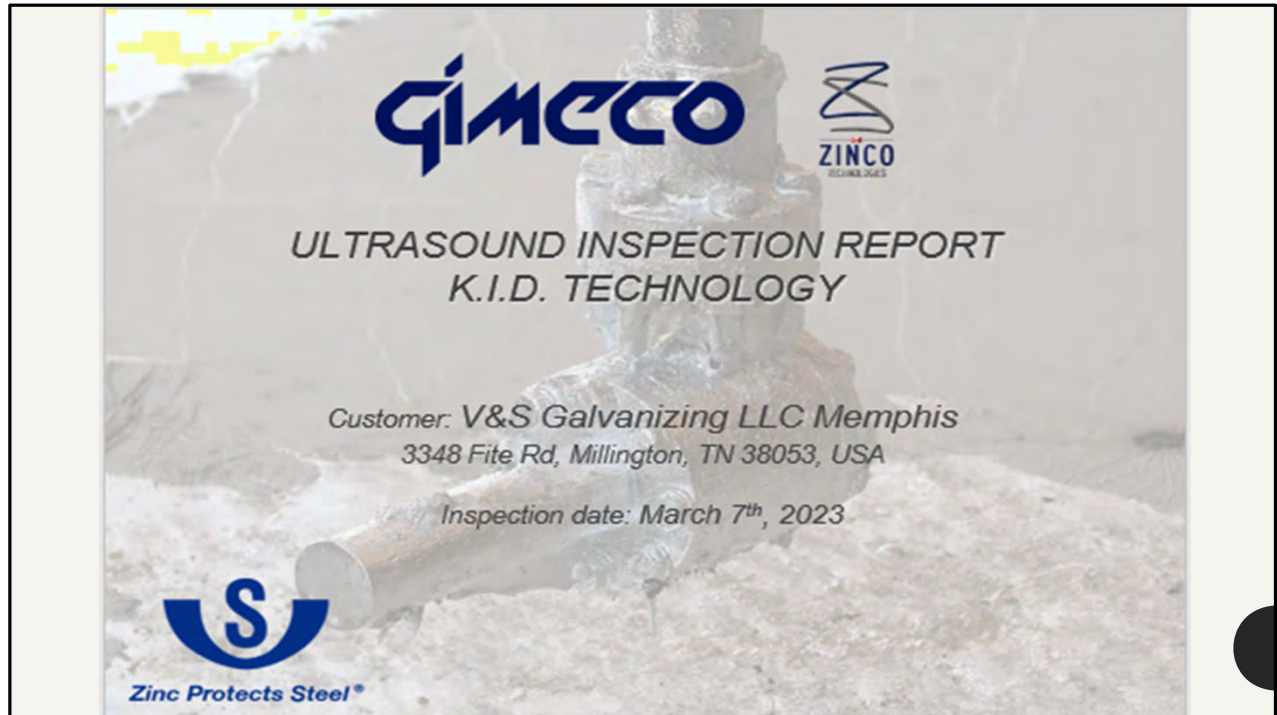
Ultrasound testing of kettle walls.
Frequency varies on time in service.

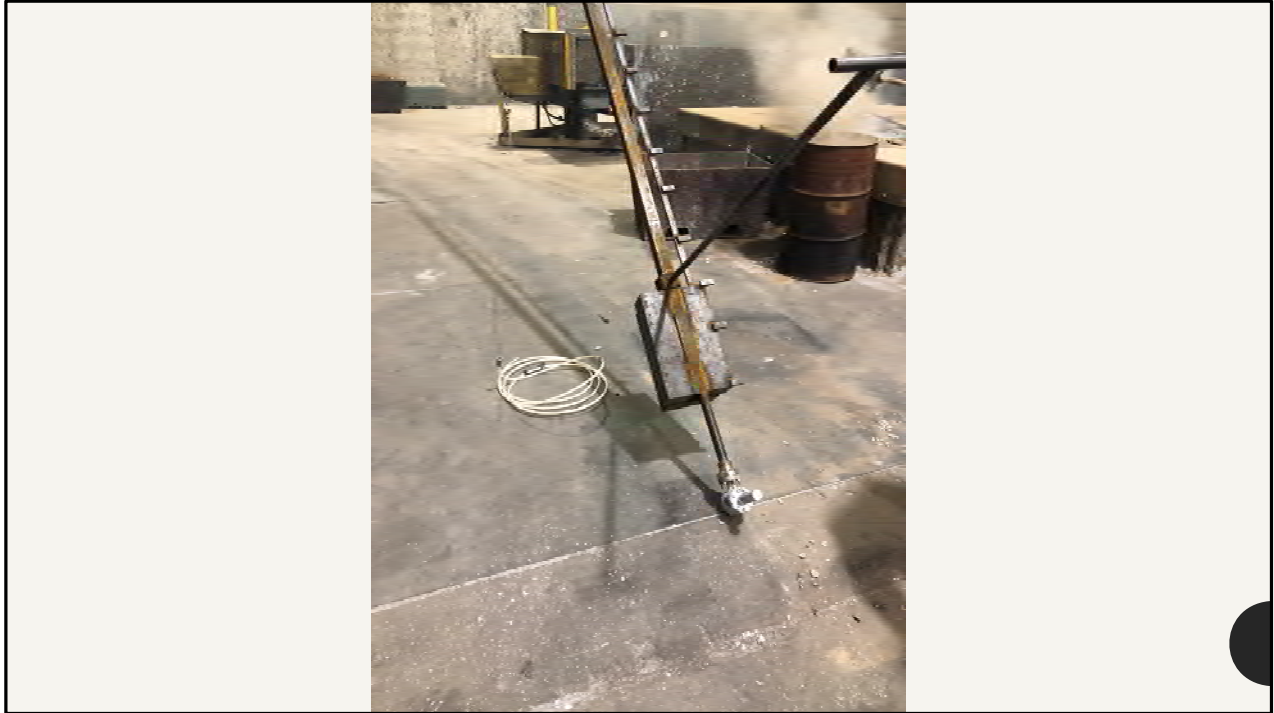
High temp probe Vendor supplied that is bolted onto plant owned steel fixture.

Plants receive a material list to purchase, and Zinco will assist in fabrication. This fixture will be used for all inspections at this plant.

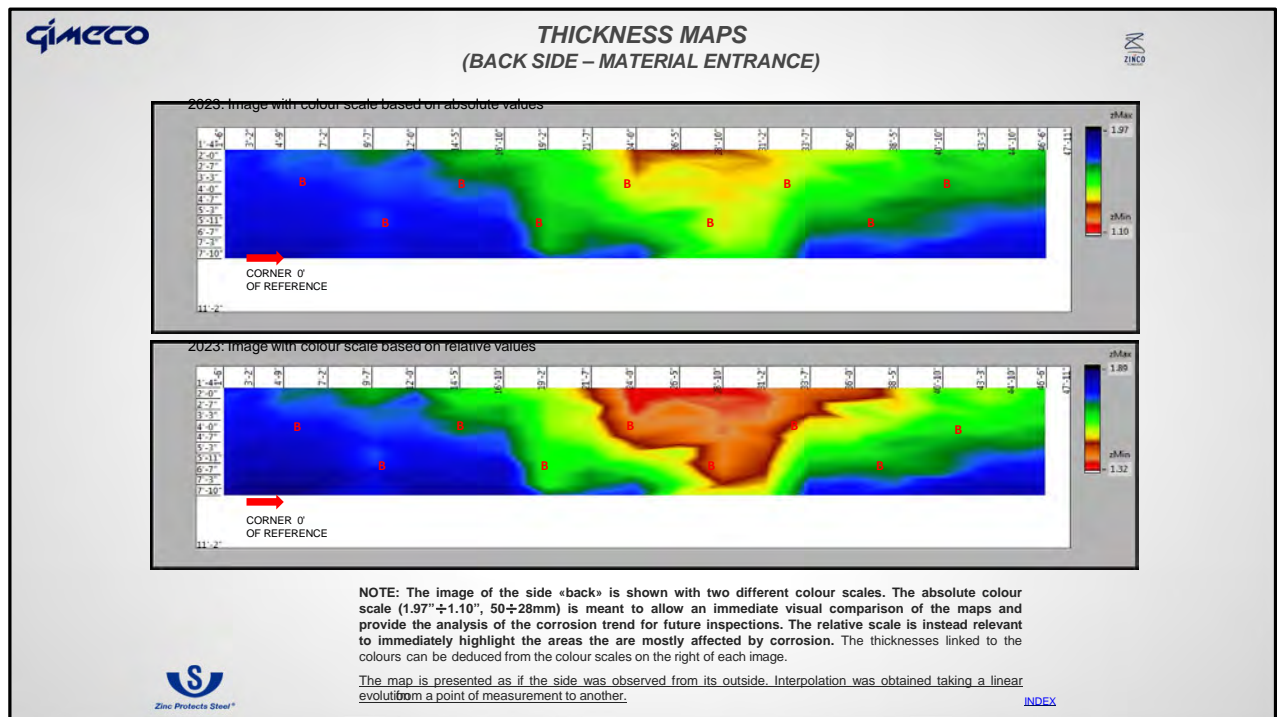
Images of color scales using absolute and relative values making it easy to see trouble areas.

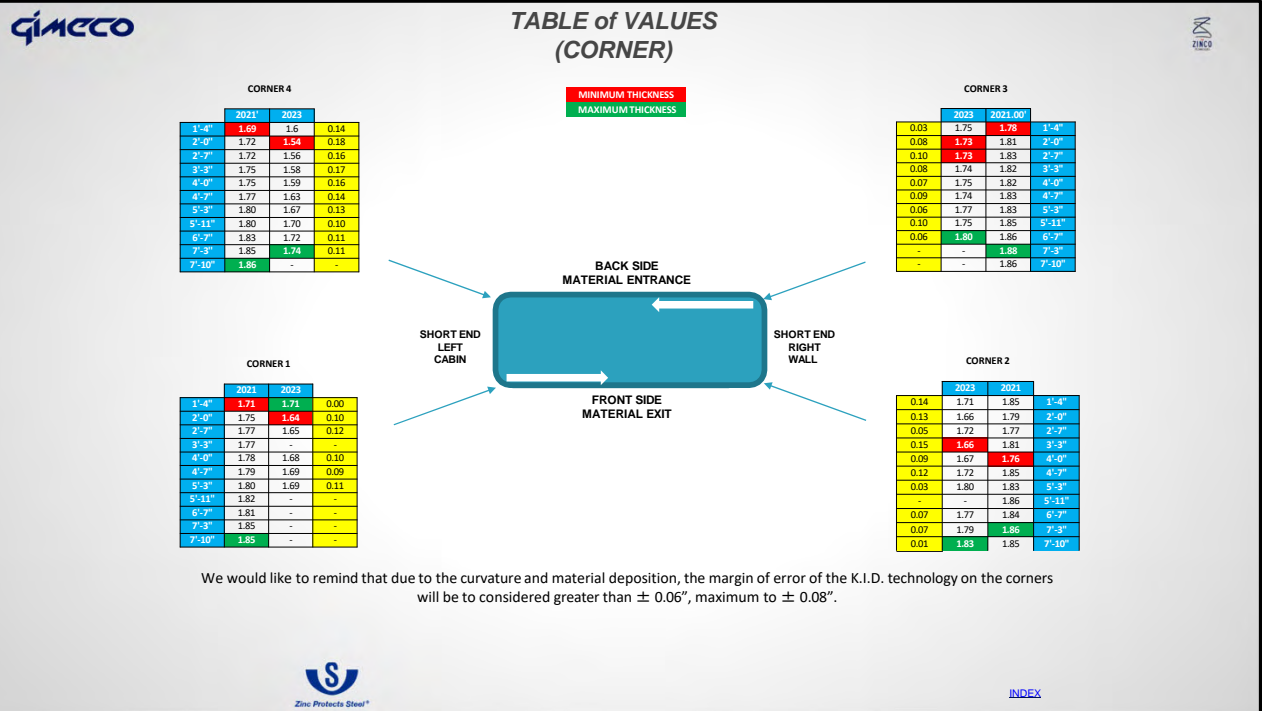
Corner and end wall readings.

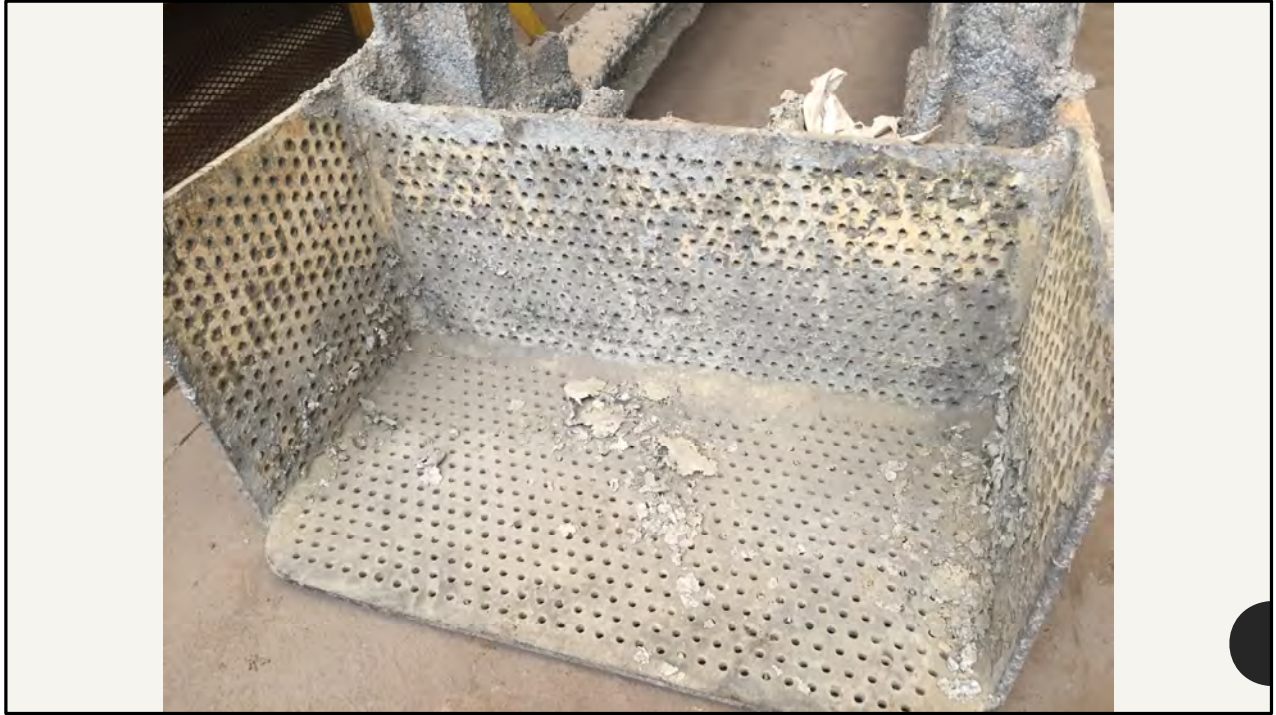
Picture showing 3/4" boiler plate shovel and large number of holes. Shovel should be more than $\frac{1}{2}$ the width of the kettle, so each pass is always cleaning a wall. Rotating back and forth cleaning entire floor.

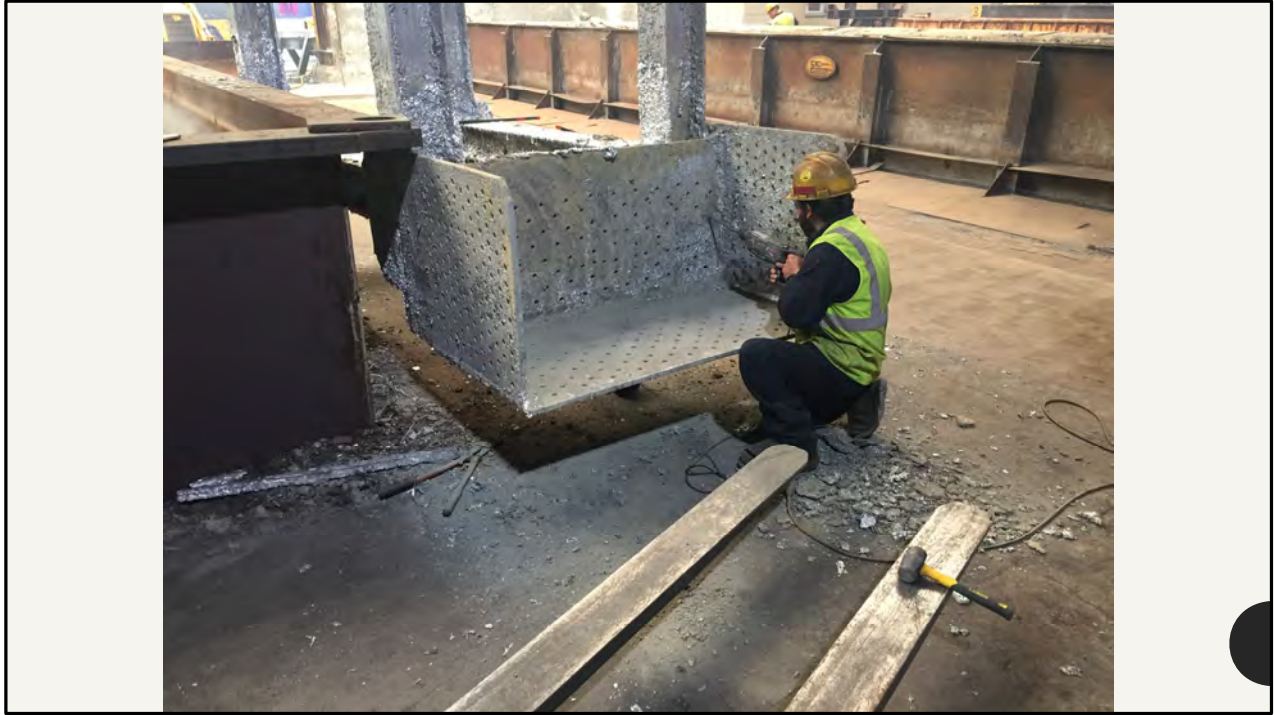
Another shovel picture of cleaning holes.

Make sure your holes are round and all the same size so you can clean dirt buildup occasionally.

Hammer drill with properly sized bit work great to just blow ash build up out of hole so you keep proper drainage.

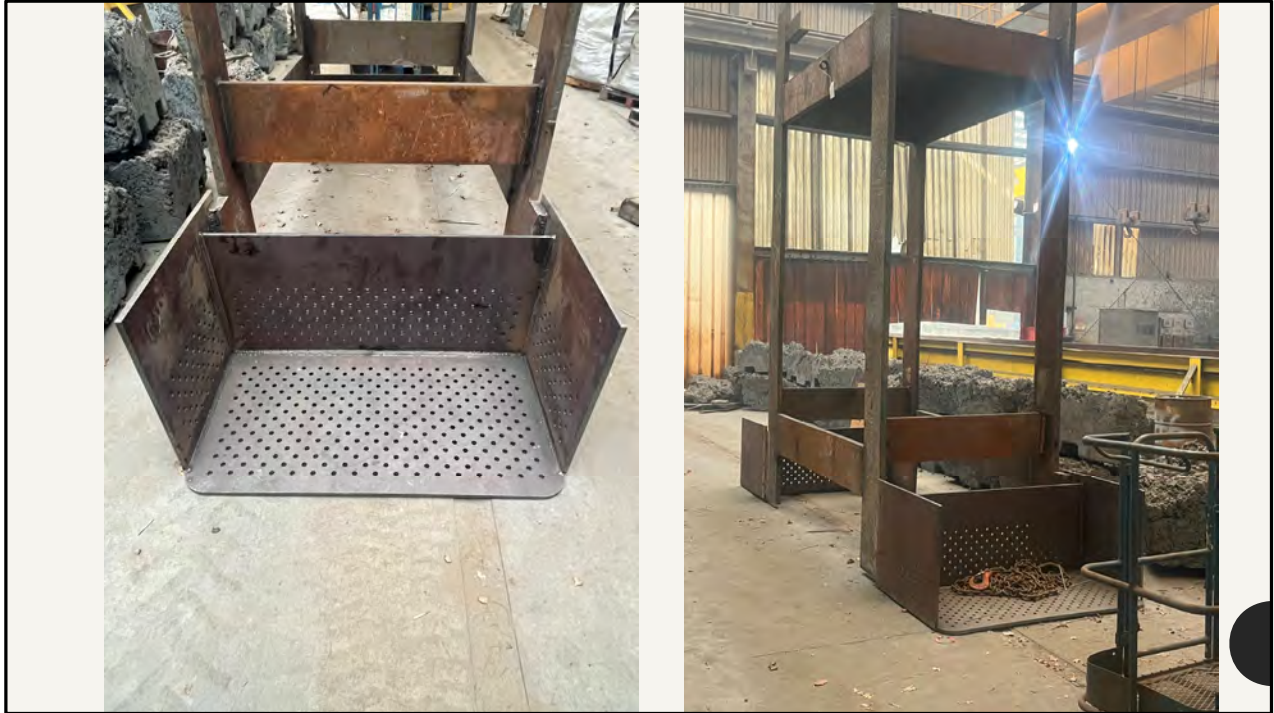
New shovel for long kettle so we added scoop at each end. Turning shovels to go the opposite direction is very dangerous and time consuming..
Ols shovels were very hard to keep clean with I-beam construction resulting in them floating because of buildup in areas.
New shovels are being made from old kettle steel plate making it much easier to keep clean.

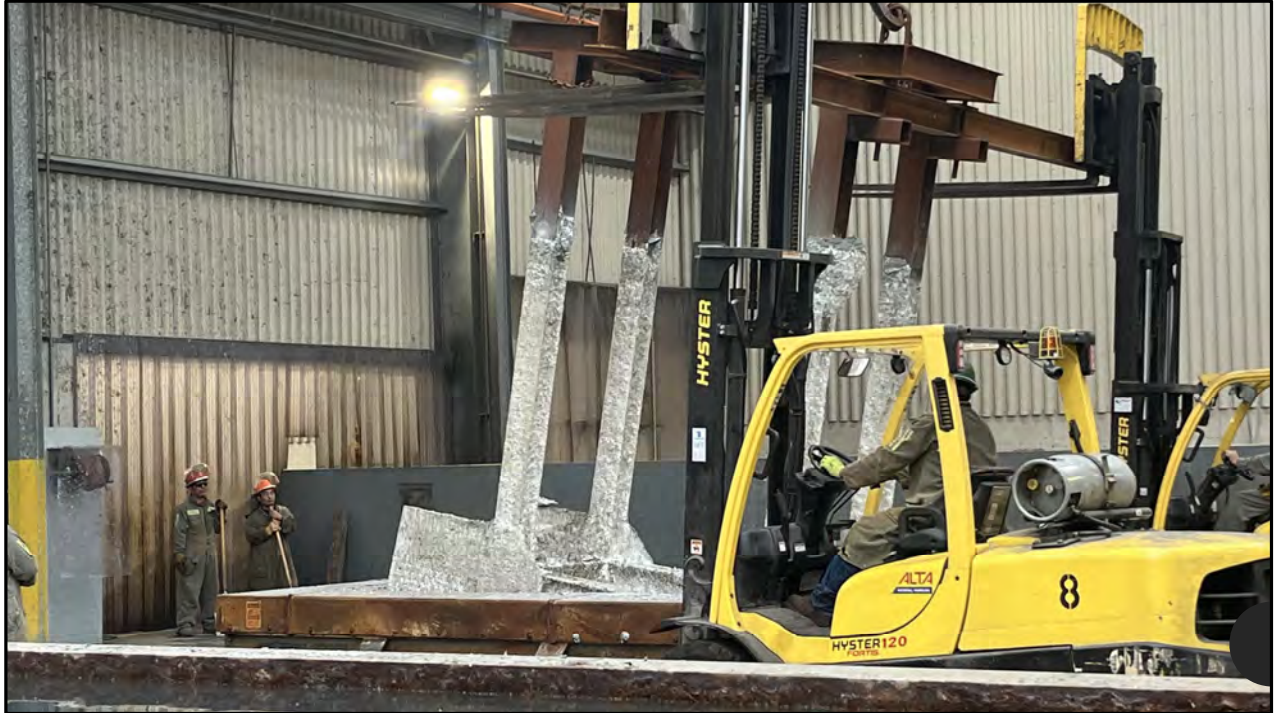
**Shorter shovels tend to want to lean forward when lifting out of the kettle because the weight of dross in the bucket.
We pin our push beam on for a bit of counterweight to the back of fixture.**

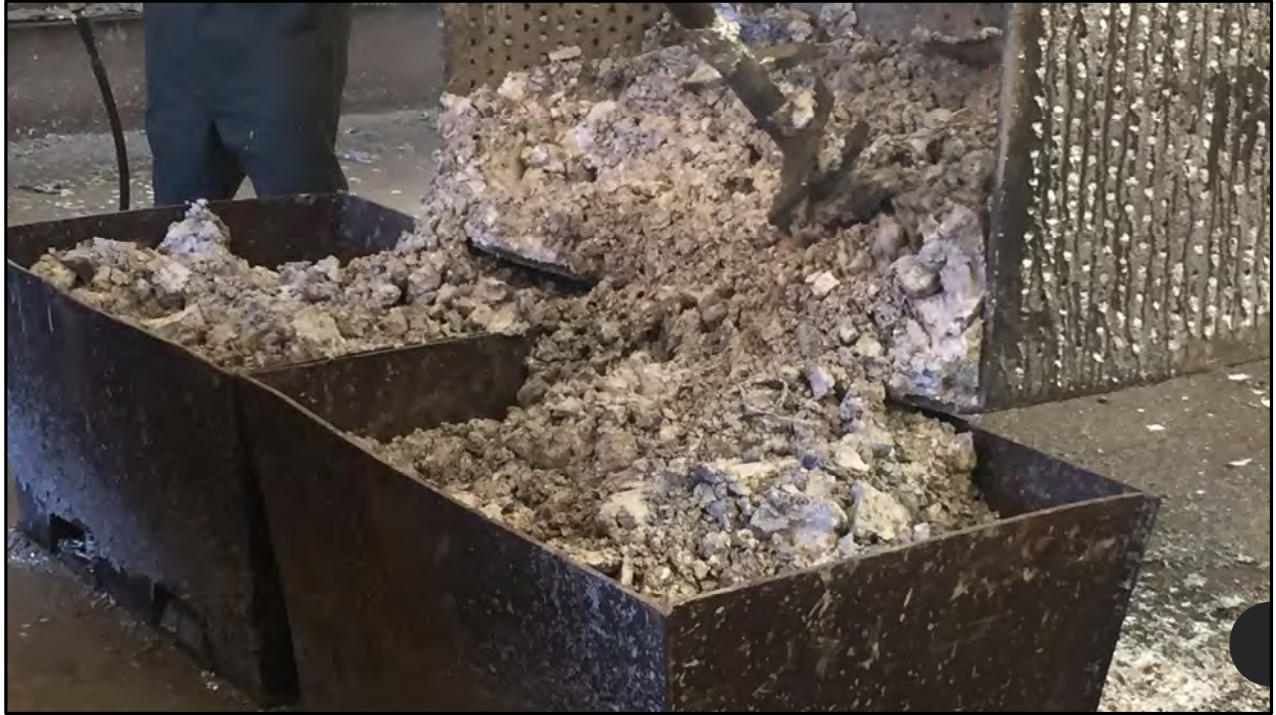
**Picture of the nice grainy dross with zinc worked out.
Barry Dugan says good dross only has 2 ½% to 3% iron in it.**

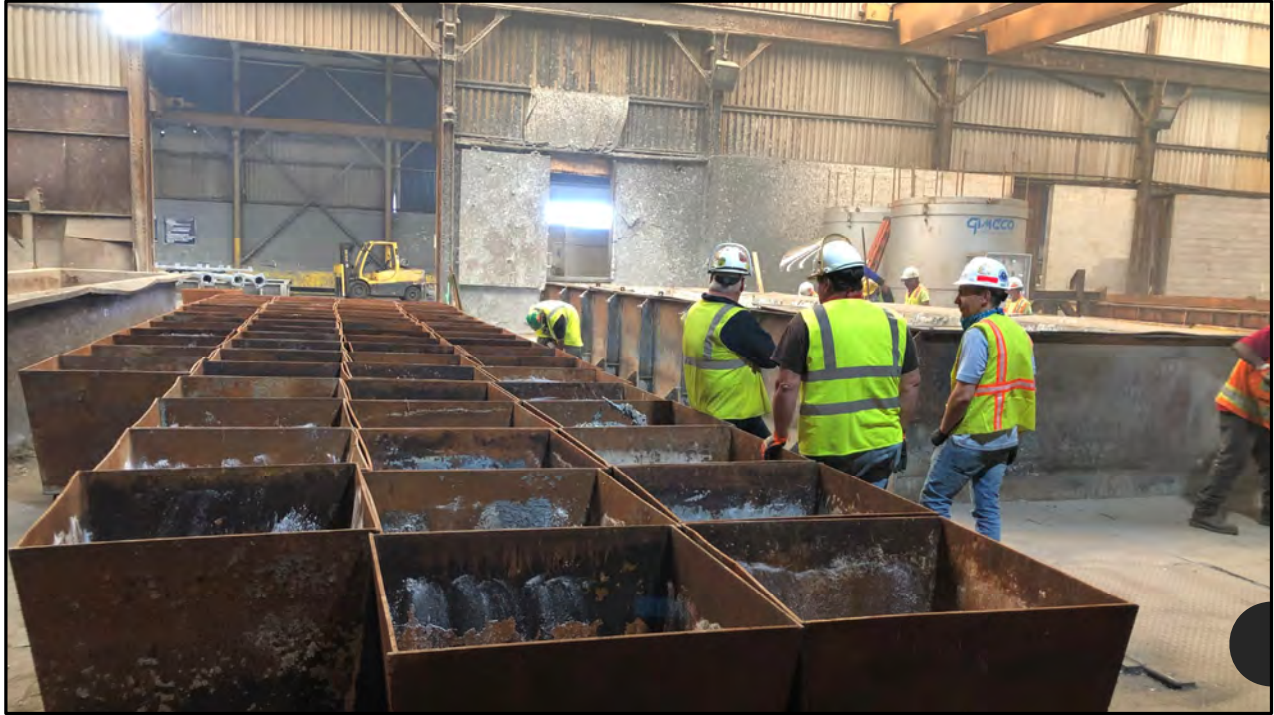
**Had some pump problems and since time starts ticking when you start pumping, we decided to scoop the remaining zinc.
We had about 120 pans to fill with two scoops going to either side of the kettle.
Two bridge cranes working with one scoop filling and one scoop dumping.
Took 5 hours to empty kettle this way.
Once you start getting below burners you have very little heat going into zinc, so it starts to cool quickly.
We transfer zinc at 865 deg. F to help give a little more of a cushion.**

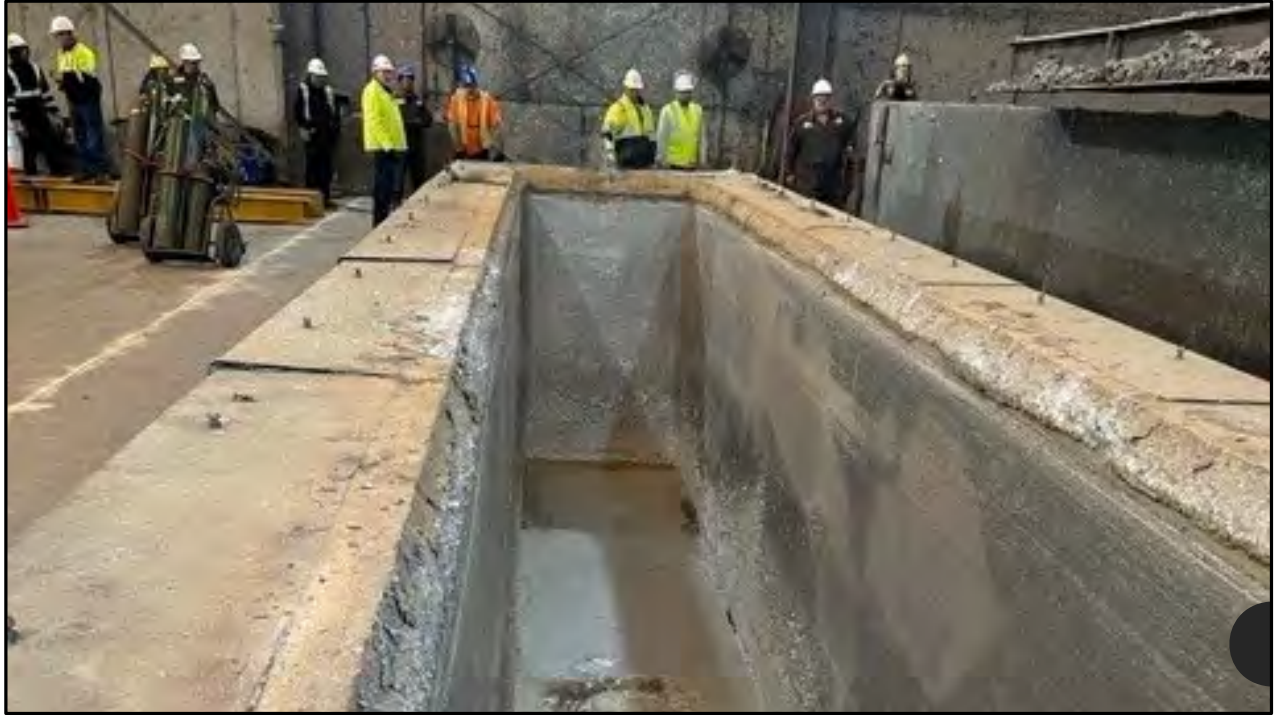
Empty kettle we need to start cooling by ripping top plates off and spraying some water on it.

Need to cool in 8 hours to be able to safely rig and remove from furnace.

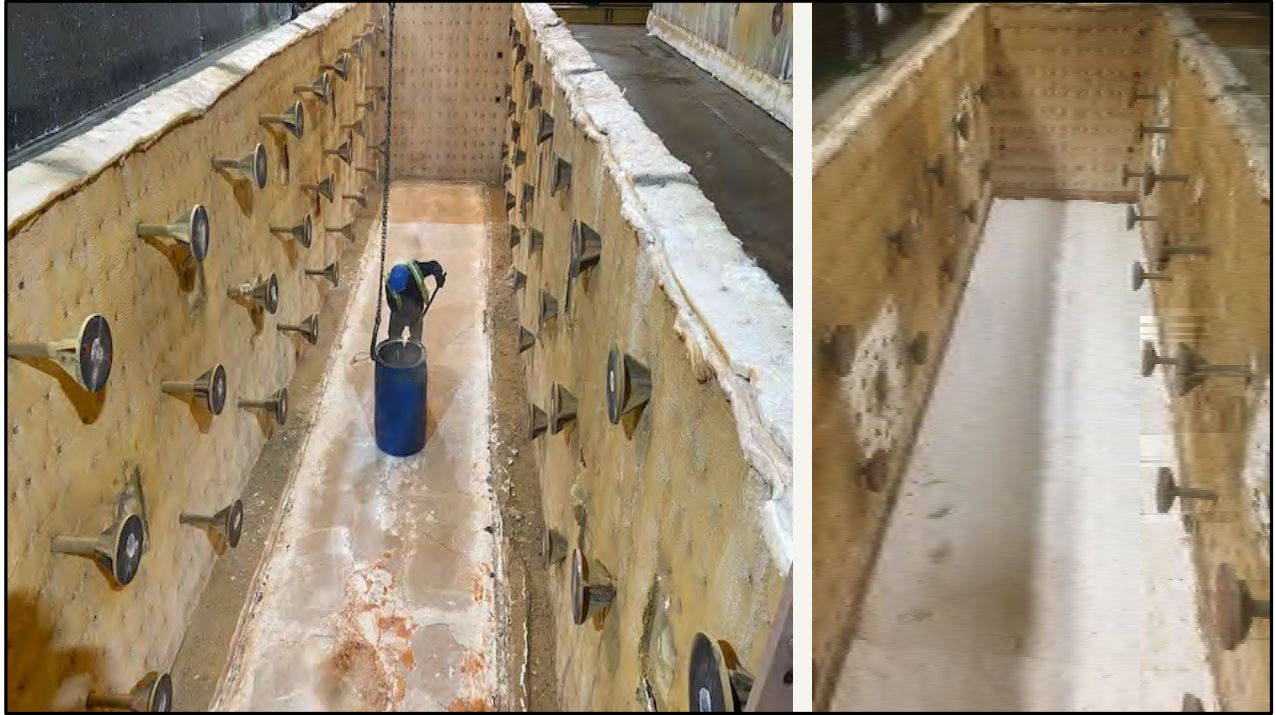
Clean, inspect and repair any areas of concern to get ready for new kettle.

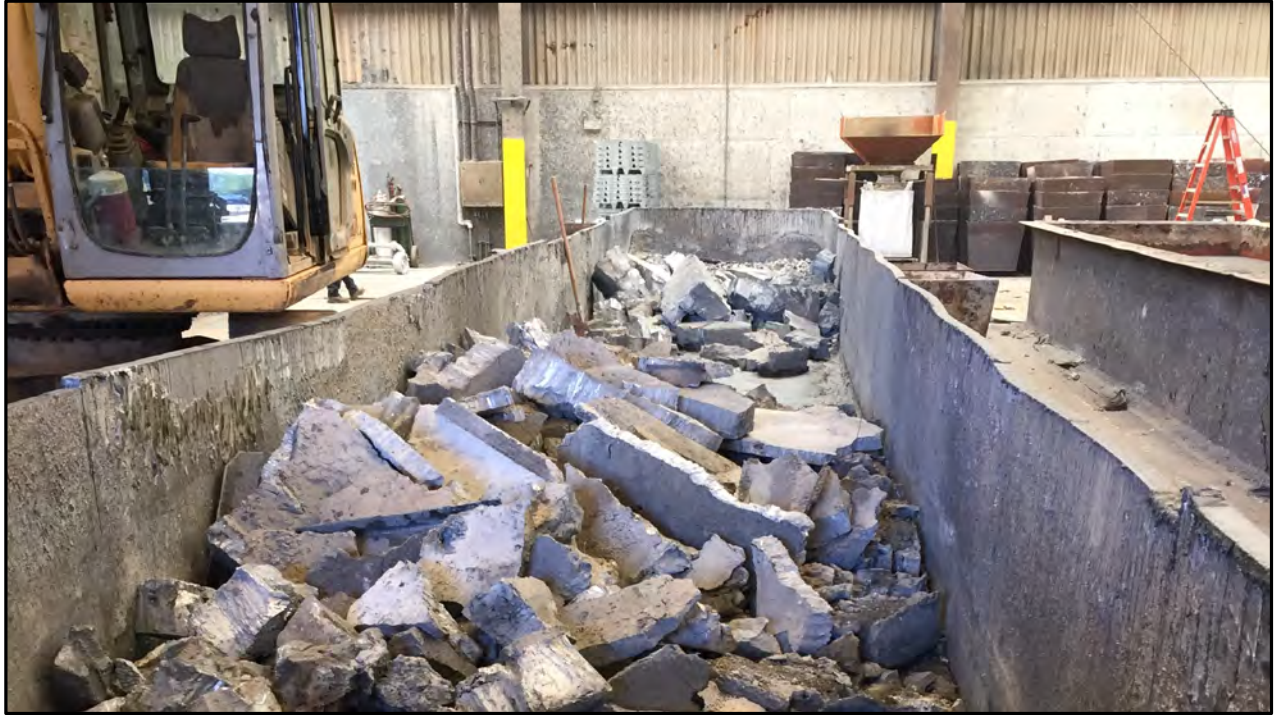
Easiest way we found to break up heel left in kettle was by large track hoe with large breaker hammer and sharpened wedge chisel point point.

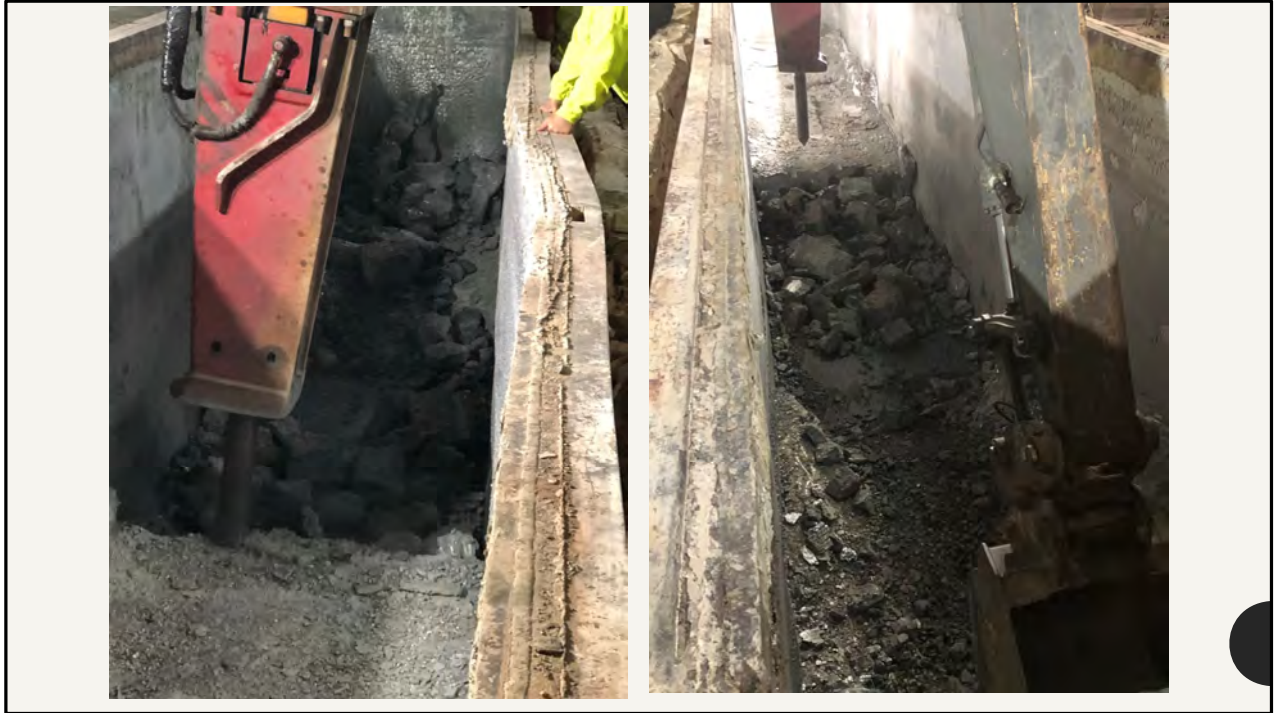
This kettle had 2' to 3' material left in and had to be cleaned quickly to lighten it up to lift.

This kettle residue was broken up and scooped out with a bucket on right to make us comfortable to lift it.

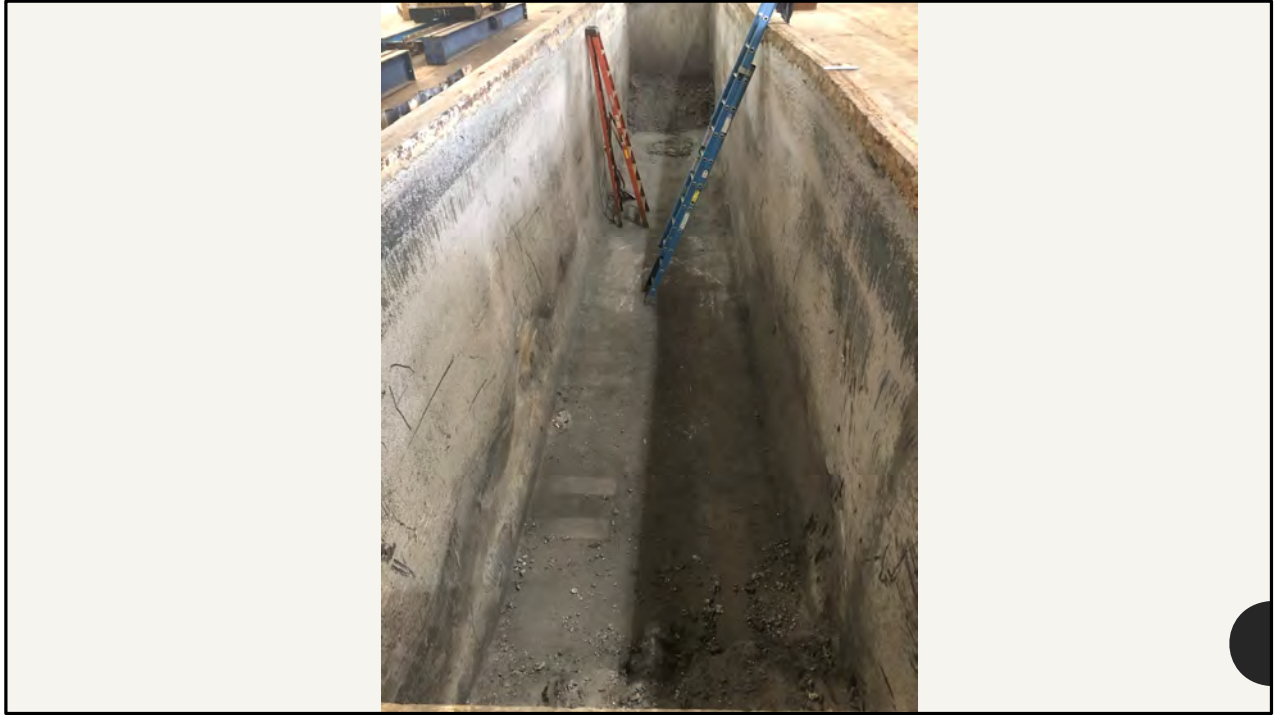
**Kettle cleaned out overnight while it was cooling.
Now it will be rigged and pulled out of the furnace.**

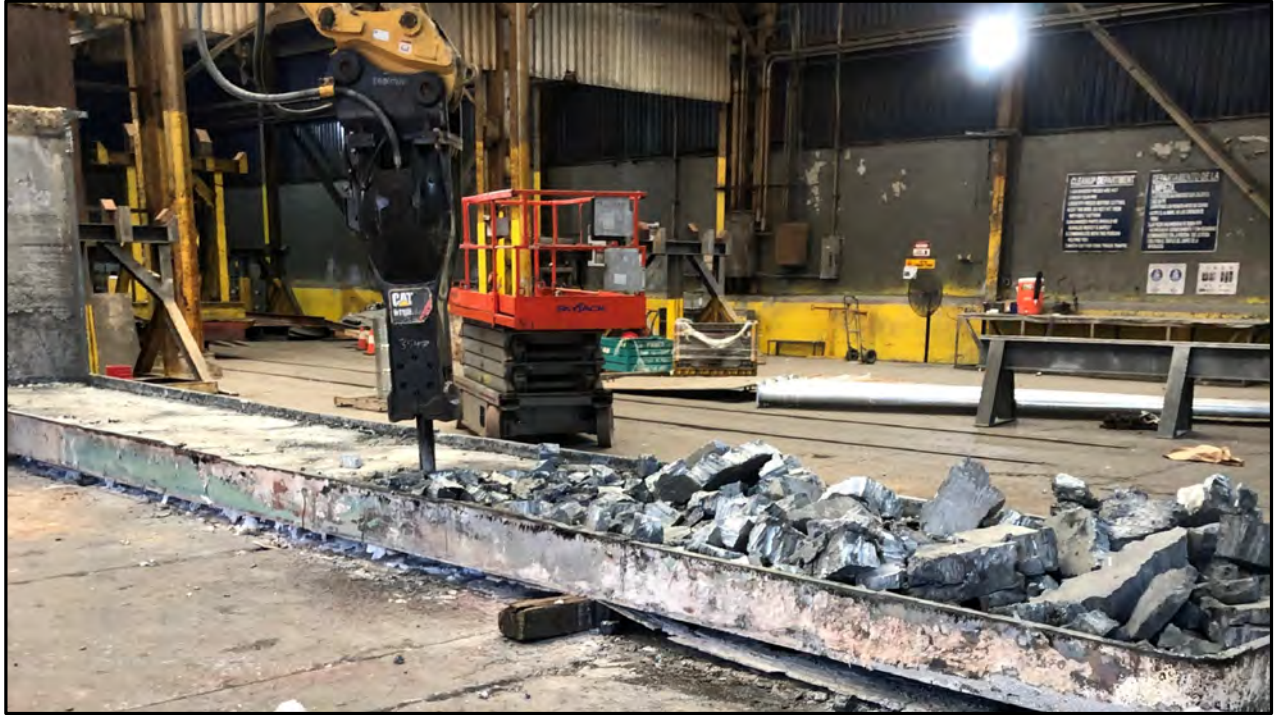
Another kettle bottom being cleaned.

All kettles we put material back into new kettle after full meltdown over the next few weeks.

We all have lead layers in the bottom and the remaining dross will be cleaned out of the new kettle.

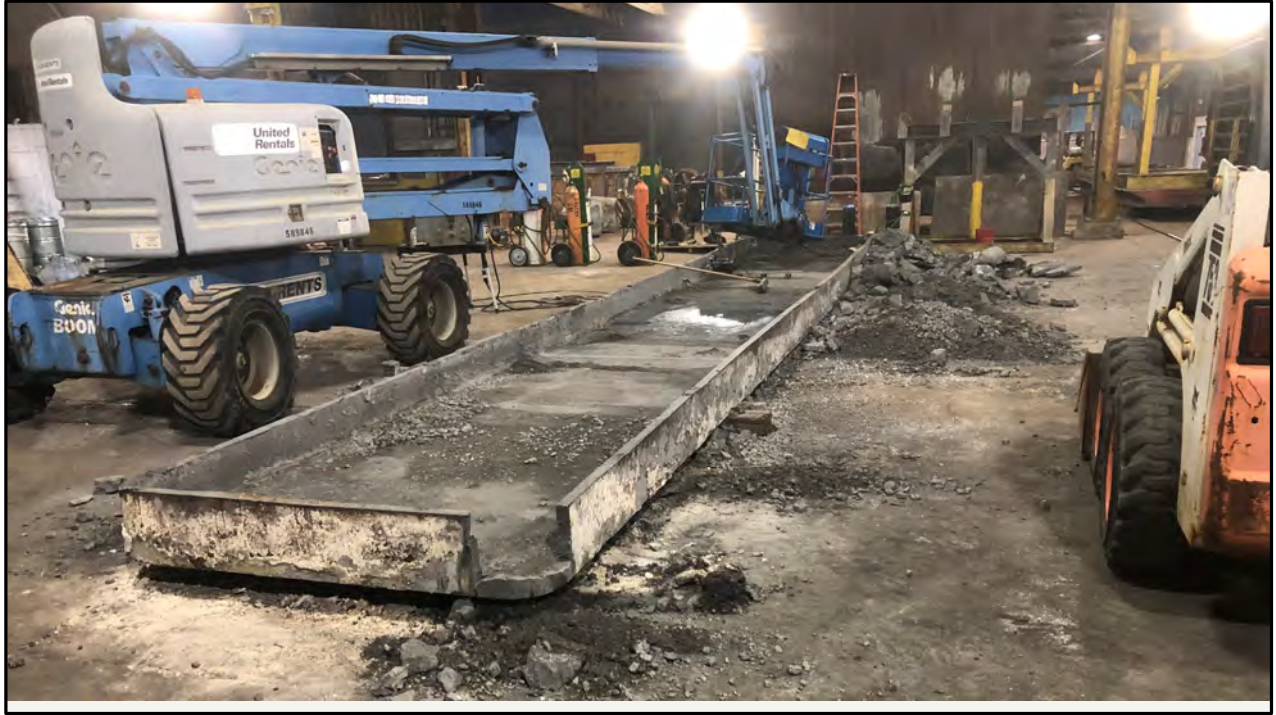
Kettle bottom almost cleaned ready to cut.

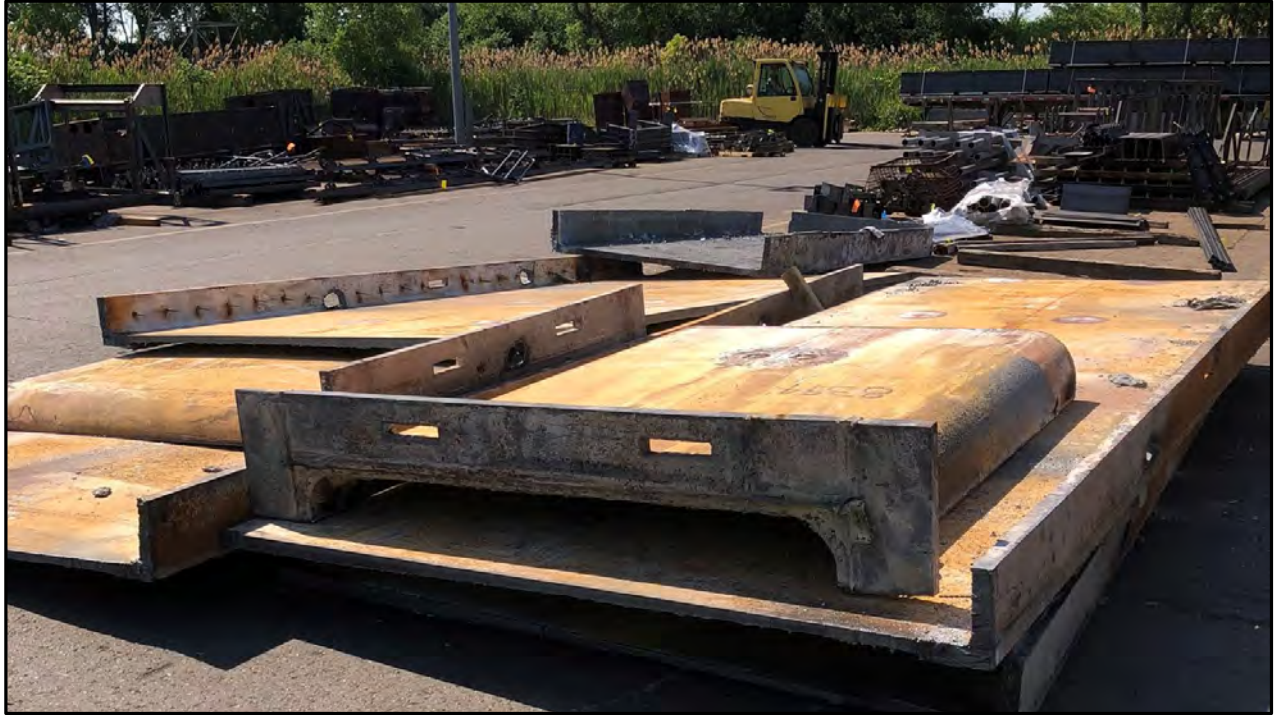
Old kettle cleaned up ready to go to scrap yard before new kettle is melted down.

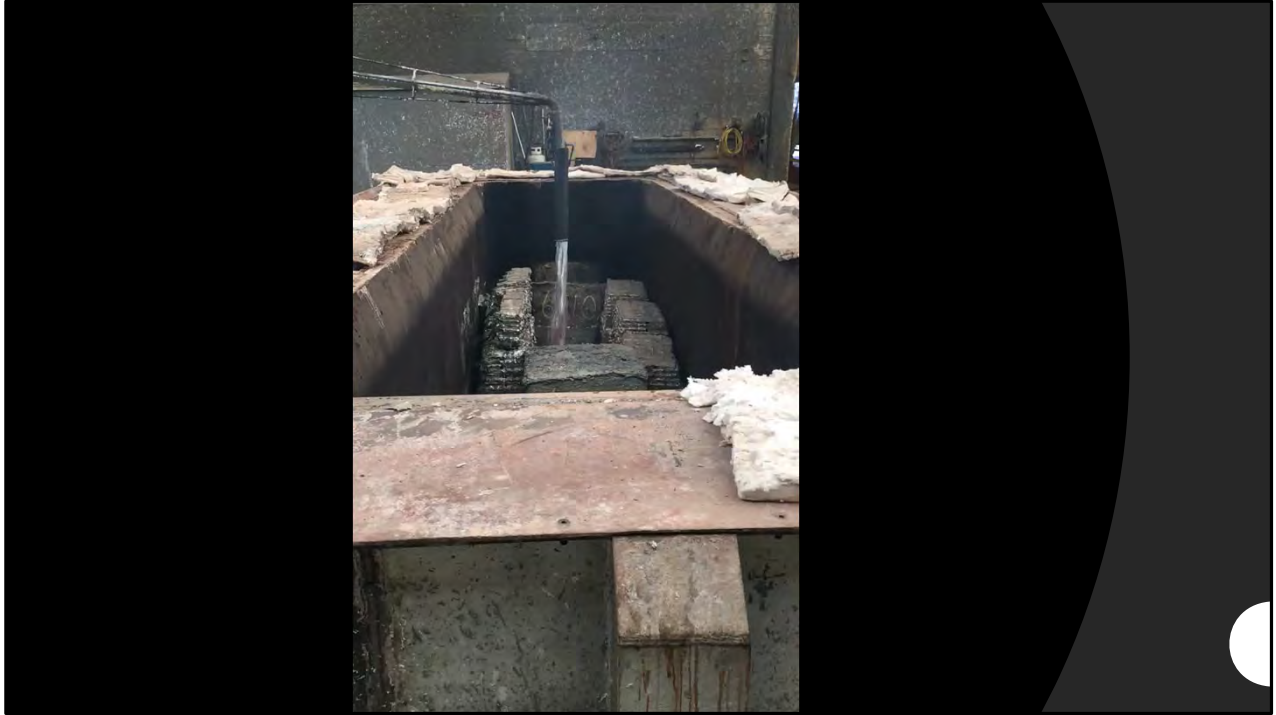
Pumping back 25' kettle.

**With 3 holding vessels only a small amount of solid zinc was needed.
After pumping this kettle was ready to galvanize 8 hours later.**

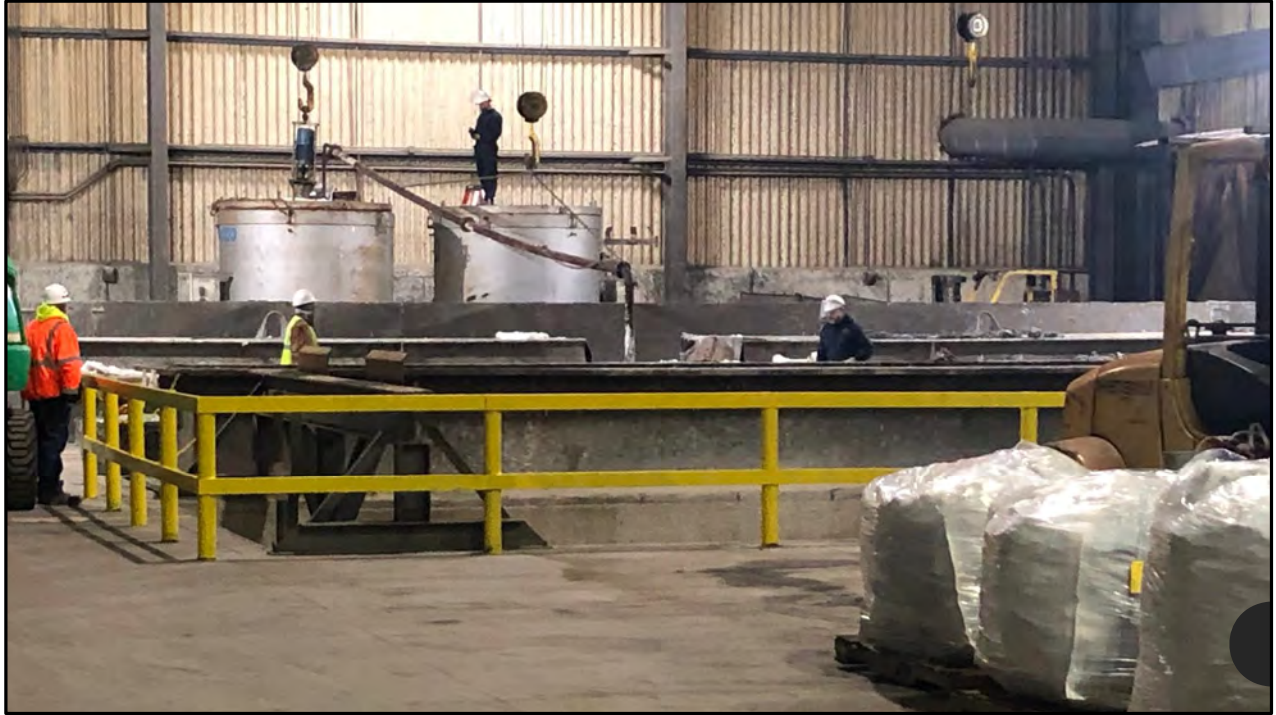
Another pump back from vessels with molten zinc.

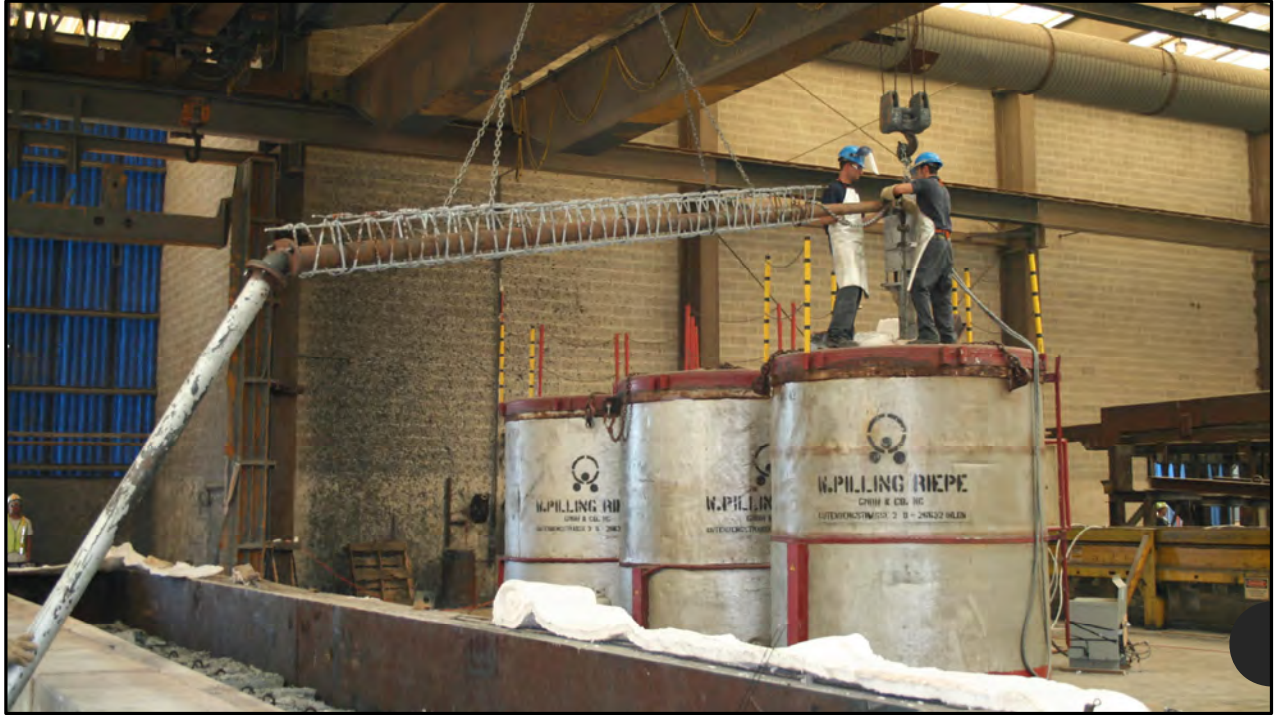
First kettle change at the Lebanon plant.
