Hot-Dip Galvanized Steel's Contribution to Zinc Levels in the Water Environment

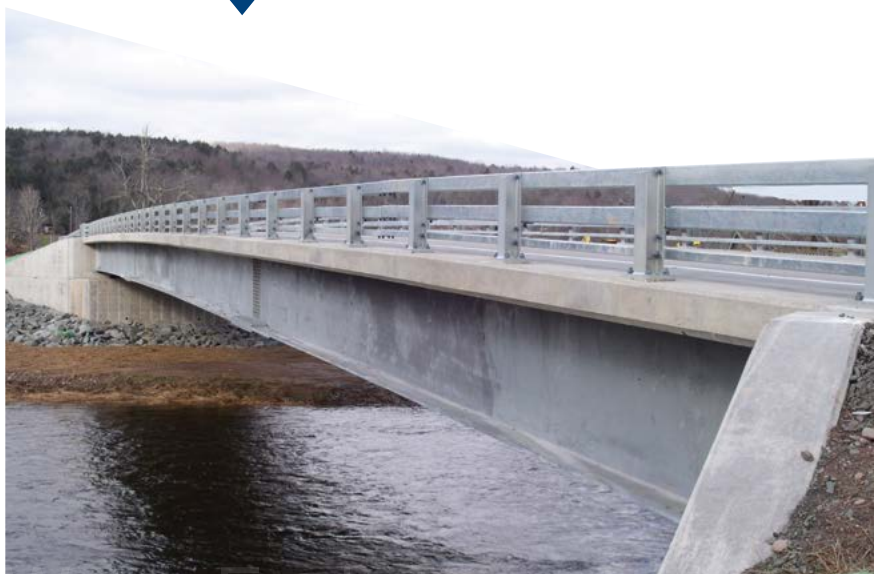
Case Study #1:

Never Sink River, Sullivan County Grey Road Bridge, Fallsburg, NY

Bridge - Constructed 2010

- ◆ 84 ft long by 40 ft wide
- ◆ 500,000 lbs. Hot-Dip Galvanized Steel (480,000 lbs. steel/20,000 lbs. zinc)
- ◆ Lifetime of zinc coating = 75 years

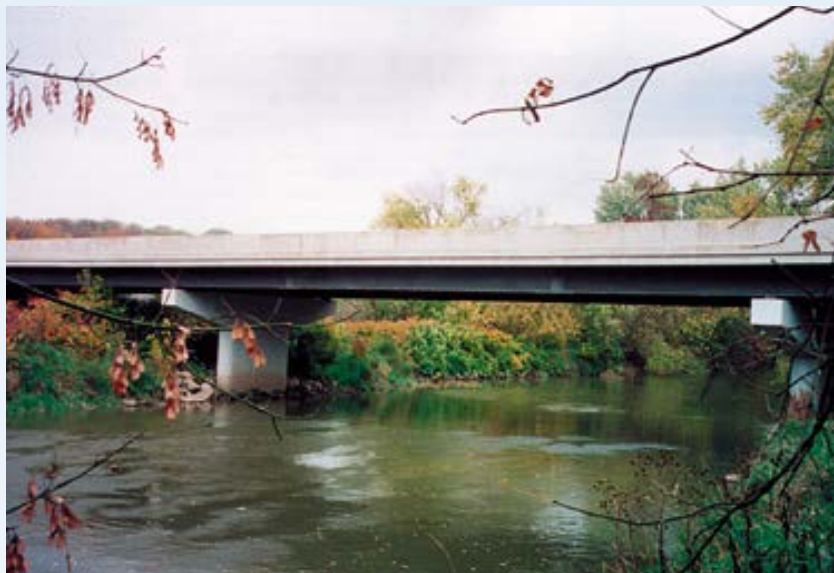
Case Study #2:

Warmington Bridge, Massillon, OH Tuscarawas River, Stark County

Truss Bridge – Constructed 1993

- 126 ft long by 40 ft wide
- 248,000 lbs. Hot-Dip Galvanized Steel (238,080 lbs. steel/9,920 lbs. zinc)
- Lifetime of zinc coating = 75 years

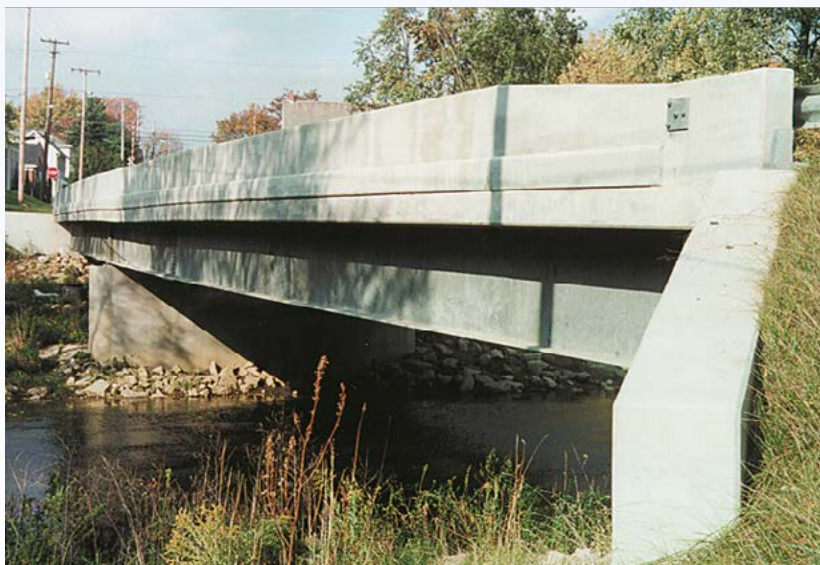
Case Study #3

Blough Avenue Bridge, Navarre, OH Ohio-Erie Canal, Stark County

Truss Bridge – Constructed 1998

- 237 ft long by 40 ft wide
- 344,000 lbs. Hot-Dip Galvanized Steel (330,240 lbs. steel/13,760 lbs. zinc)
- Lifetime of zinc coating = 75 years

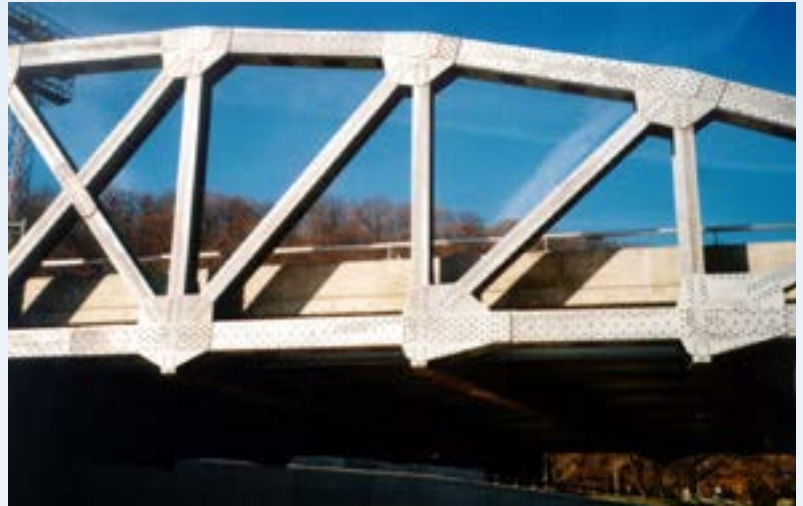
Case Study #4:

SR3023 Bridge, Johnstown, PA Little Conemaugh River, Cambria County

Truss Bridge – Constructed 2001

- 300 ft long by 40 ft wide
- 440,000 lbs. Hot-Dip Galvanized Steel
(426,240 lbs. steel/17,760 lbs. zinc)
- Lifetime of zinc coating = 75 years

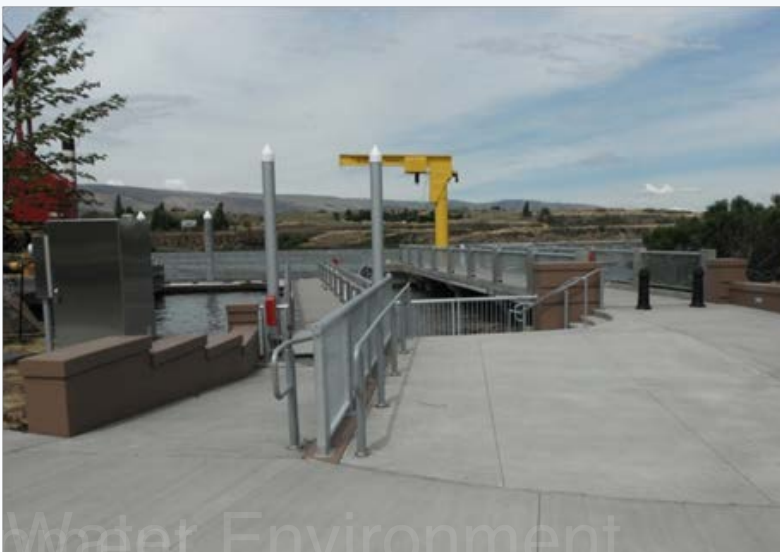
Case Study #5:

Commercial Dock Facility, The Dalles, OR Columbia River, Wasco County

Dock – Constructed 2012

- 24,542 lbs. Hot-Dip Galvanized Steel
(23,560 steel/982 lbs. zinc)
- 782 lbs. zinc above water
- 196 lbs. below water
- Lifetime of zinc coating = 75 years above
25 years below

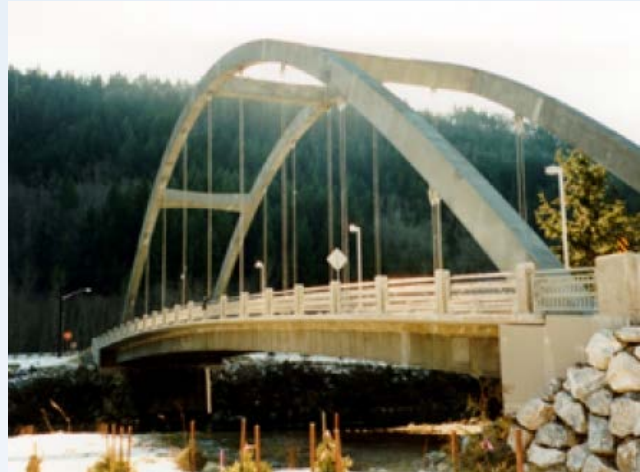
Case Study #6

Wes Smith Bridge, Index, WA

North Fork of the Skykomis River, Snohomish County

Truss Bridge – Constructed 1999

- 💧 220 ft long by 40 ft wide
- 💧 550,000 lbs. Hot-dip Galvanized Steel
(528,000 lbs. steel/22,000 lbs. zinc)
- 💧 Lifetime of zinc coating = 75 years
