City of San Antonio Northeast Service Center

San Antonio, Texas

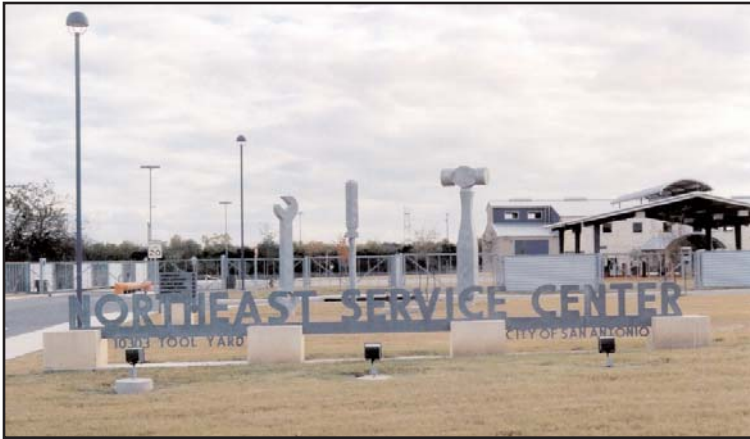
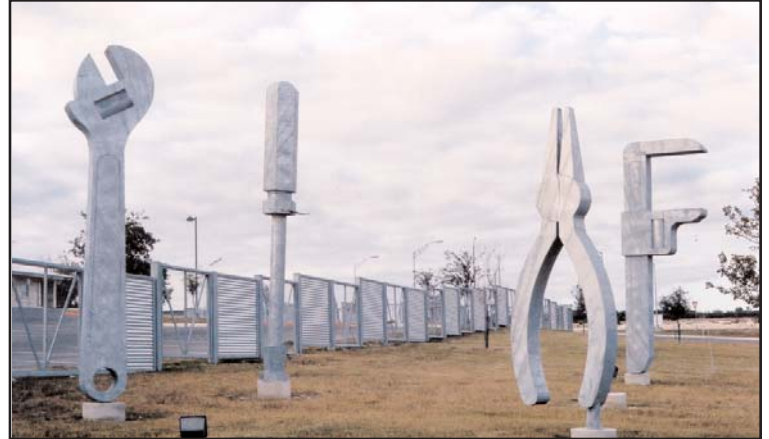
Careful planning and design consultation amongst the artist, fabricator, and galvanizer were key to making this unique series of steel sculptures a reality. Having determined that hot-dip galvanizing was the coating method of choice for aesthetic appeal and long-term durability of the "wrench set," the artist carefully designed each tool with light-gauge steel, interior baffles, and stiffeners — all to facilitate a quality galvanized result.

Ten-thousand pounds of steel were hot-dip galvanized, including the security fence surrounding the service center. Afterwards, each piece was systematically inspected by the galvanizer and the artist, ensuring dimensional accuracy and a coating appearance fitting for this high-visibility sculpture. The durable coating of the

finished piece required no touch-up after installation, and zinc's naturally developing patina assures the artist and the city of San Antonio that this piece will have a consistent look with long-lasting corrosion protection for decades to come.
