Colorado Division of Fire Prevention and Control

Fort Collins, Colorado

A critical component in the DFPC firefighting arsenal is the foam spraying on/off road firefighting vehicles. These powerful trucks are equipped with a low-profile 850-gallon hot-dip galvanized (HDG) steel water tank. The galvanized tank design provides a deck on top for mounting the compressors, pumps, hose reels, toolboxes, and additional storage. These specially equipped trucks convert the onboard water supply to a fire-suffocating foam, which the deck pumps can spray as far as 250 feet to the target hot spot.

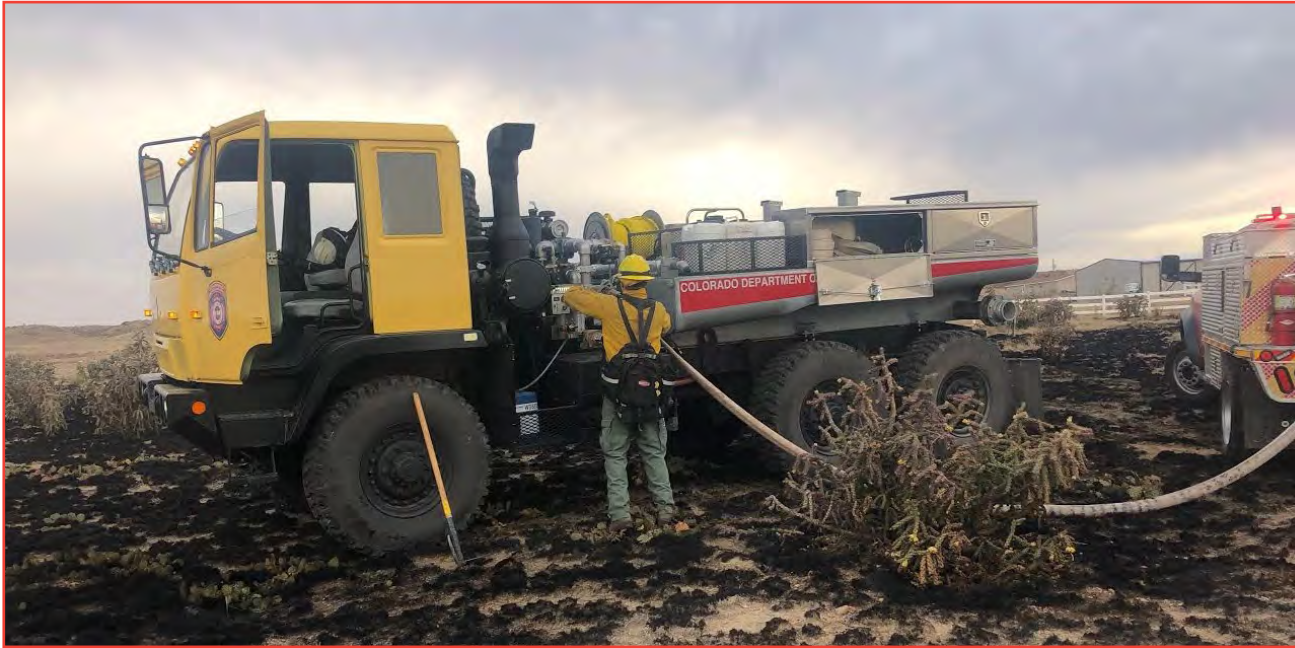
Unfortunately, within just a few years the stainless steel tanks began to develop cracks and leaks which also reduced the effectiveness of these critical go-anywhere vehicles. The DFPC eventually abandoned the stainless steel experiment altogether. In 2001 the DFPC redesigned the tank, choosing carbon steel once again to better handle the rugged terrain and this time selecting hot-dip

galvanizing to provide maintenance free protection for all internal and external surfaces. The DFPC moved forward cautiously, changing out just a few tanks each year while monitoring the effectiveness of the new design and HDG protection.
