Expocité

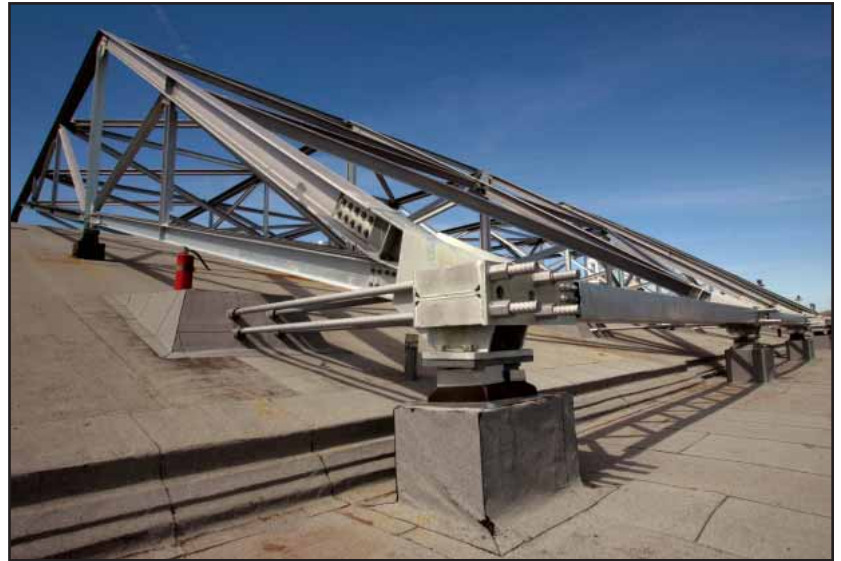
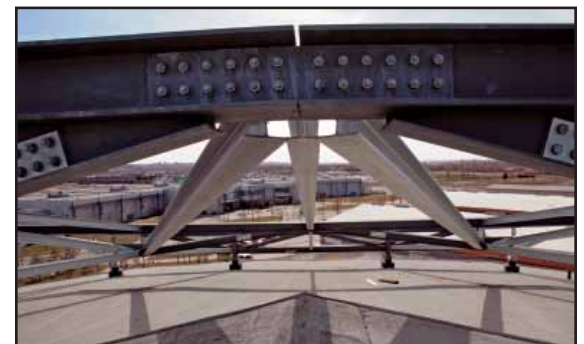
Renovation of the 80-year-old Expocité sport stadium in Quebec required a great deal of planning and environmental consideration, not to mention the removal of existing interior structural columns preventing the installation of a hockey rink. The columns were obstructing sightlines for spectators, and the engineers decided the solution was to install external trusses to support the roof from above. The tops of the old columns were used to tie in the new ones, which penetrated the roof to catch the new trusses.

This project used more than 500 tons of steel, most of which is exposed. The massive hot-dip galvanized steel trusses on top of the roof can be seen from Highway 73 (the main artery entering the downtown corridor of Quebec City,) making aesthetics an important consideration. Galvanizing the steel used in the project will keep unsightly rust stains from developing and keep the structure looking freshly renovated. The Expocité was renovated to attract a major hockey tournament in 2008, the Junior World Hockey Championship, and throughout the year various events and expositions are held within. Galvanized steel will keep the structure looking attractive for the large number of people attending events at this location.
