# Franklin Park Conservatory Ameriflora

Columbus, Ohio

lifetime achievement

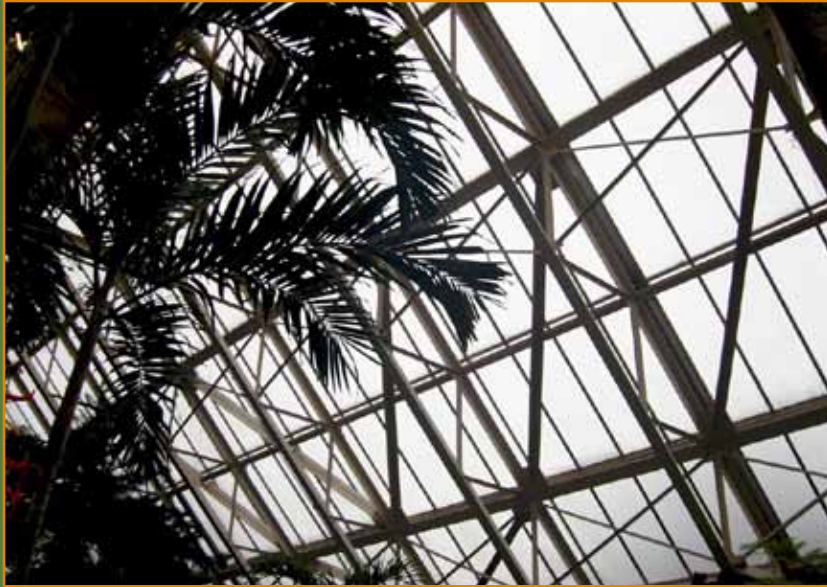
During a 2012 inspection, the duplex system showed no signs of paint failure or corrosion. There is significant and constant moisture and humidity levels on the majority of the steel due to the greenhouse atmosphere. The readings (above) were taken on the steel and show enough coating to last another 50 years or more, even in this humid environment.

Franklin Park Conservatory						
Produced 1992, Tested 2012:						
Sample Area	Readings (mils)					Average
Catwalk	10.8	11.4	11.6	10.7	10.9	11.08
Pipe Column	12.3	11.4	12.1	11.7	11.2	11.74
Angle Bracing	9.6	8.9	8.9	9.2	9.0	9.12
