Load Application Unit for the Wind Turbine Drivetrain Test Facility at Clemson University

North Charleston, South Carolina

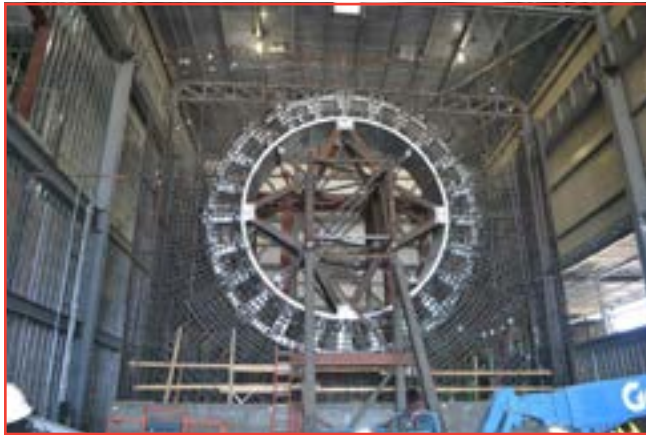
The “load application unit” is located inside an unconditioned building 300 yards from the harbor. The only conditioning will be large fans to ventilate the space to remove excess heat when operating. When not operating, the facility will be subject to ambient coastal conditions. This is an area in a high humidity region with rapid shifts in temperature leading to active condensation on large steel structures.

This is a one of a kind facility and will be the world’s most capable wind turbine drivetrain testing facility. There will be almost 1,000,000 lbs. of steel components cantilevered off the embedded ring and its surrounding concrete structure. The final mounting surface was accurate to plane within 0.028” over the entire face.

Once the ring was assembled, metrologists came in to take measurements of the entire structure to verify the 192 pipe openings were in the correct locations on all X, Y and Z axes. This proved to be the most difficult part. Typically the distortion caused by welding and galvanizing make it very difficult to ensure the tighter tolerances. In the structural world, a commercial shop generally gets + 1/8”. This particular job had some tolerances in the 1/1000ths of an inch.

The galvanizer took extra steps to reduce the possibility of warping caused by the hot-dip process. As each section was brought back to the fabrication shop from the galvanizer it was placed together to start the formation of the ring. After many days of modifying and measuring over and over, it was finally ready to be locked in place. The splice plates were match drilled to ensure that after shipping the ring would fit back in the correct location. The ring was broken into four sections for shipping from Charlotte, NC to Charleston, NC. There the construction team reassembled the ring and hung it in place.
