Duplex System

Logan Park

Boston, MA

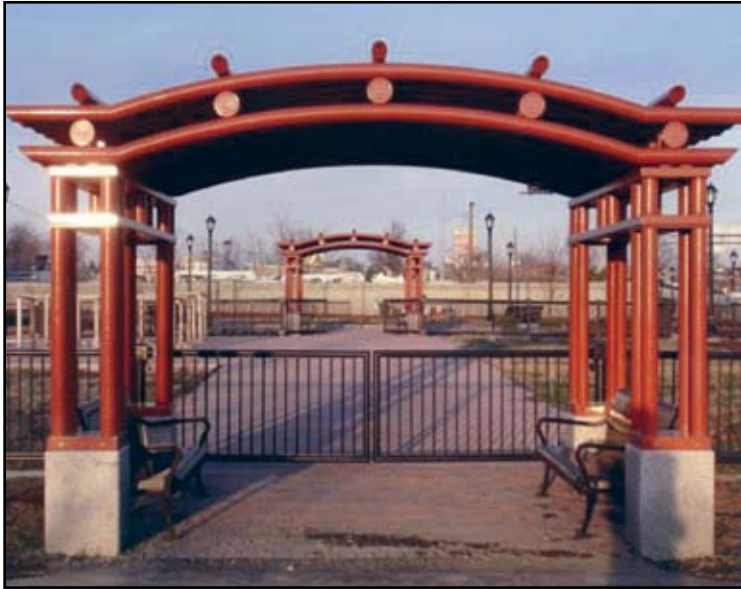
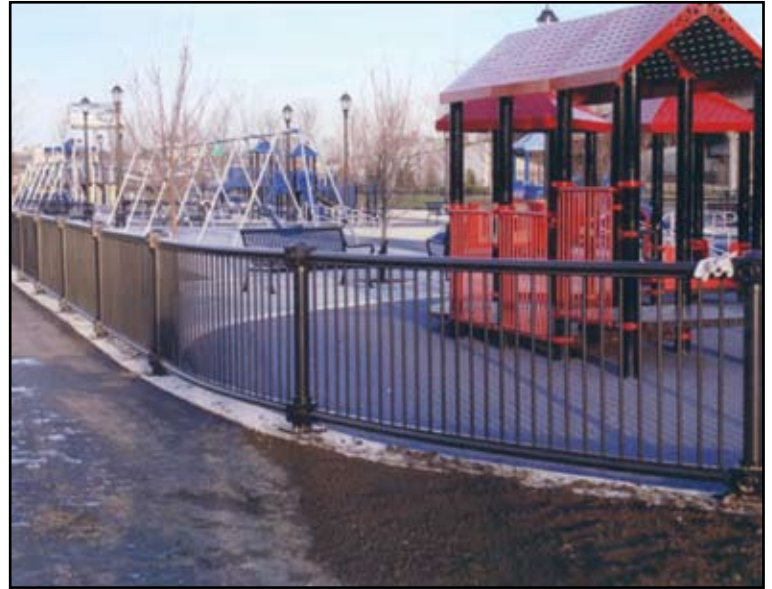
All 860 tons of structural steel fencing was hot-dip galvanized and then painted. The three-part design required the pieces to be galvanized and painted separately and then rematched and assembled in another location before delivery to the job site. The pieces required a smooth galvanized finish and paint coating because of the nature of the intended use. The duplex coating will provide superior corrosion protection and aesthetic appeal for the popular, public park for generations.
