# Valmont Irrigation Machines

Worldwide

lifetime achievement

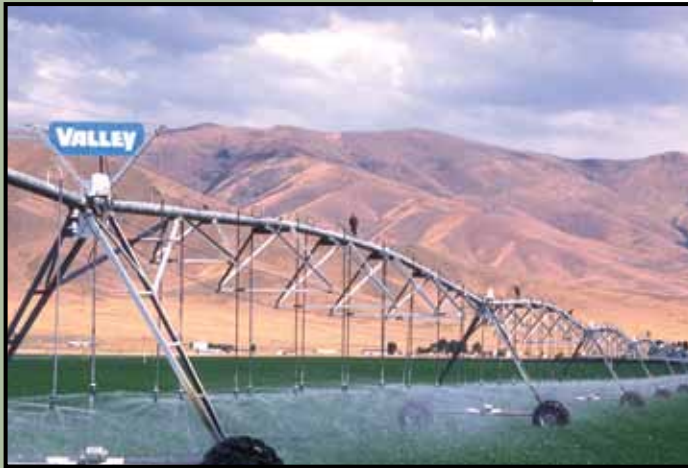
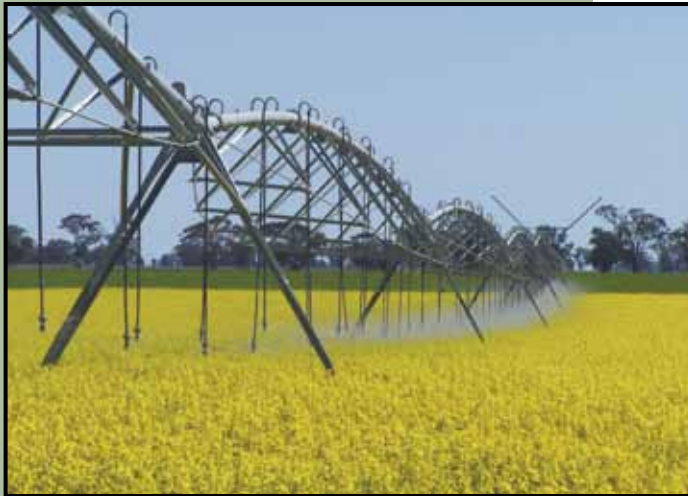
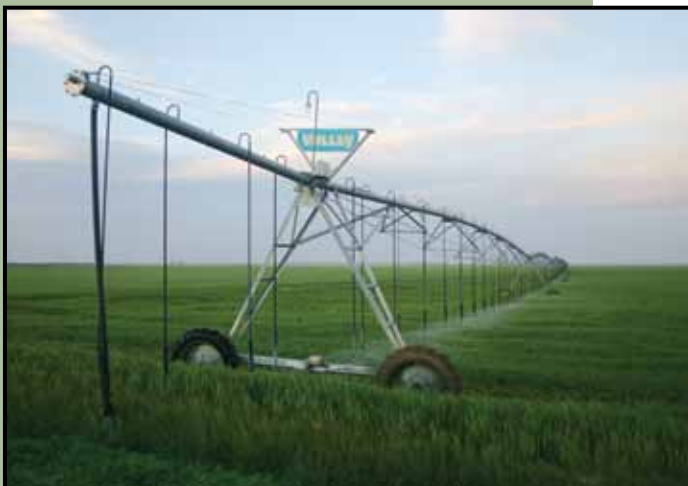
The hundreds of thousands of Valmont Irrigation center pivots and linear machines sold over the past 40 years are a testament to the superior, durable corrosion protection offered by utilizing hot-dip galvanized steel. Now considered the industry standard for protecting pivot irrigation equipment against corrosion, galvanized steel protects these vital farming tools from costly and damaging corrosion caused by constant exposure to every climate condition on the planet – beating sun, falling rain, freezing snow – as well as the water moored within.

To demonstrate the lifetime achievement of the hot-dip galvanized coating on these structures, a Valley center pivot, sold in April of 1977 was inspected. The table below shows the zinc coating thickness after 33 years. This puts into perspective the even, continued protection provided by hot-dip galvanized steel. The decades-old machine is still operational, and the piping, supporting structure, and unit legs are in excellent condition. No area of galvanized steel has been compromised, and there is no evidence of corrosion. The zinc patina on the piece is mature and

intact, and has taken on the familiar, attractive matte gray appearance. This natural zinc patina blends in with the rural environment and is considered to benefit the landscape by many end customers.

Valmont Irrigation System Produced 1977, Tested 2009:						
Sample Area	Readings (mils)					Average
Pipeline	3.9	4.1	3.9	4.0	3.9	3.9
Angle Supports	3.5	3.3	3.4	3.3	3.2	3.3
Leg Supports	3.5	3.5	3.2	3.9	3.9	3.5
