American Galvanizers Association  
*Protecting Steel for a Sustainable Future*

# Masking Materials for Preventing HDG

Masking materials, also called stop-off materials, are products applied to steel in specific areas prior to hot-dip galvanizing to prevent zinc from reacting with and adhering to the steel.

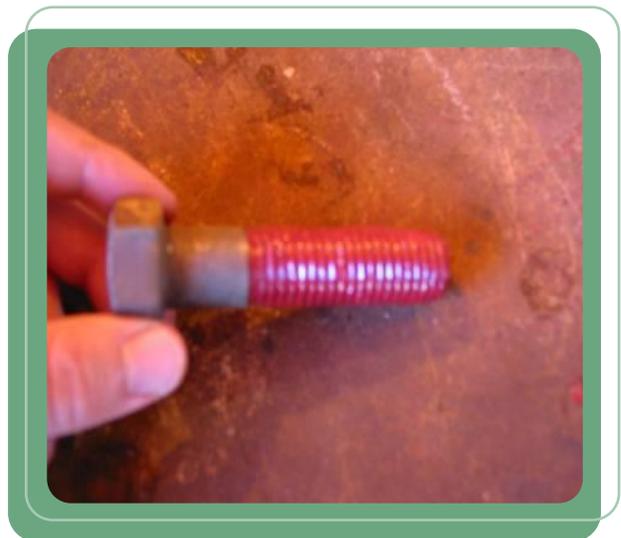
Figure 3: Coated bolt threads.

Some of the plates were drilled and tapped to provide a plate with a buried threaded hole to test the masking materials (see Figure 2). The buried threaded holes were 2½" deep holes drilled into a 3" thick plate (see Figure 2). Buried threaded holes were used only in Phase 1 testing. The bolts used in the study were ¾" in diameter and approximately 2 ½" in length (see Figure 3).

For the bolt threads, the masking materials were applied by either dipping the bolts directly into the bottle of the material, if there was enough room, or spread onto the threads using a foam brush. The material was spread onto the threads to achieve even thickness.

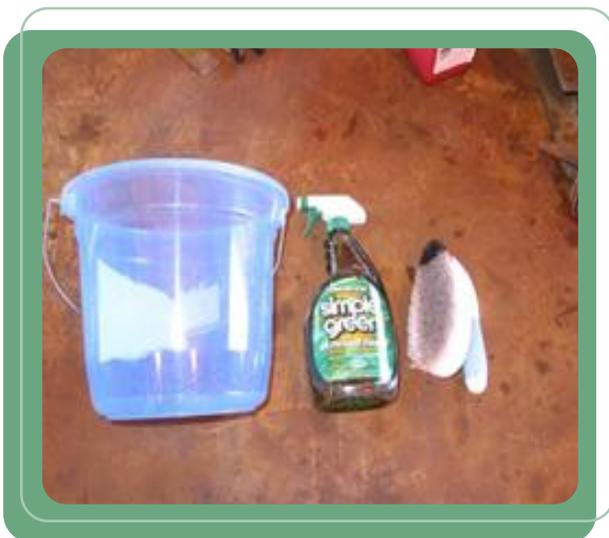
Figure 4: Simple Green and nylon brush.

cleaned steel with a nylon bristled brush and Simple Green solution was also performed to determine if the original steel finish could be restored. A grinder was also tested in Phase 2 for removing the materials on flat plate.

Cleaning the plates with the Simple Green solution had a negligible effect on removing the debris left from the masking materials.

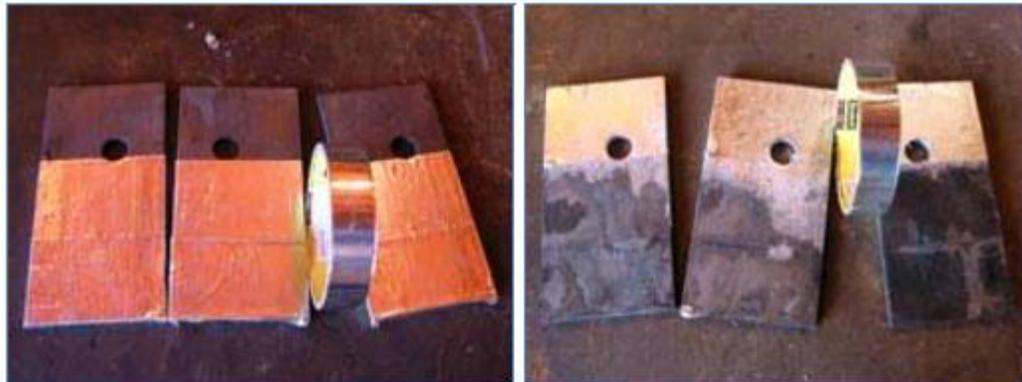
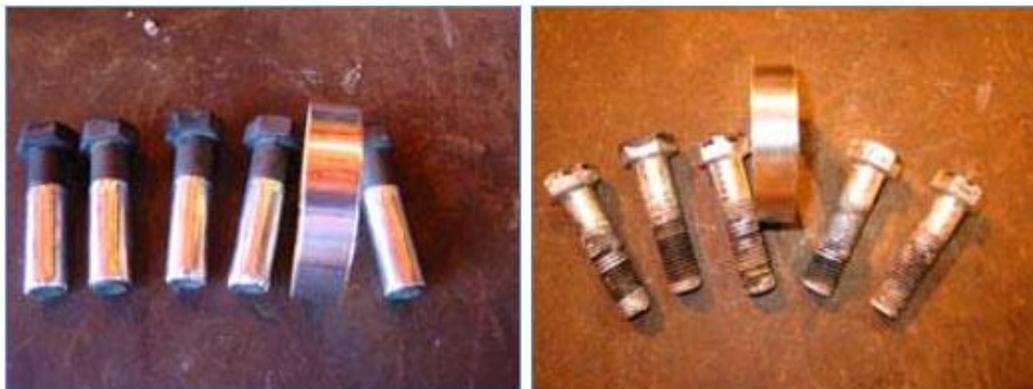
### 3M High Temperature Aluminum Tape

Product	Application Time	Application Notes	Masking Success	Notes	Removal Time	Removal Notes
3M High Temperature Aluminum Tape	17 mins., 26 secs.	Thoroughly ensured the edges were sealed.	Almost	About 12% of the area galvanized. Seepage at ends caused galvanizing in those areas.	9 mins., 24 secs.	Used a flathead screwdriver to scrape the tape and then pulled it off.
DAP Household Adhesive Sealant	3 mins., 20 secs.	Squirted the product onto plates, then spread it with a foam paint brush. Material was very easy to work with.	-	One plate galvanized completely and the two other plates had large areas that galvanized.	2 mins., 11 secs.	Scraped off with a small metal-bristled brush. The material was very gummy and hard to remove.
Dow Corning Compound #111	3 mins., 42 secs.	Squirted the product onto plates, then spread around with a foam paint brush. Material spread easily, but was messy because it does not dry.	-	At least 80% of the area galvanized.	40 secs.	Scraped with a small metal-bristled brush.

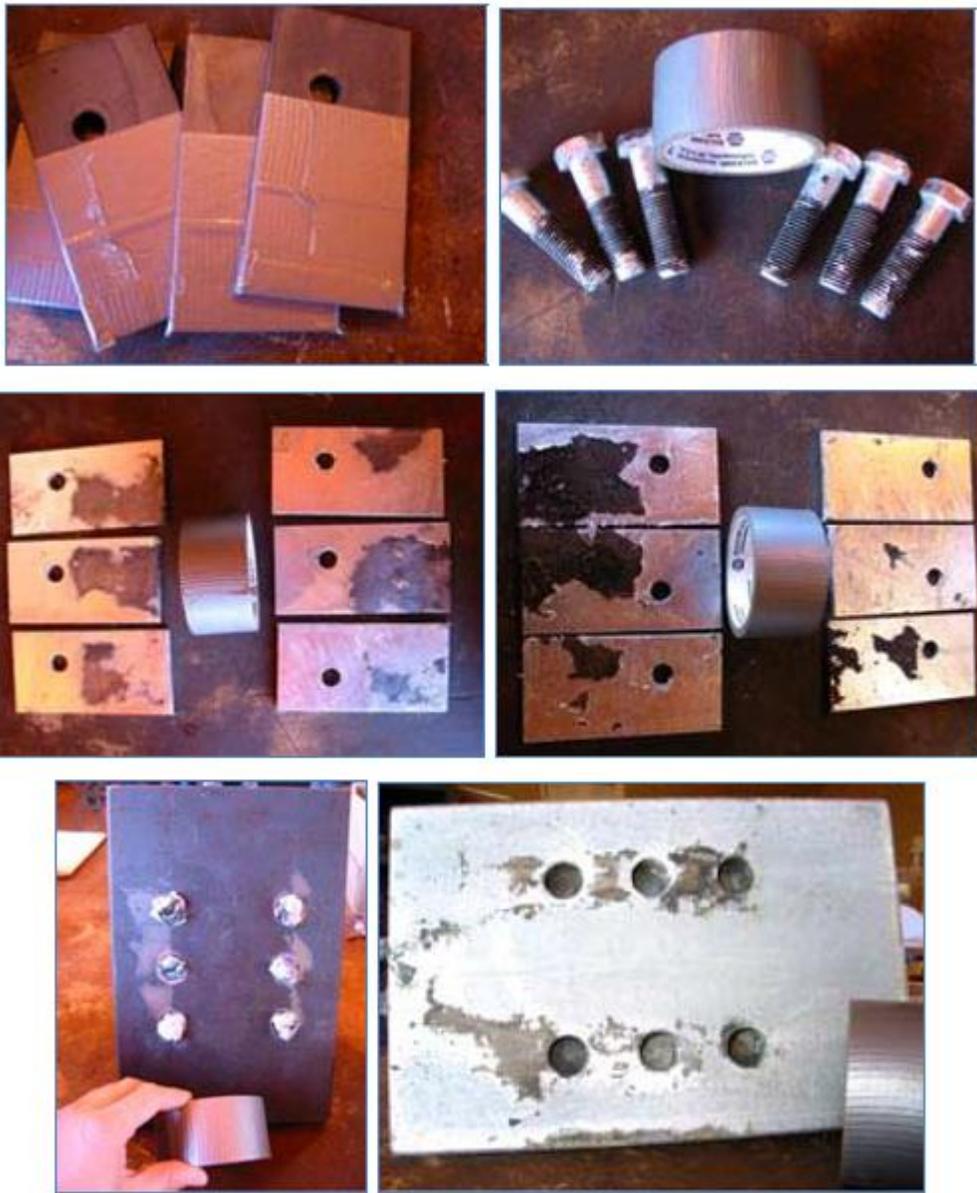
# Duct Tape

Duct Tape	25 mins.	Wrapped 2 times around plates.	-	Less than 90% remained bare	10 mins., 52 secs.	Scraped off burnt tape with a metal-bristled brush. Scraped off very easily.
Galva Stop	2 mins., 21 secs.	Shook can, poured, then spread using a foam brush.	Yes	Entire area was completely free of galvanizing	2 mins., 38 secs.	Used a small metal-bristled brush to scrape since the big metal-brush was ineffective. Had to scrape very hard to get this material off.
GE 100% Silicone Caulk	1 mins., 22 secs.	Used a caulk gun, then spread using a foam brush. Went on very thick.	Yes	The material prevented galvanizing, but the surface was stained black.	1 min.	Used big and small metal-bristled brushes to scrape away the product. It came off fairly easily.
Kapton Tape	30 mins.	2 wraps. Tape did not stick well, much harder to work with than the duct tape.	-	Less than 90% remained bare	18 mins., 39 secs.	Scored tape with a flathead screwdriver, then used a metal-bristled brush to scrape away remaining debris.

Duct Tape	5 mins.	Balled up tape, then stuffed in the holes.	-	5 of the 6 holes galvanized	6 mins., 17 secs.	Scraped w/ metal-bristled brush. Some unmasked areas around holes did not galvanize, which could fail inspection after galvanizing.
Galva Stop	2 mins., 30 secs.	Poured into holes	-	In 5 of the 6 holes, a small area galvanized. The area was about 10% of the holes.	8 mins., 26 secs.	Used a metal-bristled brush to scrape material out, which was very hard to do.
GE 100% Silicone Caulk	1 min., 15 secs.	Squirted into holes w/ a caulk gun	Yes	The very top of one hole galvanized a tiny bit, but it could have been an application error, as the hole was not filled to the very top.	5 mins., 18 secs.	Used flathead screwdriver to break apart material, then used a small metal-bristled brush to scrape material out.
Kapton Tape	8 mins.	Slightly harder to work with than duct tape. Balled up, then stuffed in the holes.	-	3 out of the 6 holes galvanized	5 mins., 40 secs.	Used flat-head screwdriver to scrape out tape, then used a metal-bristled brush to get the rest. Some unmasked areas around holes did not galvanize, which could fail inspection after galvanizing.

Duct Tape	5 mins., 30 secs.	Wrapped 5-6 times around each bolt.	-	Had large bare areas, but many areas still galvanized.	5 mins., 44 secs.	Used a big metal-bristled brush to scrape away the material, which came off very easily.
Galva Stop	3 mins.	Dipped bolts into bottle to apply material. Hardened, but still flexible. Will stick to itself if it touches other coated products.	Yes	A few tiny areas did galvanize.	6 mins., 50 secs.	Brushed off black ashy material very easily with a big metal-bristled brush.
GE 100% Silicone Caulk	10 mins., 30 secs.	Smearred material on w/a foam paint brush. Somewhat easier to handle than NAPA RTV red.	Yes	Threads were completely bare.	7 mins., 30 secs.	Used a small metal-bristled brush to scrape away the material, which came off pretty easily.
Kapton Tape	6 mins., 30 secs.	N/A	-	Could not remove masking material. One bolt was lost during the galvanizing process.	Tape was nearly impossible to remove from threads	Unable to remove tape from threads. This material would not work as a masking material, as it cannot be removed w/o damaging the threads.

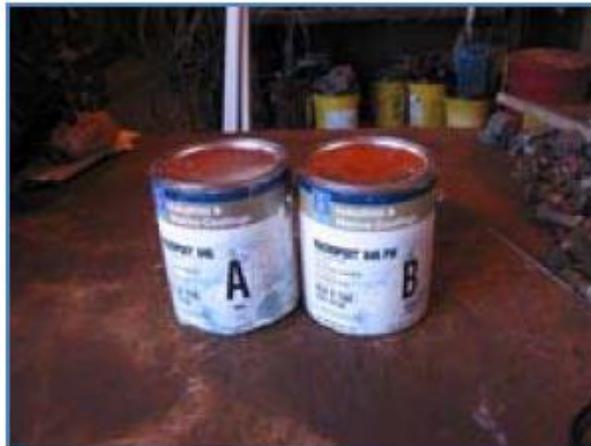
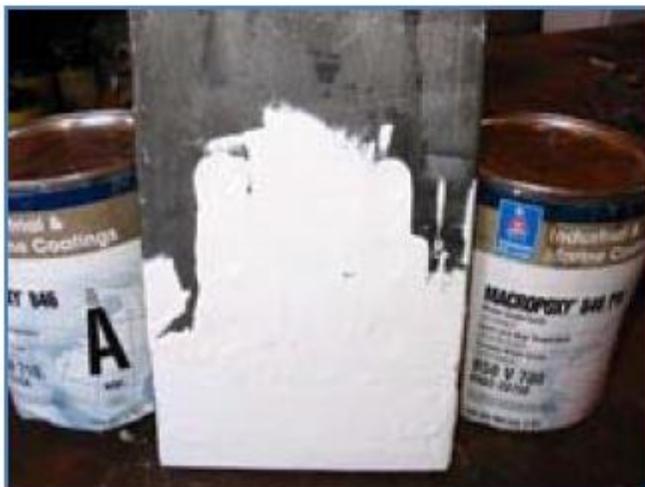
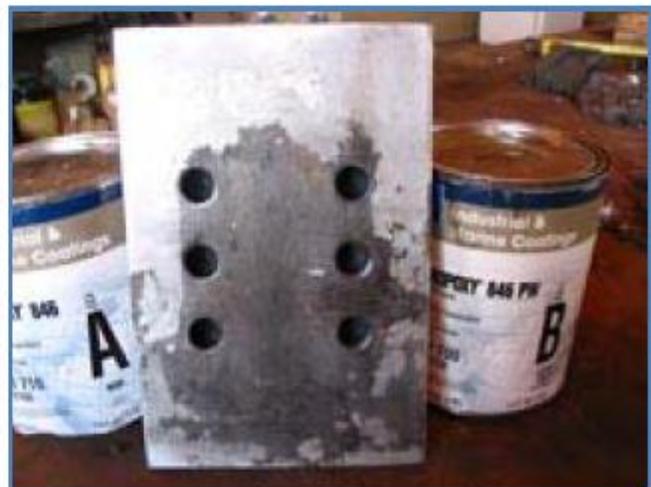
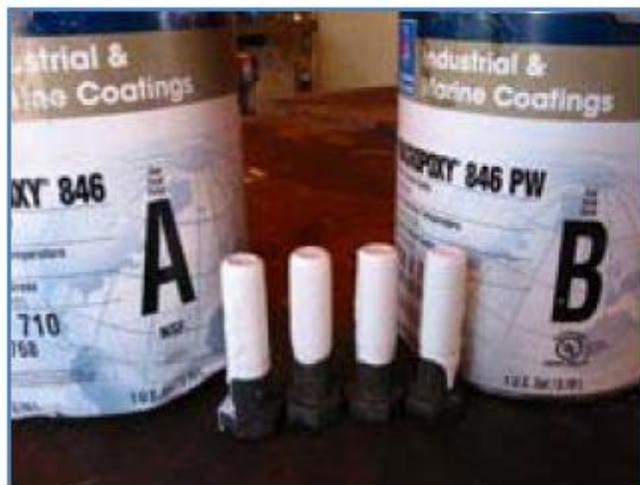
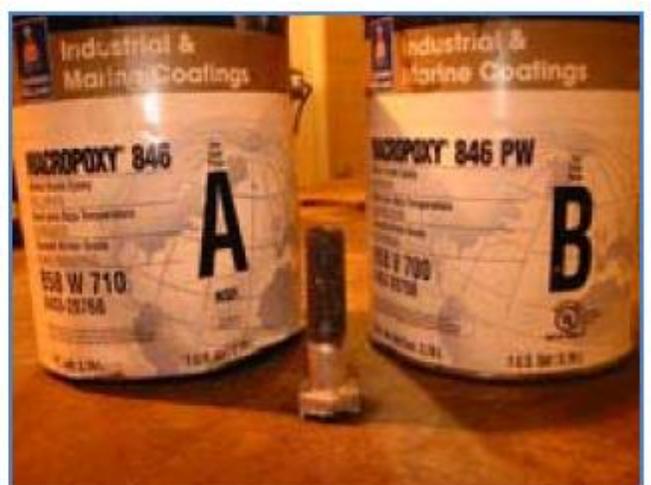
# Macropoxy 846

Macropoxy 846	32 mins., 14 secs. (31/32 mins. spent on prep time for epoxy)	Poured onto the surface and spread with a foam paint brush.	-	About 15% of the area galvanized	1 min., 37 secs.	Used a small metal-bristled brush to scrape the material off.
Maskote Zinc Stop - Off	2 mins., 37 secs.	Very runny - dries very quickly, making it hard to spread around. Used a foam brush for spreading.	Yes	Entire area was completely free of galvanizing, very clean.	1 min.	Used a big metal-bristled brush. The material came off very easily.
NAPA RTV Red	1 min., 32 secs.	Used a caulk gun, then spread using a foam brush. Went on easy, but kind of thick.	Yes	Almost the entire area remained free of galvanizing	1 min.	Used a big metal-bristled brush to scrape away the material.
Stop Galv	4 mins., 26 secs.	Poured the product on, spread with a foam paint brush. Product went on thick and dried quickly.	Yes	Very slight seepage at perimeters.	5 mins., 48 secs.	Used a small metal-bristled brush to scrape the material off. The material adhered to the surface tenaciously, which required much harder scraping.

Macropoxy 846	32 mins., 26 secs.	Preparation time for product took 31 minutes. Poured into holes; very runny and messy.	Yes	None of the holes galvanized.	8 mins., 40 secs.	Used flathead screwdriver to break apart material inside the holes. Material was extremely hard, required considerable force. Used a small metal-bristled brush to scrape out rest of the material, which also required considerable effort.
Maskote Zinc Stop - Off	5 mins., 13 secs.	Poured into holes; runnier than Galva Stop or Stop Galv. Dries faster than other products, too.	Yes	None of the holes galvanized. Holes looked very clean.	3 mins.	Used a small metal-bristled brush to clean material out of the holes. Material came out very easily.
NAPA RTV Red	1 min.	Squirted into holes with a caulk gun	-	2 of the holes galvanized completely, 4 holes galvanized partially.	5 mins., 51 secs.	Used flathead screwdriver to pry out material, then used a small metal-bristled brush to clean the rest of the material out.

Macropoxy 846	37 mins., 10 secs.	Preparation of the product took 31 mins. Dipped bolts into masking material to apply. Material was runny, like paint.	Yes	Received only 1 bolt back (the rest must have fallen out of the basket during the galvanizing process). A few very small areas did galvanize.	1 min., 11 secs.	Used a small metal-bristled brush to scrape away the product, which came off pretty easily.
Maskote Zinc Stop - Off	5 mins., 12 secs.	Very runny, hard to smear around. Rather than smearing, it dries, lumps up, and comes off the metal. Very strong, nauseating smell - similar to nail polish remover.	Yes	Some small areas did galvanize.	3 mins., 5 secs.	Used a small metal-bristled brush to scrape off the material, which came off very easily.
NAPA RTV Red	9 mins., 45 secs.	Smearred material on w/ a foam paint brush. Applied thick in many areas because of product consistency.	Yes	A few small areas picked up a little zinc.	4 mins., 18 secs.	Used a small metal-bristled brush to scrape away the material, which came off very easily.

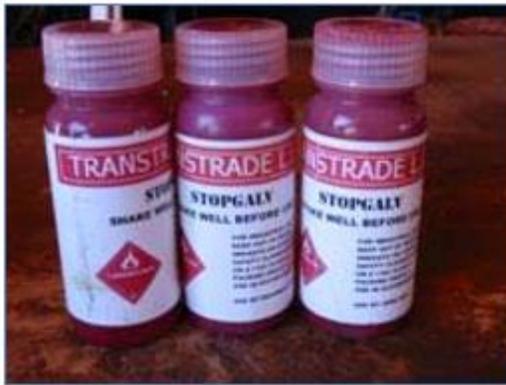
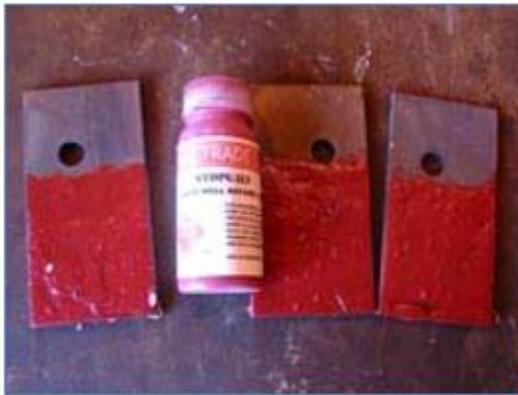
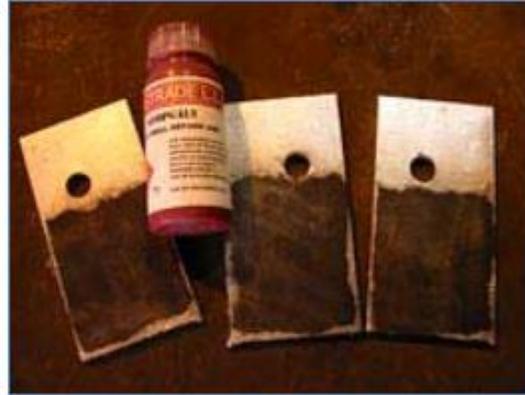
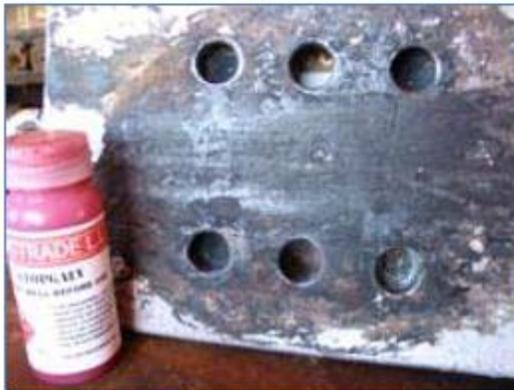
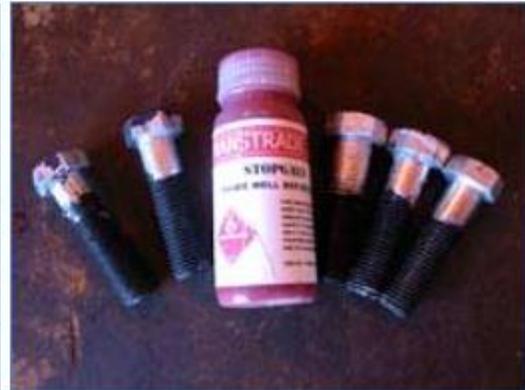
# Stop Galv

Stop Galv	4 mins.	Poured into holes.	-	1 of the 6 holes galvanized	11 mins., 30 secs.	Used a metal-bristled brush to scrub the material out. Holes were charred black inside.
Valmont Masking Compound	10 mins., 30 secs.	Had to cut into the side of the roll, since an industrial size caulk gun was not available.	Yes	In addition to masking intended areas, it caused bare spots in surrounding areas.	5 mins., 28 secs.	Used flathead screwdriver to break apart material, then used a small metal-bristled brush to scrape out remaining material.
VHT Header Paint	N/A	N/A	N/A	N/A	N/A	N/A
ZYP Boron Nitride Hardcoat	3 mins., 24 secs.	2 minutes of application time was due to stirring product. Poured material into the holes. Material dried fast.	Yes	None of the holes galvanized, but there was some frozen zinc inside the holes that had to be wedged out. Wedging out the zinc might not always be possible for all fabrications.	7 mins., 52 secs.	Used flathead screwdriver to break apart hard ash, then used small metal-bristled brush to scrape out the rest. Some small particles remained inside the holes.

Stop Galv	5 mins.	Dipped bolts into bottle to apply material. Thicker than Galva Stop. Hardened, but still flexible. Sticks to itself if it touches other coated products.	Yes	Got 5 bolts back. Almost all threads were completely bare.	10 mins., 20 secs.	Scraped the material off with a big metal-bristled brush. The material came off very easily and the threads had very little residue.
Valmont Masking Compound	9 mins., 10 secs.	Goes on very thick, so it could get expensive. Used a foam paint brush to spread around. Need an industrial size caulk gun.	-	All bolts lost during testing.	N/A	N/A
VHT Header Paint	N/A	Not tested, as paint cannot be easily removed after galvanizing.	-	N/A	N/A	N/A
ZYP Boron Nitride Hardcoat	4 mins., 5 secs.	Three mins. of application time due to stirring. Dipped bolts into material. Dries very fast.	-	Many areas had zinc frozen between the threads.	4 mins., 57 secs.	Used small metal-bristled brush to scrape material off. Baked-on material was much harder than other products. Could not remove all of the product.

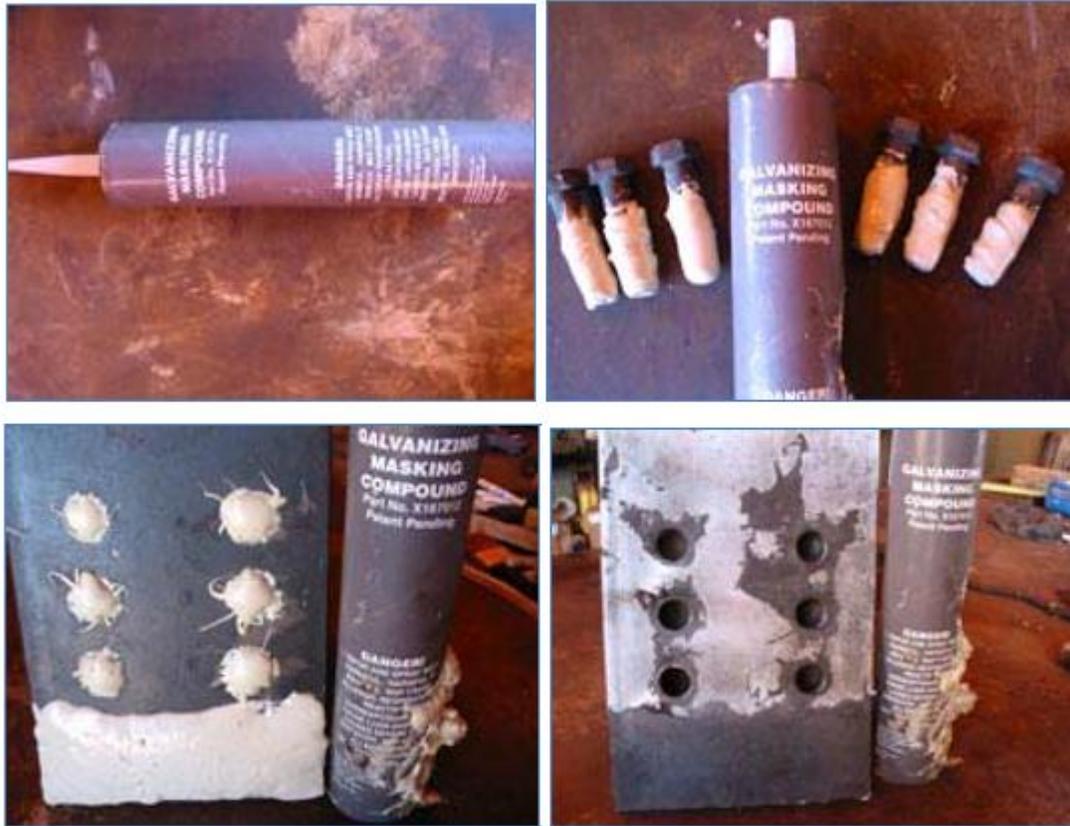
## Valmont Masking Compound

Valmont Masking Compound	2 mins., 32 secs.	Very thick, like a paste. Used a foam brush to spread around.	Yes	Entire area was completely free of galvanizing.	1 min.	Used big and small metal-bristled brushes to scrape material off the metal.
VHT Header Paint	1 hr., 33 mins.	Applied 2 coats of paint. Allowed for dry time between coats.	-	All the plates galvanized	N/A - product failed completely.	N/A
ZYP Boron Nitride Hardcoat	3 mins., 48 secs.	Two minutes of application time was to stir the product. Poured onto the surface and spread with a foam paint brush.	-	About 20% of the area galvanized.	2 mins., 32 secs.	The burned product adhered to the steel very well. I had to score it with the edge of a flathead screwdriver and then scrape it with a small metal-bristled brush.
ZYP Boron Nitride Lubricat	4 mins., 16 secs.	Poured onto the surface and spread with a foam paint brush. Material had the runniness of paint and was very messy. 3 minutes of the application time was due to stirring the product like paint.	-	The entire area galvanized.	N/A	N/A

The bolts masked with Valmont Masking Compound were lost during the galvanizing process during testing.

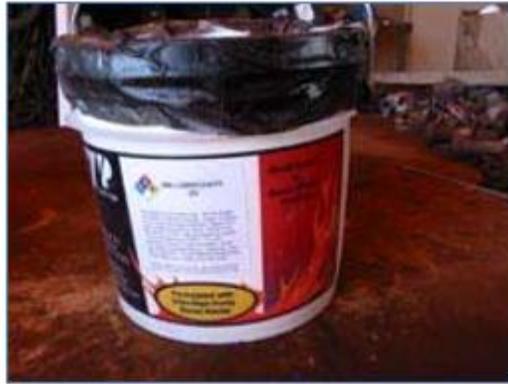
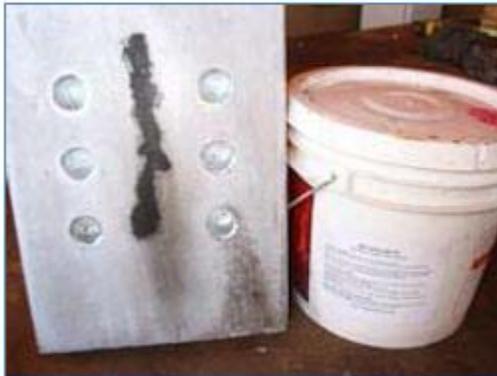
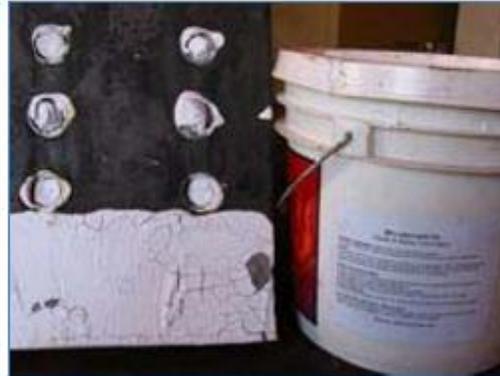
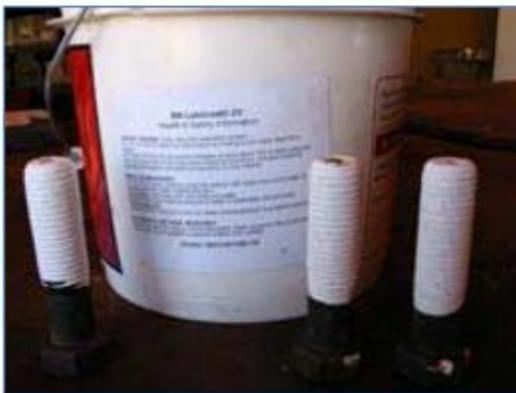
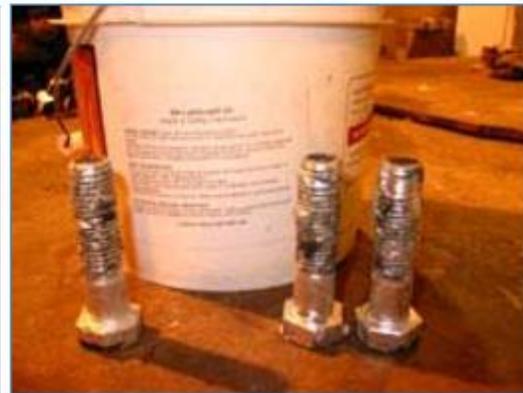
## ZYP Boron Nitride Lubricant

ZYP Boron Nitride Lubriccoat	4 mins., 16 secs.	3 minutes of application time was due to stirring the product. Poured into holes.	-	All of the holes galvanized 100%.	N/A	N/A - all holes galvanized 100%.

ZYP Boron Nitride Lubricoat	5 mins., 14 secs.	Three minutes of application time was stirring the product. Dipped bolts into masking material to apply.	-	All bolts picked up excessive zinc. A lot of the zinc was just frozen, but many areas galvanized too.	N/A	N/A
