Irondequoit Bay Seasonal Outlet Bridge

Rochester, NY; 1998

Bridge & Highway

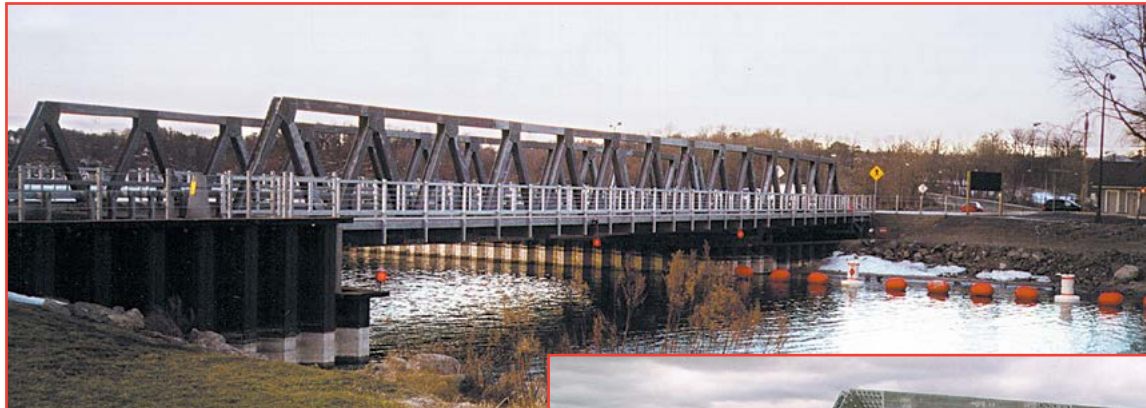
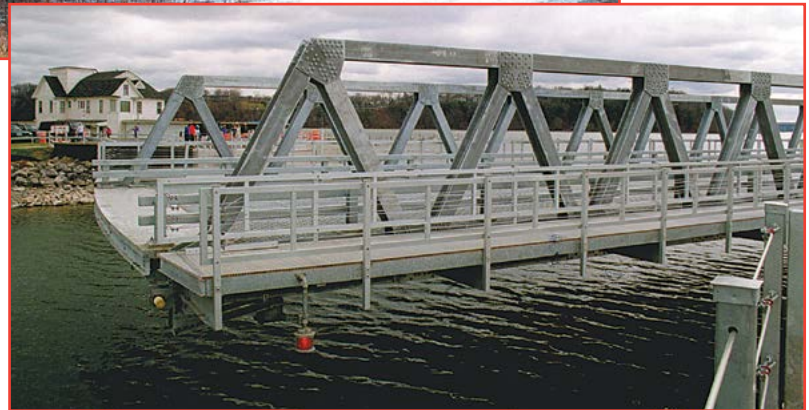
This is a 24-foot-wide, 2-span swing bridge with a 132½-foot main span and a back span of 53 feet. The structure is a galvanized pony truss with all bolted connections and has a five-foot cantilevered walkway along each side. An open grate steel decking was used to reduce the weight of the bridge. Hot-dip galvanizing was specified because a cost analysis showed galvanizing was not only competitive in initial cost, but also superior in long-term costs when compared to the traditional 3-coat paint system.

This unique seasonal structure allows winter vehicular access to businesses west of the outlet, summer boating entry to Lake Ontario, and year-round emergency vehicle access. Because its proximity to the water and open-deck drainage result in continuous exposure to moisture, galvanizing was chosen for long-term corrosion protection. Additionally, because the bridge must be available in case of emergency, the maintenance-free galvanized coating was the logical choice. Galvanizing also relieved some fabrication stress, with a resulting increase in the fatigue capacity of the grating. A total of 160 tons of structural steel, 25 tons of reinforcing steel, 4,000 square feet of decking, and traffic and pedestrian accoutrements were galvanized, thus assuring emergency personnel, consumers, and boating enthusiasts will encounter no maintenance delays for many years to come.
