# Hot-Dip Galvanized Steel vs. Paint

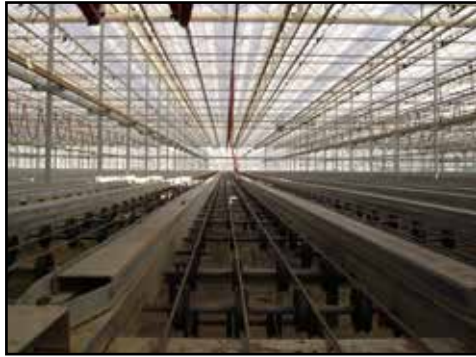
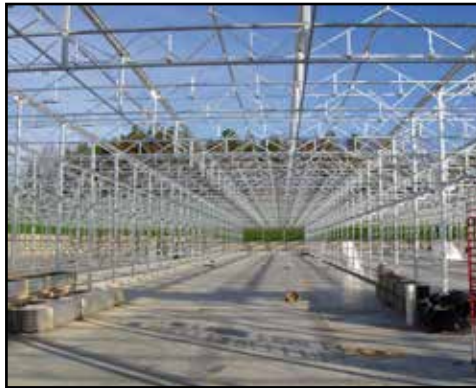
Metrolina Greenhouses Galvanized in 1971

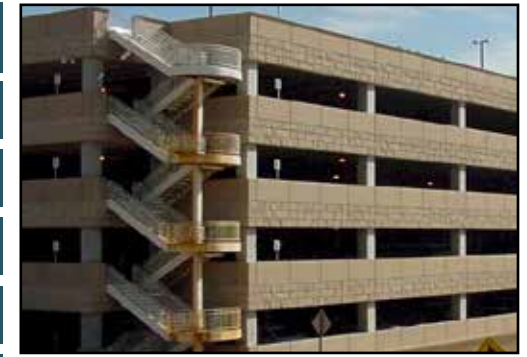
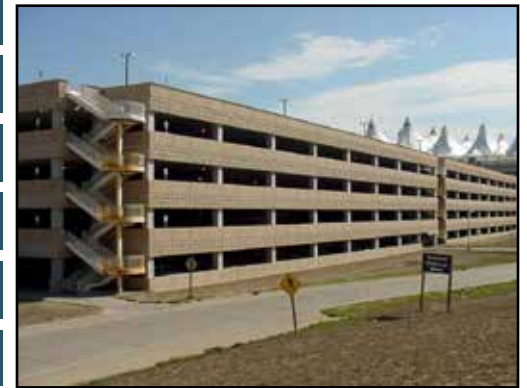
Painted Parking Garage Stairs after (8 years of service)
