Hot-Dip Galvanizing

COSTS LESS, LASTS LONGER

Information and Case Studies Examining the Cost-Effective Nature of Hot-Dip Galvanizing

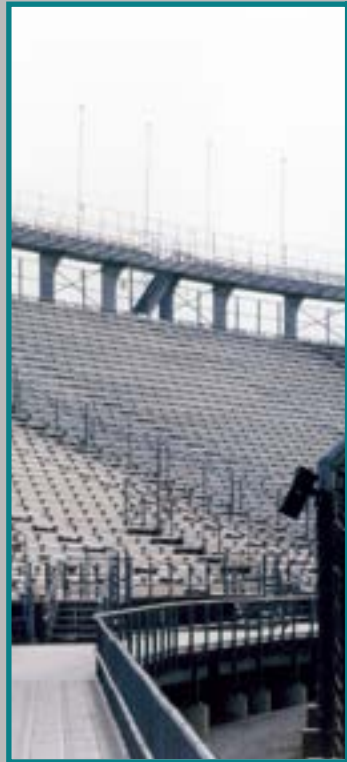
A thousand tons of steel bleachers were galvanized during the 1991 renovation, and the success of the coating led IMS to set a goal to replace one section of bleachers each year between scheduled events until the entire structure was protected by hot-dip galvanizing. In 2009, nearly 20 years after the original galvanizing was installed, an inspection of the steel in Turn 3 was conducted to test the zinc coating thickness. Even after being subjected to years of constant foot traffic, debris, and constant exposure to Indiana’s weather, the hot-dip galvanized coating was thick enough to meet the minimum coating specification.

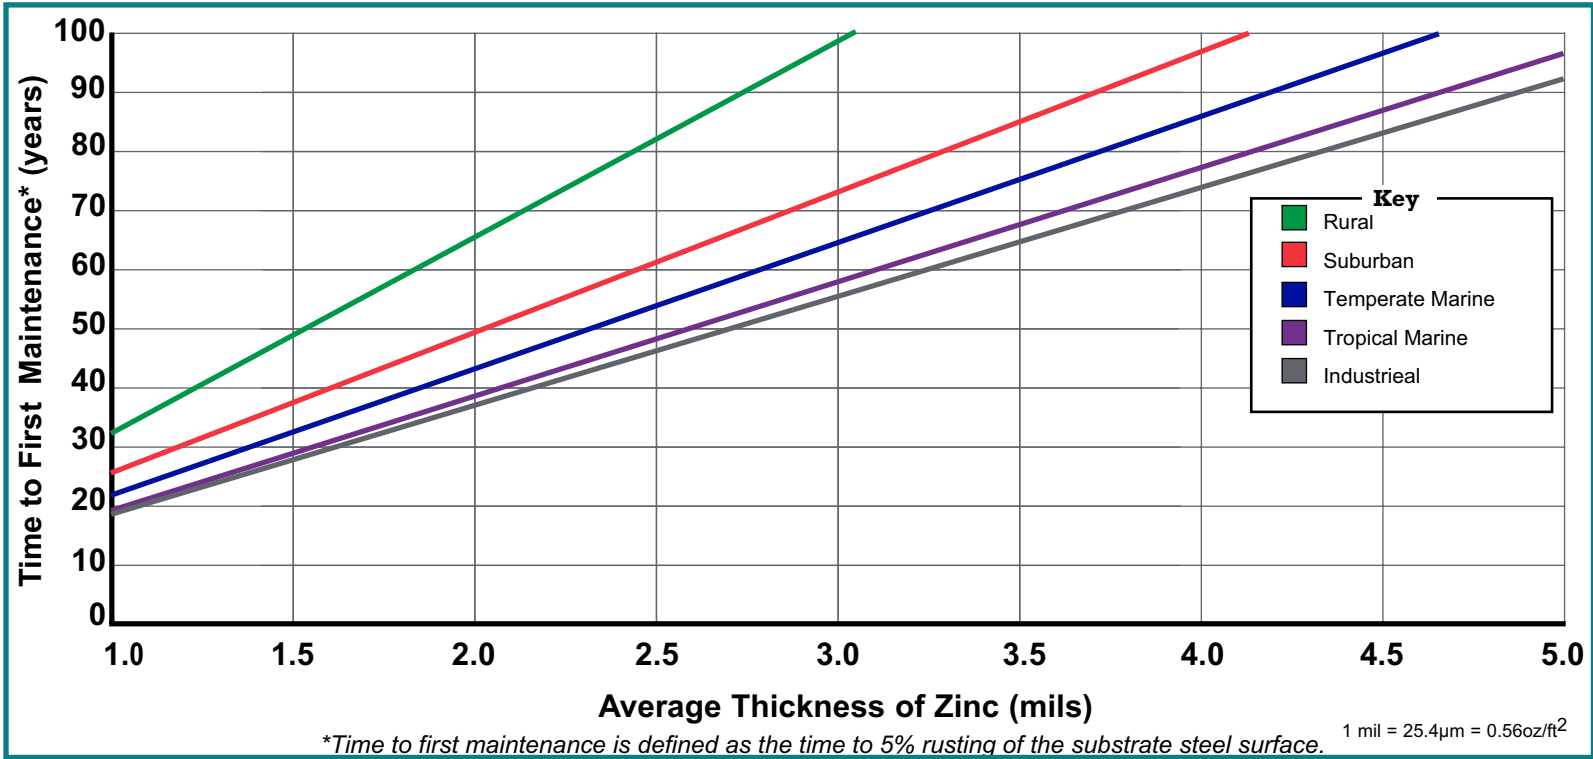
Figure 1: Time to First Maintenance

When evaluating steel corrosion protection systems, understanding the severity of the service environment is very important. The maintenance schedules for corrosion protection systems are dictated by the environment where the project is located. Each corrosion protection system, whether paint or hot-dip galvanizing will have an estimated time to first maintenance based on the corrosion rate in the given environment (*Figure 1*).

Each paint manufacturer provides a practical time to first maintenance for the specific coatings in the NACE paper. Similarly, the hot-dip galvanizing industry, using real world data from around the globe, has estimated the time to first maintenance of galvanized steel in five environments (*Figure 1, page 8*).

The environmental factor is an important variable in the life-cycle cost calculation because the different coating systems corrode at different rates in each of these conditions. The corrosion kinetics involved with hot-dip galvanized steel are quite different than the corrosion of painted or powder coated steel.
